**CITY OF CHICAGO - DEPARTMENT OF TRANSPORTATION
BRIDGE INVENTORY REPORT**

Structure No. 016-6042

**100th Street
over
the Calumet River**

Inspection Date: August 16, 2021

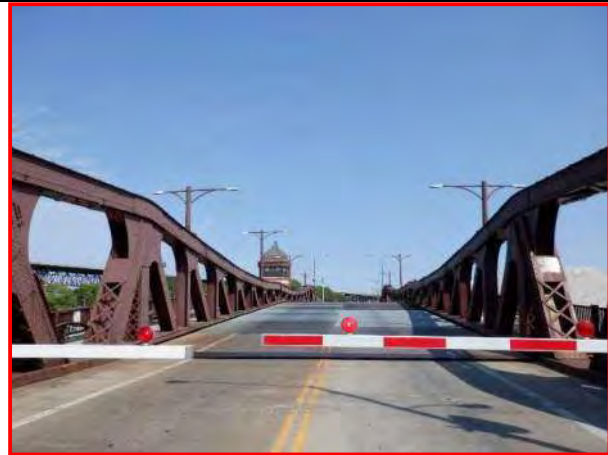
1. Overall top of deck, looking east

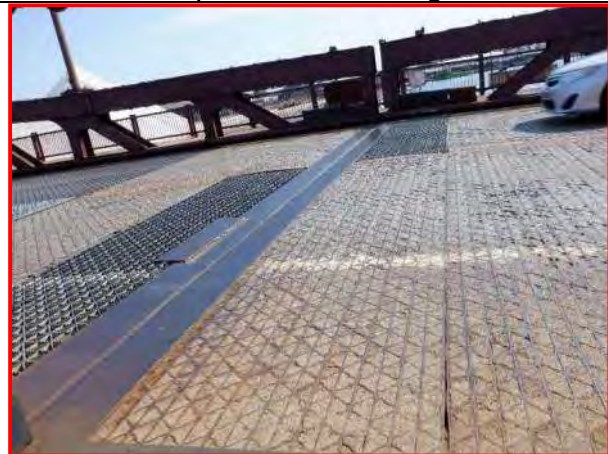
- In Span 3, the concrete-filled steel grating at the center and rear breaks typically exhibit heavy corrosion, scaling and pop-outs.
- The three panels on either side of the center break are heaved (see Photographs 2 and 3).
- In Span 3, approximately 60% of the open grating panels have been replaced since the last inspection. The remaining open panels have minor corrosion.

3. West leaf near the center break, looking southeast

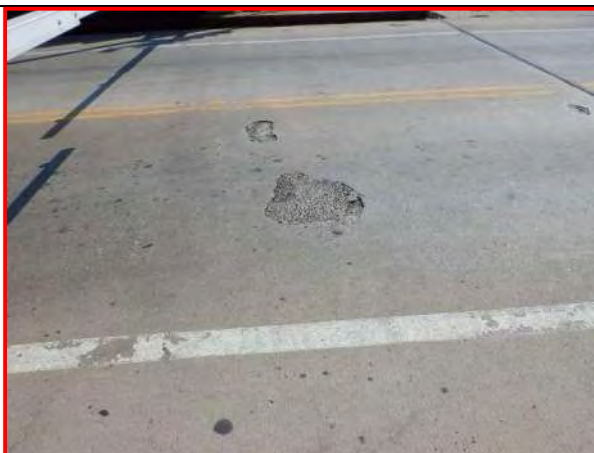
- In the fixed spans, the concrete wearing surface has numerous spalls up to 6 SF, some with failing asphalt patches, scattered narrow to medium transverse and longitudinal cracking, and hairline to narrow map cracking (see Photograph 4).
- Pavement markings are faded throughout and have missing sections in Span 3.

4. Spans 4 and 5 top of deck, looking south

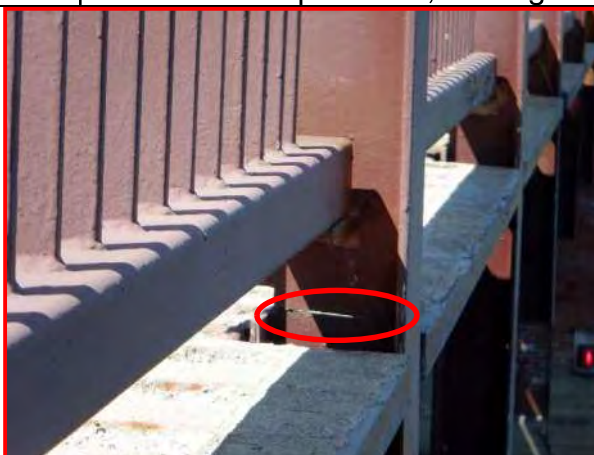
- In Span 3, several of the bridge railing supports are partially or fully cracked through the web section (see Photograph 5).
- The bridge railing has paint peeling scattered throughout.
- The stone parapets in the fixed spans have hairline to narrow vertical cracks and slightly deteriorated stones and joint filler material (see Photograph 6).
- The northeast approach bridge railing has been removed and replaced with fencing since the last inspection.

5. Bridge railing, looking west

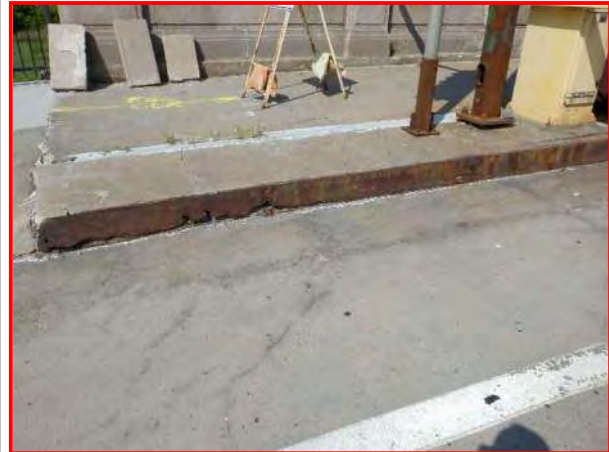
- In the movable span, the steel plate curbs have isolated spots of minor scrapes and corrosion.
- In the fixed spans, the steel curb plates exhibit heavy corrosion and section loss with several detached or missing steel plate sections and spalled concrete behind the plates (see Photograph 7). At the northeast corner, the curb plate is wavy.

7. North curb plate in Span 4, looking north

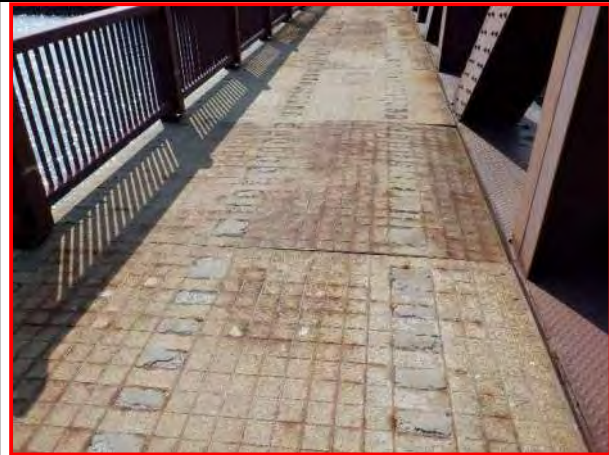
- At the time of inspection, the north sidewalk was closed to pedestrians.
- In the movable span, the top surface of the sidewalks exhibits spalls and heavy rust staining within the concrete filled deck and moderate to heavy corrosion in the steel grating.
- The top surface of the north movable span sidewalk is sloped to the north. A few panels in the south movable span sidewalk are bowed (see Photograph 8).
- The underside of the movable span sidewalk exhibits moderate corrosion and minor section loss of the steel grating (see Photograph 9).
- In the fixed spans, the sidewalks have several narrow to wide transverse and longitudinal cracks, small spalls, and pop outs in the top surface.

8. South sidewalk in Span 3, looking west

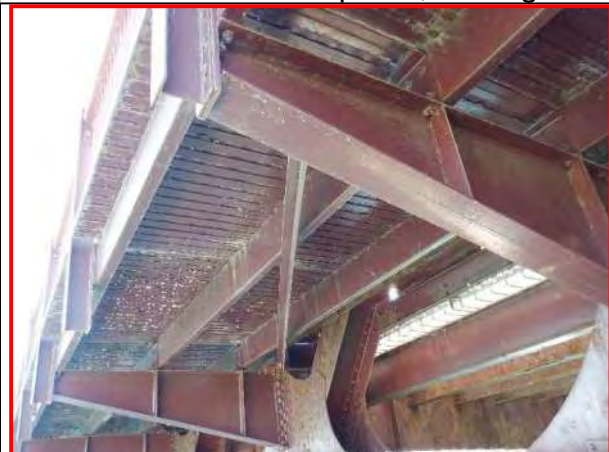
9. North sidewalk soffit in Span 3, looking southeast

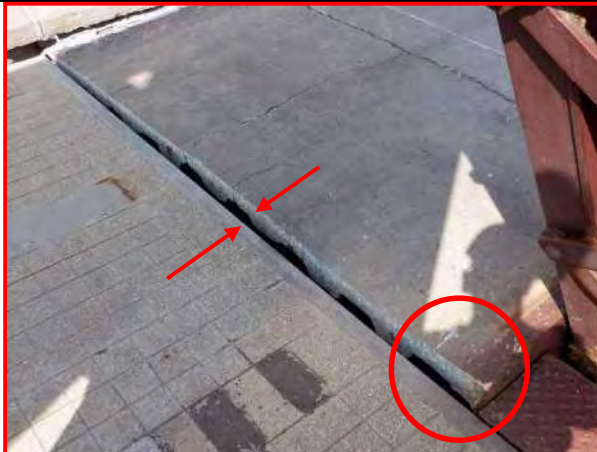
- At the east rear break, the first north fixed span sidewalk panel is broken, and there is up to a 2½” wide gap and ¼” vertical differential between the fixed sidewalk panel and the movable span (see Photograph 10).
- There are a couple of temporary plywood repairs in the sidewalks.
- The heaving at the northwest approach sidewalk has been repaired (see Photographs 11 and 12).
- Away from the repair area noted above, there is up to a 3” vertical differential between the northwest sidewalk and the northwest approach sidewalk (see Photograph 12).
- The northeast approach sidewalk has been replaced since the last inspection (see Photograph 13).
- The southeast approach sidewalk has a vertical differential at the East Expansion Joint.

10. Span 2 north sidewalk, looking northeast

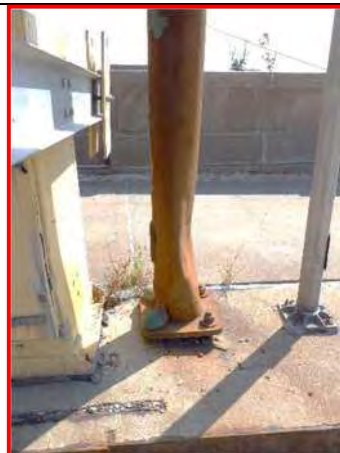
- The light standards typically have moderate corrosion, peeling paint, missing anchor bolt covers, and loose or missing hand hole covers with exposed wiring.
- In Span 5, the south light standard has a dent in the pole near the base and a 10" long crack at the base (see Photographs 14 and 15).
- Span 3, the light standard on the east end of the Southwest Truss is not in place and there are exposed wires.

14. South light standard in Span 5, looking south

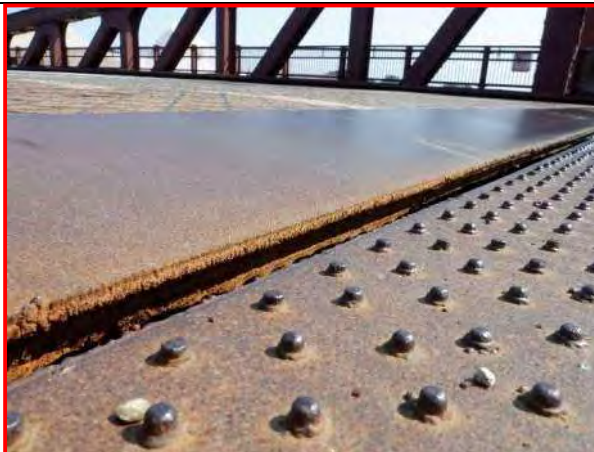
- The West Abutment Expansion Joint has moderate corrosion in the bike lanes, a wavy seal, 3' of tears, and debris accumulation.
- The west rear break weldment is sloping downward toward the opening (see Photograph 16).

16. West rear break, looking southeast

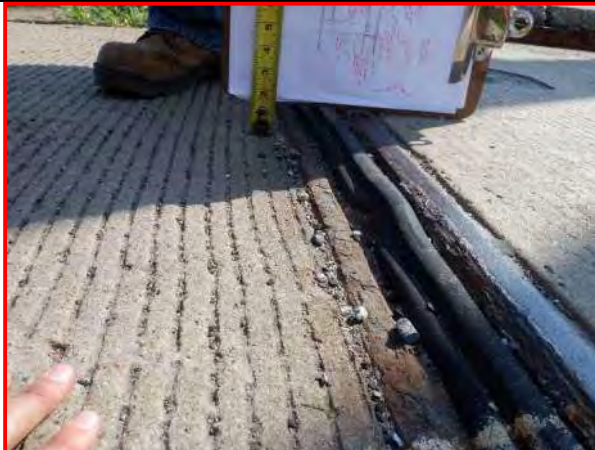
- The bridge side of the East Abutment Expansion Joint is 1½” higher than the approach slab side at the south gutterline. The vertical differential decreases to nearly level at the north gutterline (see Photograph 17 & 18).
- The East Abutment Expansion Joint has tears, a 2’ length of broken rail, moderate corrosion, and gouges.
- The center break has an insufficient gap. In the eastbound lanes, the west leaf is 1½” higher than the east leaf and the steel open grating is another 1” higher than the west plate of the center break (see Photographs 19 & 20). In September, after this inspection was completed, construction began to replace the center break weldments.

17. East Expansion Joint, looking south

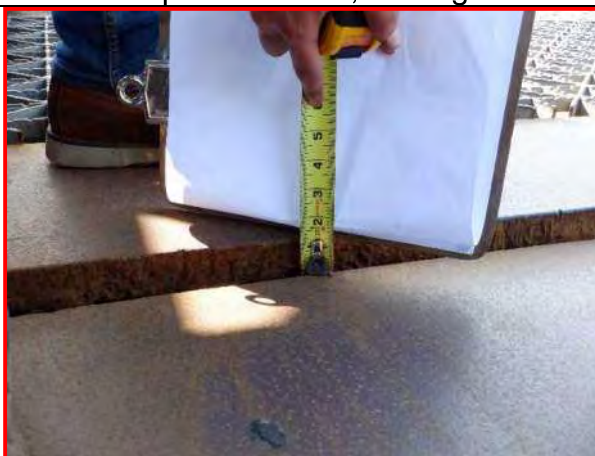
20. Vertical differential at center break, looking west

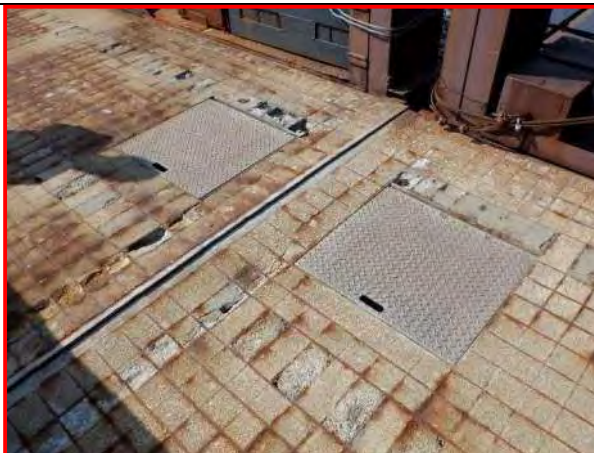
- In the south sidewalk at the center break, the west leaf is resting on top of the east leaf (see Photograph 21).
- At the rear breaks, the fixed spans are between $\frac{1}{8}$ " to $\frac{1}{4}$ " lower than the movable span. The east break weldment is cracked along the centerline of roadway (see Photograph 22).
- The northwest longitudinal sidewalk joint is failing (see Photograph 23).

21. South sidewalk at the center break, looking northwest

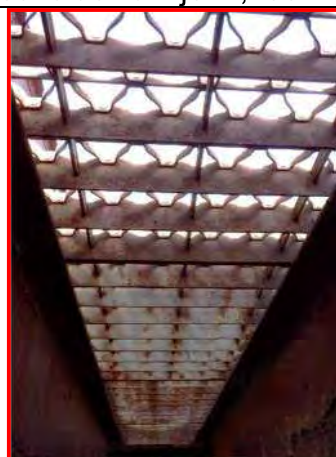
- In Span 3, the open steel grating has minor corrosion (see Photograph 24).

24. Open grating in Span 3, looking up

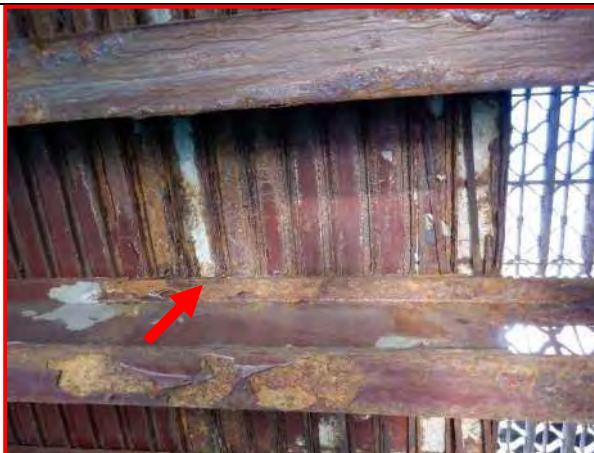
- The metal pans in the filled steel grating portions typically exhibit moderate to heavy corrosion, moderate to heavy section loss, and corrosion holes. Where the concrete is visible through the corrosion holes, it is typically spalled (see Photograph 25).
- In the fixed spans under the roadway, the deck soffit has scattered hairline leaching longitudinal and transverse cracks.
- In the fixed spans under the sidewalk, there is heavy delaminations/spalls up to 50 SF with exposed rebar, heavy scaling, and the remaining stay-in-place forms have corrosion holes (see Photographs 26 & 27). The south sidewalks have more deterioration.
- At the east rear break, the edge of the fixed span soffit is spalled (see Photograph 28).

25. Metal pans in Span 3, looking up

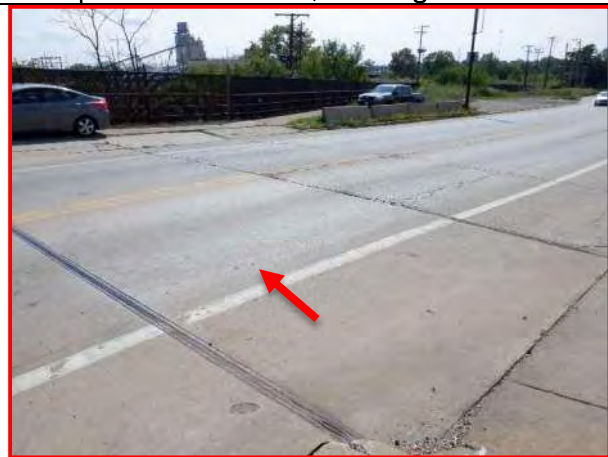
- The approach slabs exhibit scattered hairline to narrow longitudinal and transverse cracks (see Photograph 30).
- The approach pavements have large areas of missing bituminous material, wide longitudinal cracks, spalls along the relief joint, and map cracking along the shoulders.
- The approach sidewalks are heavily deteriorated and have differential settlements between panels (see Photographs 31).

30. West Approach, looking southwest

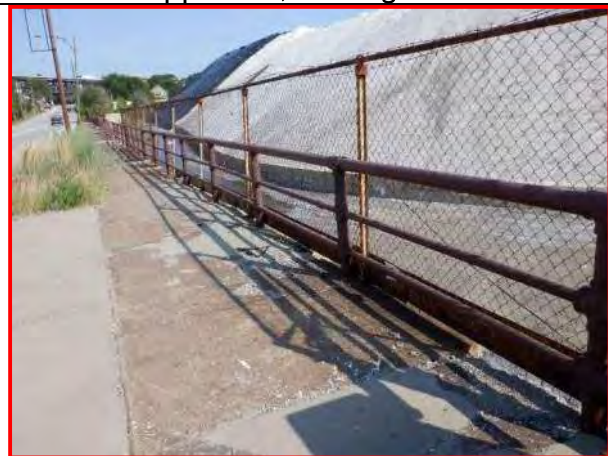
31. Southeast Approach sidewalk, looking east

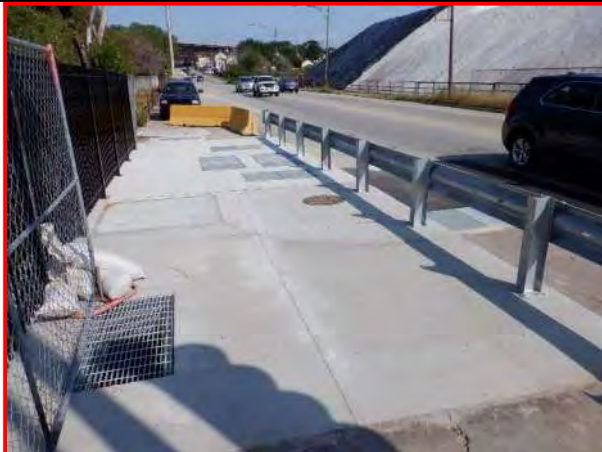
- In the northeast corner the guardrail has been replaced since the last inspection (see Photograph 32).
- The northwest approach guardrail has minor corrosion in the base plates.

32. Northeast guardrail, looking east

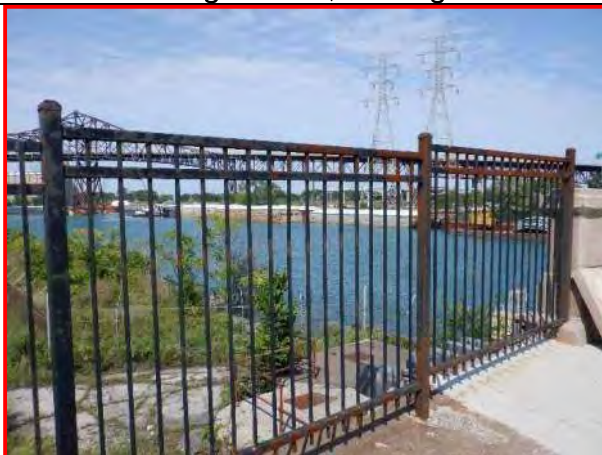
- Fencing is present at all four corners of the bridge directly adjacent to the fixed span stone parapets. Except for the new fencing in the northeast corner, the fencing typically has minor to moderate corrosion and minor section loss (see Photograph 33).
- The fencing in the northeast corner was replaced since the last inspection.
- The fence at the northwest corner of the bridge has a few loose base posts near the west end of the stone parapet.
- There is fencing around the rear arms of the truss. The fencing in the southwest corner is disconnected at the base and from the truss guard (see Photograph 34). The fence in the northeast corner has a few bent bars.

33. Northwest approach fence, looking northeast

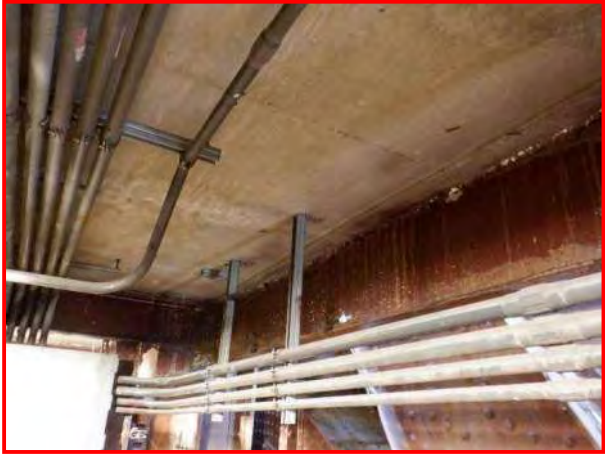
<p><i>Utilities</i></p> <ul style="list-style-type: none">• There are utility conduits attached to the deck soffit.

<p>35. Span 4 utilities, looking northwest</p>
<p><i>Signage</i></p> <ul style="list-style-type: none">• In Span 3, the north street sign on the bridge railing is slightly bent (see Photograph 36).• The other signs have no notable deficiencies.

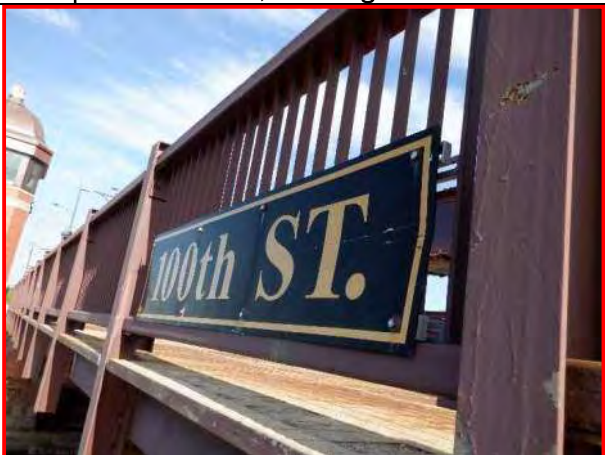
<p>36. Span 3 bridge sign, looking southeast</p>
<p><i>Other</i></p> <ul style="list-style-type: none">• The life preservers are in place on both bridge houses (see Photograph 37).• The truss guards have several corrosion holes, torch cut holes, and minor to moderate corrosion and section loss.

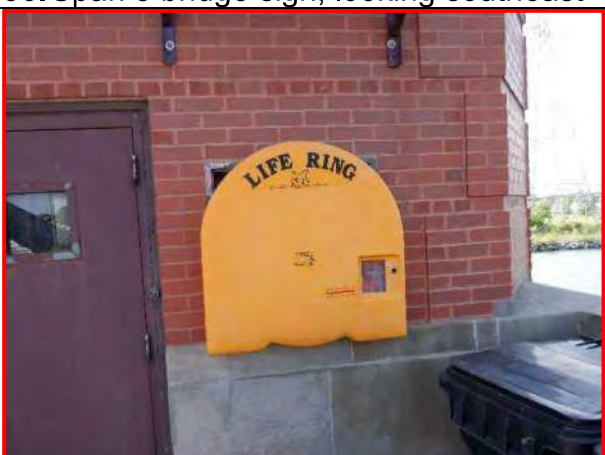
<p>37. Life preserver box at the northeast bridge house, looking west</p>

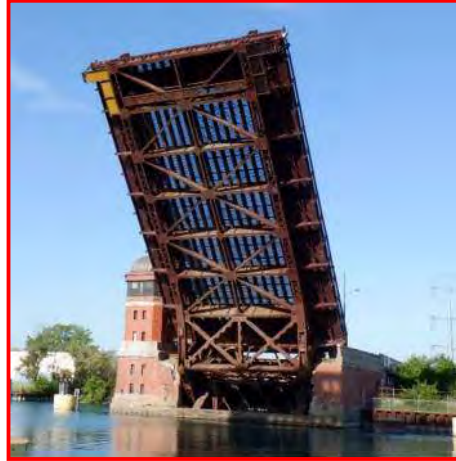
- The superstructure is in serious overall condition which corresponds to a NBIS and IDOT condition rating of 3. (Note – this condition rating is governed by the Fracture Critical rating.)

38. Overall underside of the movable span, looking southwest

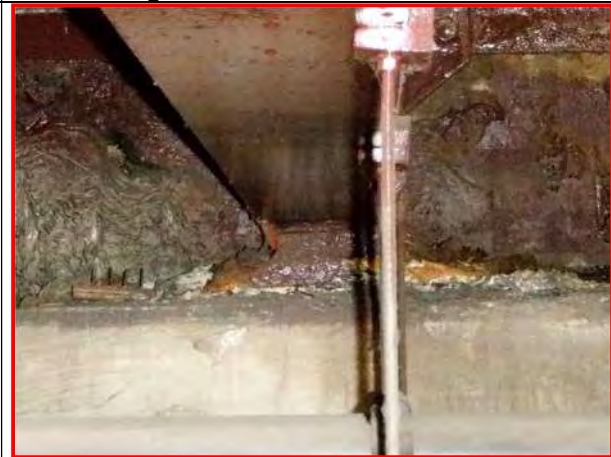
- The roadway bearings at the abutments typically exhibit moderate to heavy pitting and minor corrosion (see Photograph 39).
- The sidewalk bearings at the abutments have heavy corrosion and pitting.
- Several abutment bearings are laterally out-of-alignment with the stringers by up to 1 inch, and the anchor bolts and nuts exhibit heavy section loss.
- In Span 1 at the East Abutment, Stringers S3, S4, and S6 are not in contact with the bearing resulting in a gap up to 1" between the stringer and the bearing (see Photograph 40).
- The trunnion bearings exhibit moderate to heavy corrosion with minor section loss.
- The live load bearings have moderate corrosion, and the anchor bolts exhibit moderate section loss.

39. Typical West Abutment Bearing, looking west

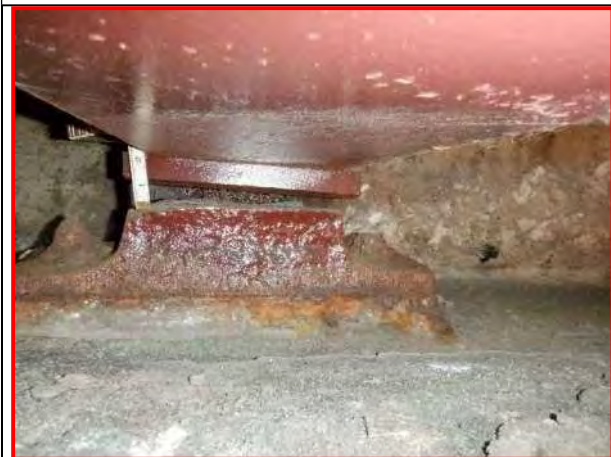
40. Span 1 Stringer S6 bearing, looking east

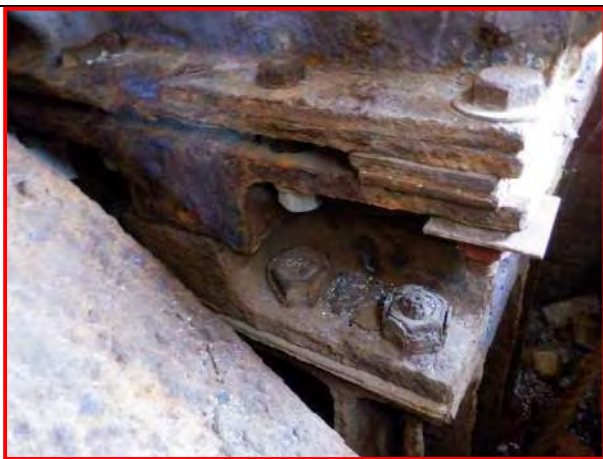
- The northwest and southwest live load bearings are shifted slightly east (see Photograph 41).
- The live load and trunnion girder bearings have bearing area loss, see Piers section for more details.
- The secondary live load bearings at the anchor columns have moderate to heavy corrosion and minor section loss (see Photograph 42).
- The secondary live load bearings have up to a 1/8" gap between the anchor column and the shoes.
- The trunnion girder bearings on the river pier have moderate to heavy corrosion with minor section loss.

41. Northwest live load bearing, looking north

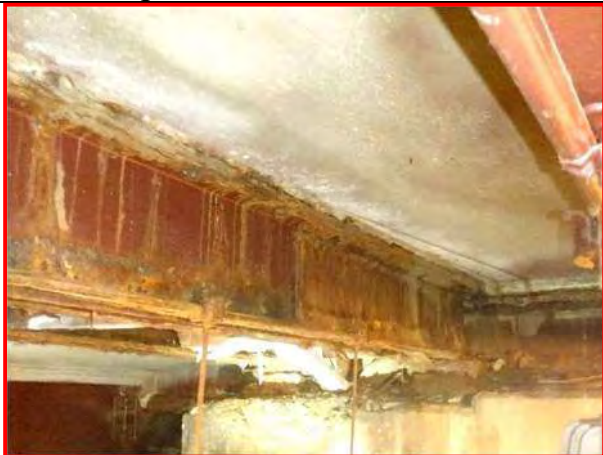
- In Spans 2 and 4, the roadway stringers have isolated areas of minor corrosion and section loss particularly near the rear breaks. The two fascia stringers in Span 4 have heavy corrosion and section loss.
- The sidewalk stringer ends at the abutments typically have heavy corrosion, section loss, and corrosion holes (see Photograph 43).

43. Span 5 north sidewalk stringer, looking southwest

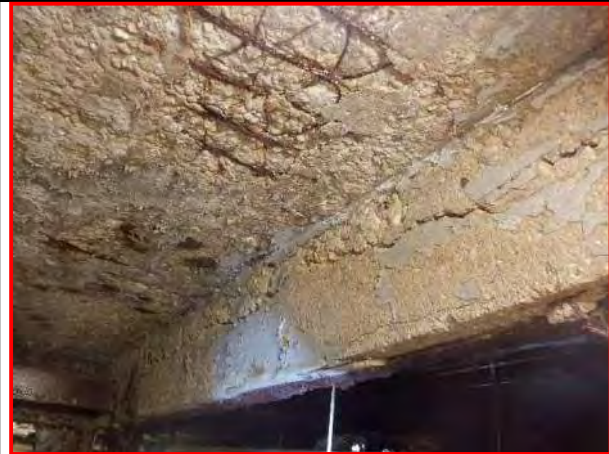
- In the fixed spans, the sidewalk stringers are deteriorated with moderate to heavy corrosion, heavy section loss, and crumbling encasement (see Photograph 44).

44. Span 4 sidewalk stringers, looking northwest

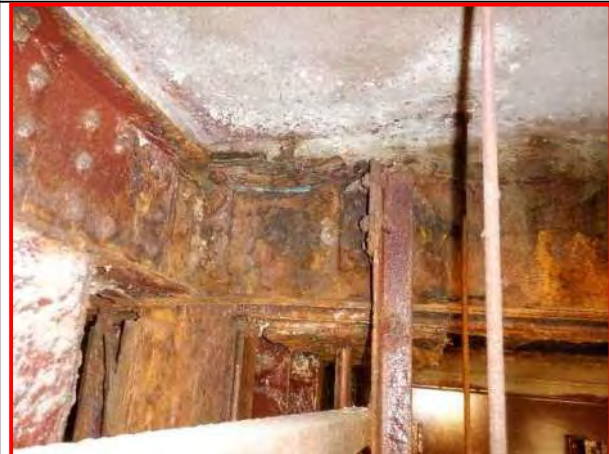
- The two southern sidewalk stringers in Span 1 have multiple puncture holes/tears in the web.
- There is heavy corrosion and almost 100% section loss at the connection between the double channel section sidewalk stringer near the anchor column and the sidewalk floorbeam in Span 5 (see Photograph 45).

45. Connection between sidewalk stringer and floorbeam in Span 5, looking south

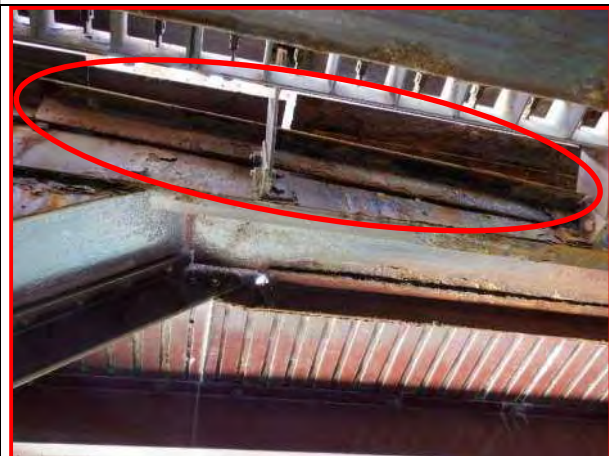
- In the movable span, the curb stringer to truss connections exhibit moderate to heavy corrosion and section loss (see Photograph 46).
- The top flange angles at the curb stringers in the movable spans have heavy corrosion and section loss, are missing or loose, and have cracked welds (see Photograph 47).

47. Top flange angle at the curb stringer, looking up

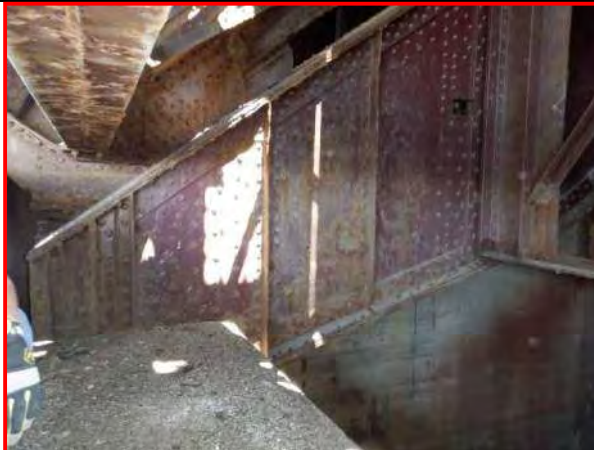
- The trunnion girders exhibit moderate corrosion and minor section loss in the bottom flanges and isolated minor corrosion and section loss in the web. The top cover plates have heavy pitting and minor corrosion along the outside edges and between the trunnion and river pier (see Photograph 48).
- The bearing stiffeners at the river pier exhibit corrosion and moderate section loss (see Photograph 49).

48. Northeast Trunnion Girder, looking north

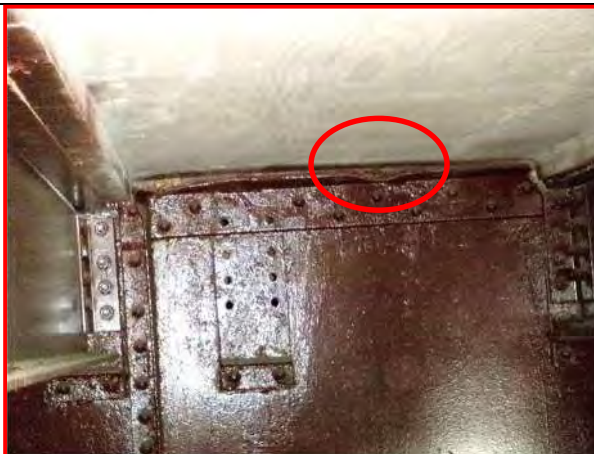
- Floorbeams 16-16 exhibit scattered areas of paint peeling.
- Floorbeams 21-21 have localized minor deformation in several locations in the top flanges over the counterweight pits (see Photograph 50).
- In the fixed spans, the sidewalk floorbeams exhibit moderate to heavy corrosion with heavy section loss.

50. Floorbeam 21-21W, looking west

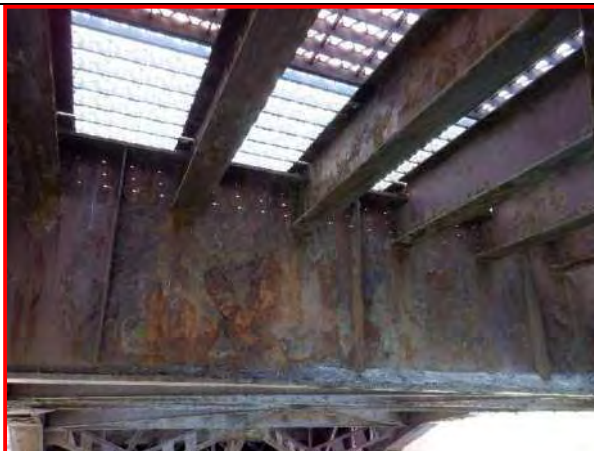
- In the movable span, the floorbeams exhibit minor to moderate corrosion with isolated spots of heavy corrosion, minor section loss and flaking, and debris accumulation along the bottom flange (see Photograph 51).

51. Floorbeam 8-8W, looking west

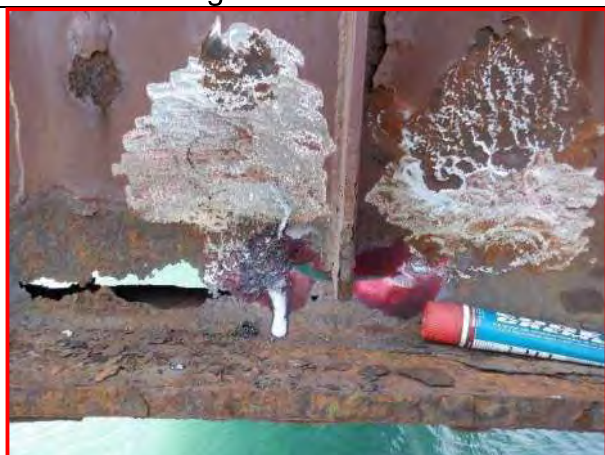
- Floorbeam 0-0E has 2 web cracks and Floorbeam 0-0W has 5 web cracks under the full-height stiffeners. Since the inspection, arrest holes have been drilled at all crack ends (see Photographs 53 & 54). Both Floorbeams' webs are distorted surrounding the stiffeners and cracks.

53. FB 0-0W crack, looking west

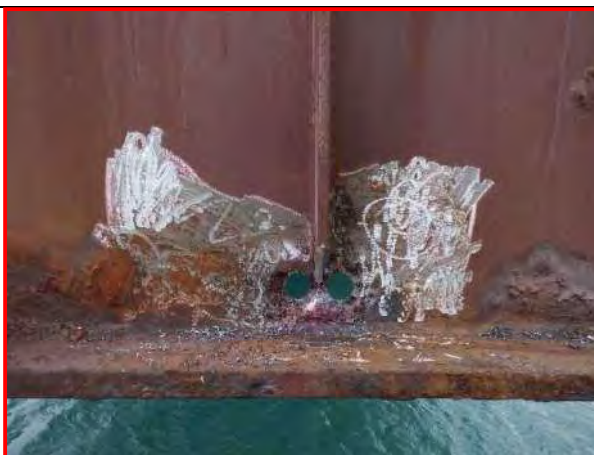
54. FB 0-0E crack, looking east

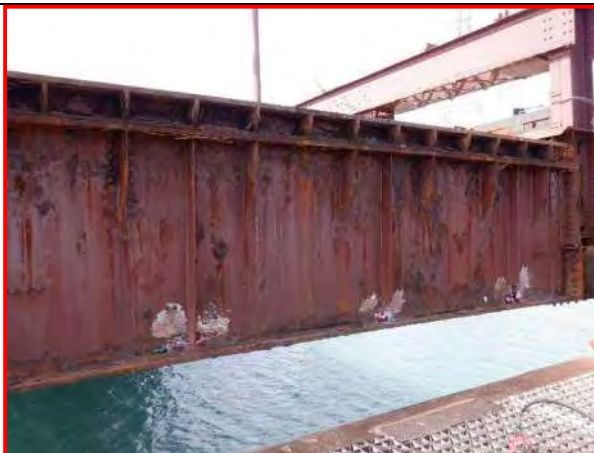
- Floorbeam 0-0W has heavy section loss in the bottom 1' of the web (see Photographs 55 & 56).
- In the movable span, the sidewalk brackets exhibit minor corrosion and areas of section loss in the flanges and webs. The deterioration is primarily in the southern brackets as most northern brackets are newer. The southern sidewalk bracket at 12-12E has a 9"x3" corrosion hole in the web (see Photograph 57).

55. FB 0-0W, looking northwest

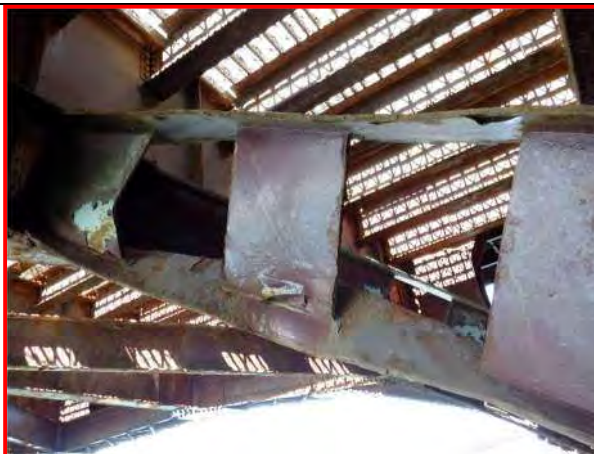
- The bottom lateral bracing in Panel 1 of the moveable span has multiple areas of bent flanges (see Photograph 58).

58. Span 3 Panel 1 lateral bracing, looking north

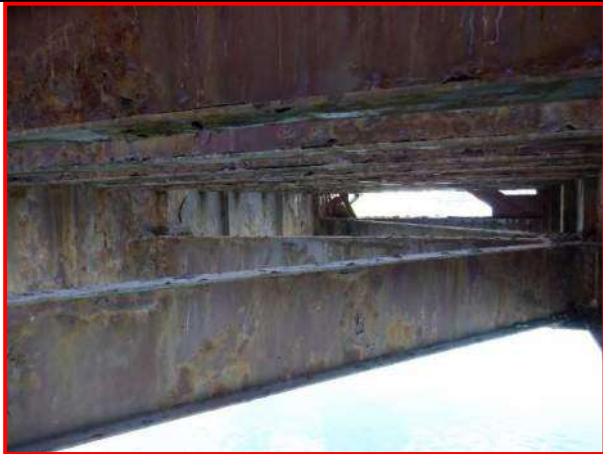
- The lateral bracing in Panels 2 through 14 have some areas of heavy corrosion, paint peeling, minor section loss, and vibrate under live load (see Photograph 59).
- At southwest Panel Point 12, the lateral brace connection has 2 missing bolts.
- The lattice trusses, 14-16W and 14-16E, have multiple fractured members and members with heavy section loss. The west lattice truss has a deteriorated wooden work platform (see Photographs 60).
- The diaphragms at the abutments typically have moderate to heavy corrosion and heavy section loss (see Photograph 61).

59. Typical lateral brace condition, looking north

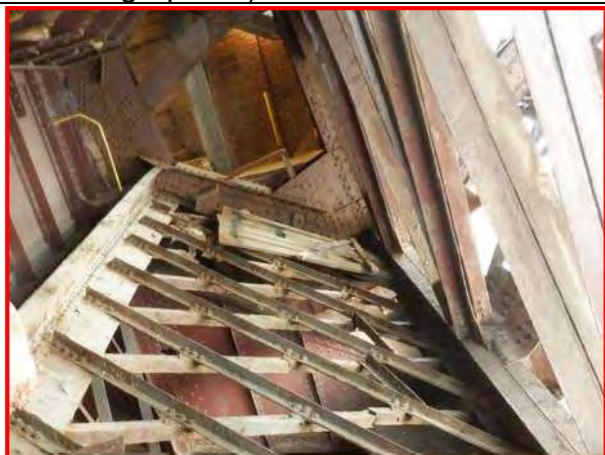
60. Span 4, lattice truss, looking north

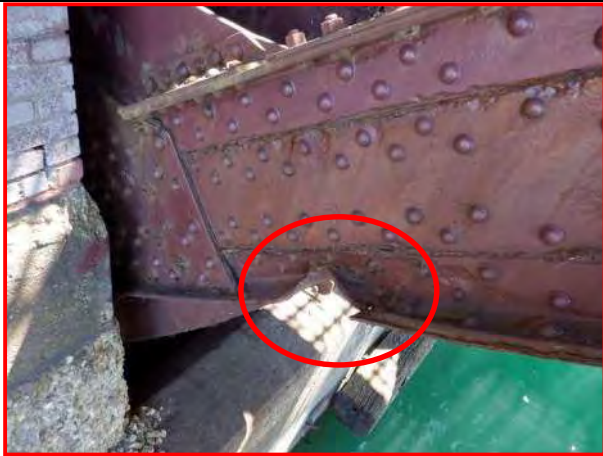
- There are bent and torn bottom chord flanges at the following locations: southeast, northeast, and southwest members 12-14, northeast and northwest members 2-4 and southwest member 0-2 (see Photograph 62).
- The bottom chords from Panel Point 4 to 14 exhibit moderate corrosion, minor to moderate section loss, and isolated corrosion holes along both flanges and intermittently along the web plates. Broken bottom lacing bars are also present at several locations.

62. Northeast Truss Member 12-14, looking south

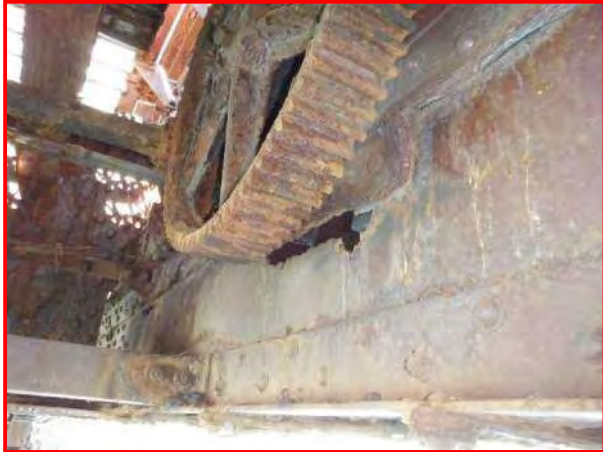
- The bottom chords from Panel Point 0 to 4 exhibit heavier deterioration and isolated large corrosion holes up to 18” (see Photograph 63).
- The outside face of Southwest Truss Member 0-2 has been repaired since the previous inspection (see Photograph 64). The inside face was not repaired.

63. Northwest Truss Member 0-2, looking southeast

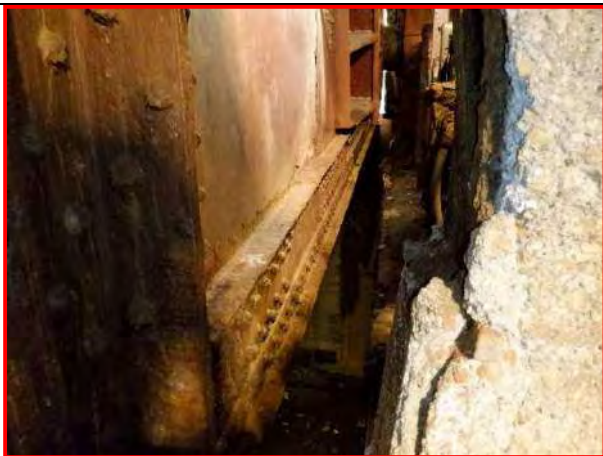
- Bottom chord members 14-20 have heavy corrosion and section loss near the front of the counterweight (see Photograph 66).

66. Bottom chord southwest truss, looking east

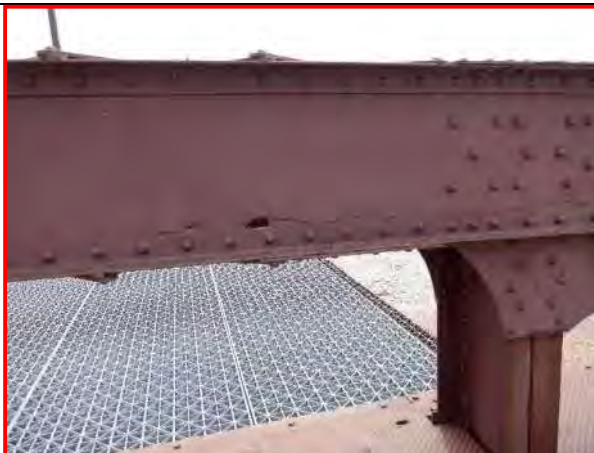
- The top chords have minor to moderate section loss throughout as well as several areas of corrosion holes and pack-rust along the web plates and the batten plates (see Photograph 67).
- Members 17-18 have a corrosion hole on the cover plate above the roadway.
- The truss diagonals and verticals exhibit minor to moderate corrosion, rivet head loss, pack-rust, and scattered heavy section loss and corrosion holes, primarily at and below the deck level (see Photographs 68 & 69).
- The truss vertical and diagonal members have several bent flanges.
- Along the vertical and diagonal members of the southwest truss, there is a welded railing attachment with several cracked and broken welds (see Photograph 70).

67. Top chord corrosion hole, looking south

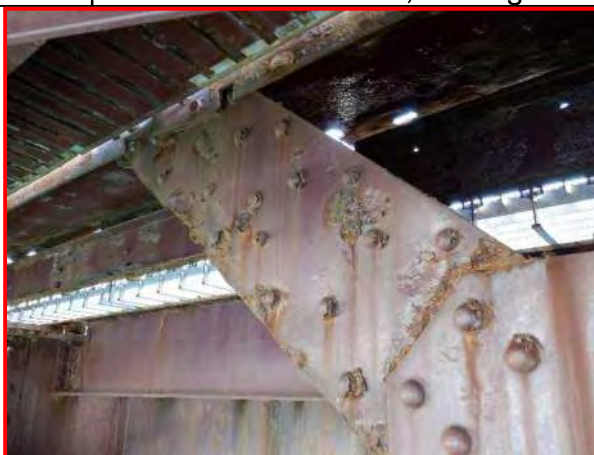
68. Typical diagonal member, looking northwest

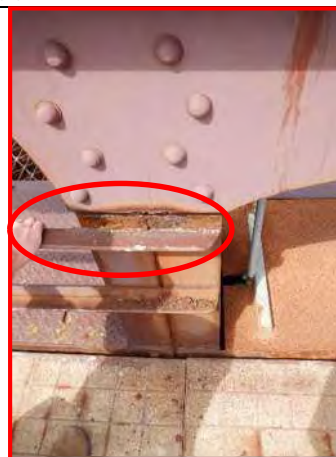
70. Weld on vertical member of southwest truss, looking north

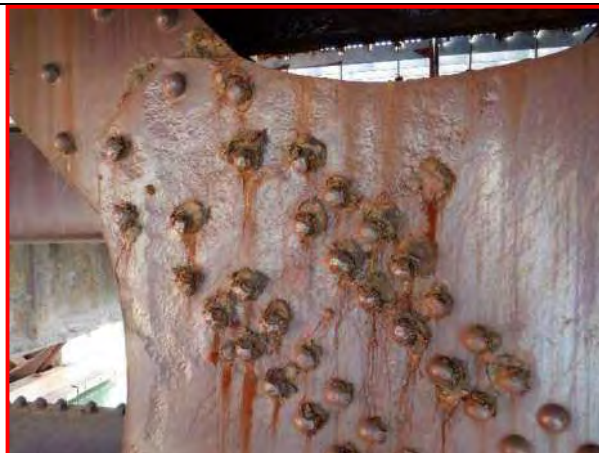
- The gusset plates exhibit minor corrosion and moderate to heavy section loss with isolated corrosion holes (see Photograph 71). The inside gusset plates tend to have heavier section loss.
- At Panel Point 0, the gusset plates exhibit heavy deterioration, primarily along the top of the bottom chord. Table 1 below summarizes the section loss along the top of the bottom chord for both the inside gusset plate (I.P.) and outside gusset plate (O.P.) at each Panel Point 0 (see Photographs 72-74).

71. Typical gusset plate, looking north

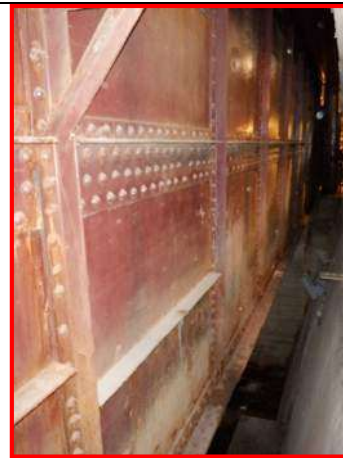
- The rear of the counterweight box has minor corrosion, minor section loss, and areas of corrosion holes along the stiffeners. The edges have worse deterioration (see Photograph 75).
- The bottom framing has areas of heavy corrosion and section loss, flaking, and areas of corrosion holes predominately at the corners (see Photograph 76).

75. Rear East Counterweight Box, looking northwest

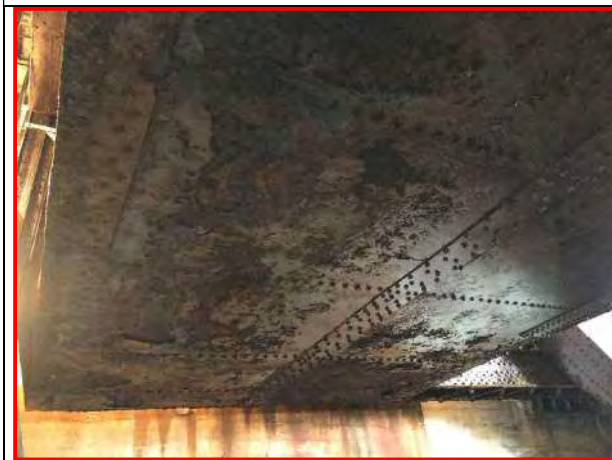
76. East counterweight box, looking south

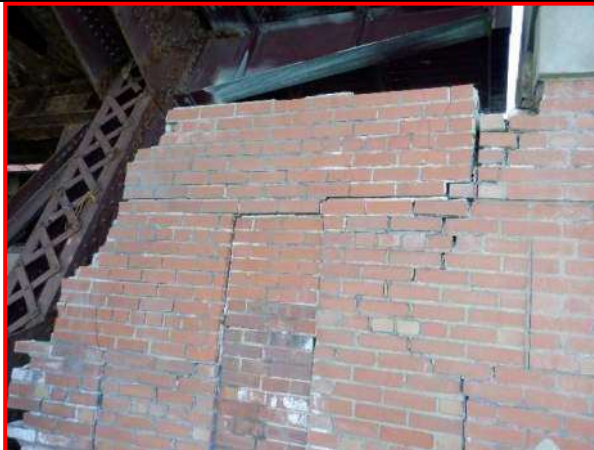
- The brick enclosure walls have mortar joint cracks, missing bricks, and broken pieces (see Photograph 77).
- In the southeast corner of the west bridge house, there is a large hole in the roof (see Photograph 78).

77. North enclosure wall at West River Pier, looking west

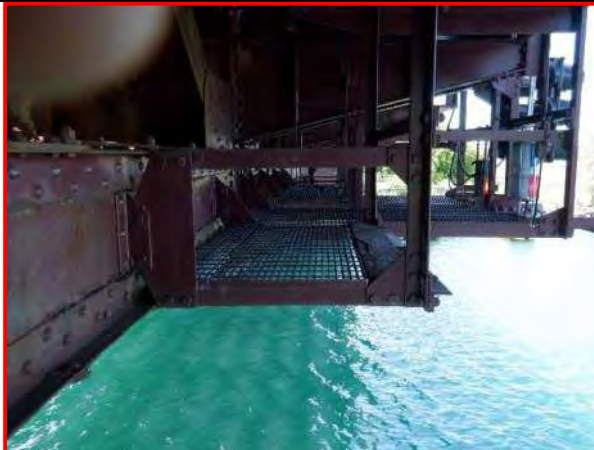
- The catwalks below the sidewalks at the center break have no notable defects (see Photograph 80).
- In Panel 8, the steel plate catwalk near Floorbeam 2-2W is heavily corroded with areas of corrosion holes up to 3' long by 2' wide (see Photograph 81).
- The navigation lights attached to the catwalks at the center break are in place and were functioning during the time of inspection.

80. Typical catwalk at the center break, looking west

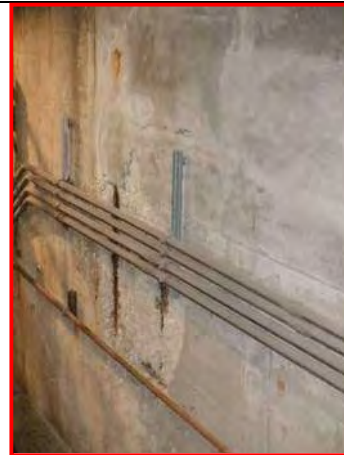
- The abutments exhibit hairline to narrow vertical and horizontal cracks with efflorescence and leakage along the stem. The West Abutment stem has approximately 160 SF of spalls and delaminations with exposed rebar (see Photograph 82). The East Abutment stem has delaminations in 50% of the scattered patched areas.
- The abutment backwalls have delaminations/spalls with exposed rebar up to 20 SF. In the north corner of the West Abutment, there is a 6 SF area of missing backwall (see Photograph 83).
- On both abutments, the roadway bearing seats and backwalls have staining and minor debris accumulations.
- The bearing seats and backwalls below the sidewalks exhibit concrete spalling and hairline to narrow vertical cracks.

82. West Abutment elevation, looking southwest

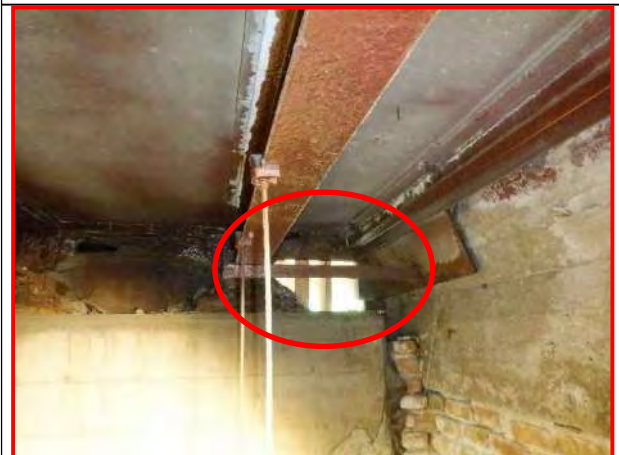
83. West Abutment backwall, looking west

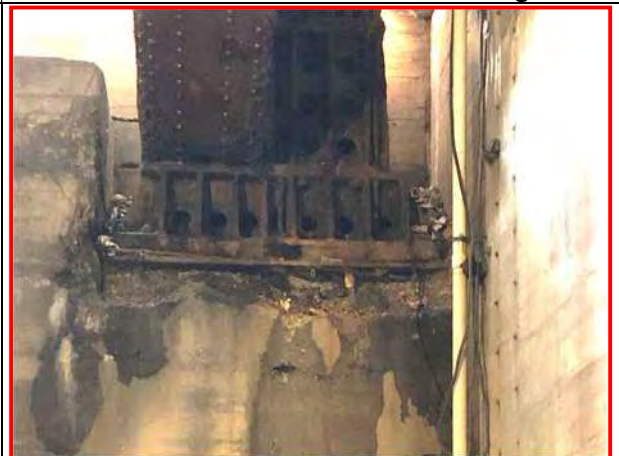
- The river side of the river piers have heavy scaling and large spalls.
- At both river piers, there are spalls below the live load and trunnion girder bearings measuring up to 8' long by 2' high by 1' deep with exposed rebar and moderate loss of bearing area (see Photograph 84).

84. West River Pier inside face at the south trunnion girder bearing, looking east

Both river piers have 8' long by 2' high by 1' deep spalls under the LL & trunnion girder bearings w/ mod. loss of bearing area. Near the center of the river piers on the counterweight pit side, there are full height up to 2' deep spalls w/ exp. rebar.

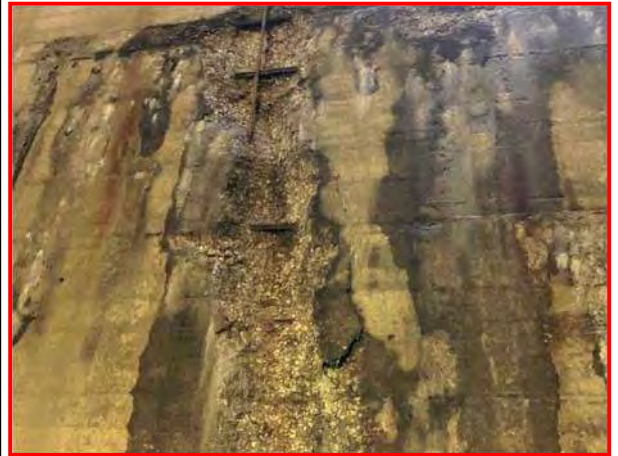
- Near the midpoint of the West River Pier on the counterweight pit side, there is a 2' wide by full-height by up to 2' deep spall with exposed rebar (see Photograph 85).
- The counterweight pit side of the East River Pier has spalls that are 3' wide by full-height, 2' high by full-width, and a 7' wide by 3' high spall (see Photograph 86).
- The anchor column floorbeams typically have minor pitting, several drilled holes with gouges adjacent, and heavy section loss and holes in the stiffeners. At the ends, the anchor column floorbeams have heavy corrosion and minor section loss (see Photograph 87).
- In the East Anchor Column Floorbeam, there is a puncture in the web with a small tear at the Stringer 3 connection (see Photograph 88).

85. West River Pier counterweight pit face, looking east

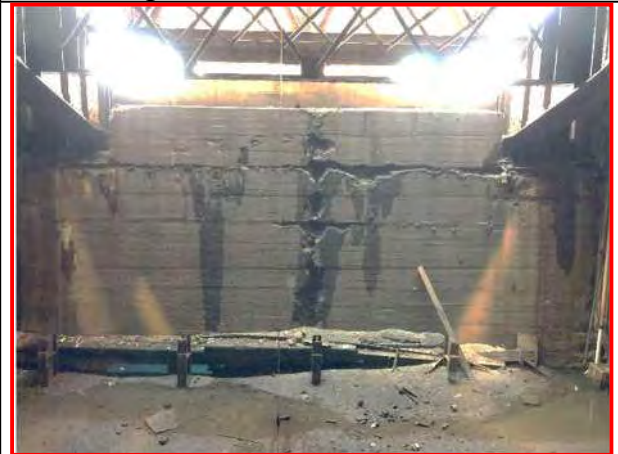
86. East River Pier counterweight pit face, looking west

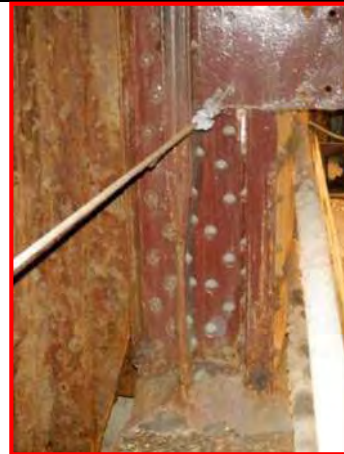
- The anchor columns have moderate to heavy corrosion and minor to moderate section loss with isolated spots of heavy section loss typically concentrated at the bases and flanges (see Photograph 89).
- The sidewalk columns have concrete encasement that ranges from being delaminated to complete missing. The exposed steel has heavy corrosion and moderate to heavy section loss (see Photograph 90).

89. Southwest Anchor Column, looking south

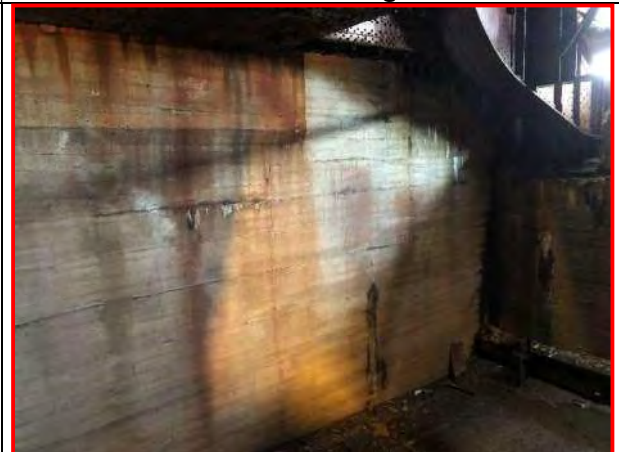
- The north and south pit walls have narrow to medium horizontal and vertical cracks with efflorescence, rust staining below the truss bottom chords, and areas of spalling with exposed rebar (see Photograph 91).
- The stairs leading down to the counterweight pits have spalls with exposed reinforcement on some of the steps and missing tread plates.
- During the time of inspection, there was no standing water and moderate debris in the counterweight pits.

91. East Counterweight Pit South Wall, looking southwest

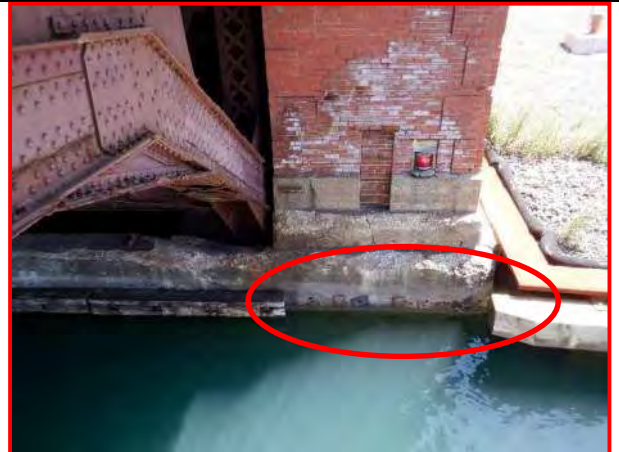
- The timber fender system is missing in the southern half of the West River Pier and in several sections of the East River Pier (see Photograph 92).
- There are dolphins in place at all corners of the structure apart from the southeast corner. The dolphins have minor corrosion.

92. Timber fenders missing on East River Pier, looking east

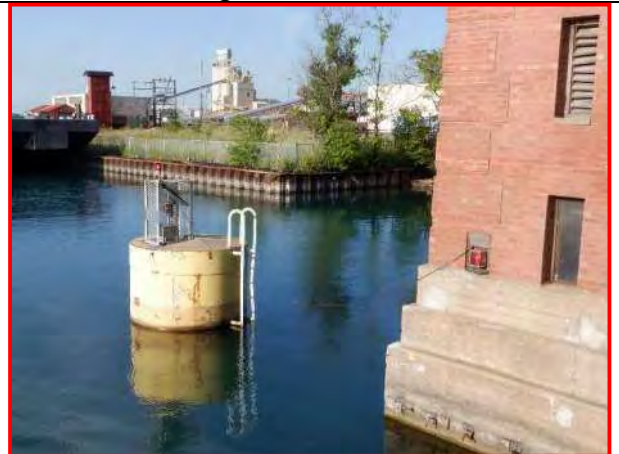
93. Red navigation light at the West River Pier and dolphin, looking southwest

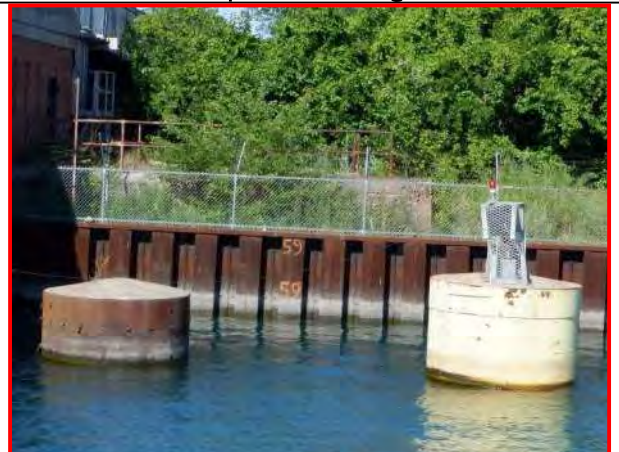
94. Light cage on the northwest dolphin, looking west

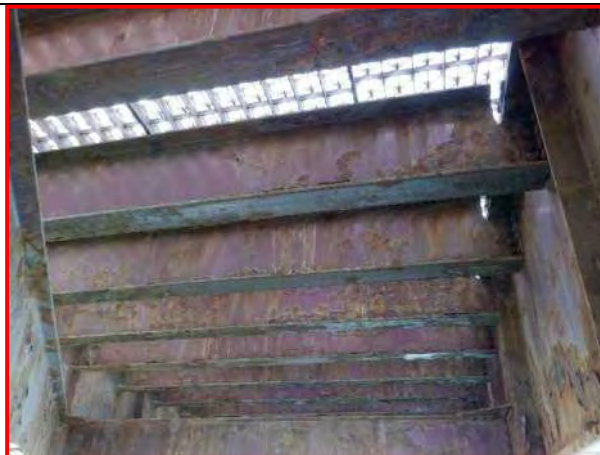
- The paint system has extensive deterioration along the movable span floorbeams and stringers.

95. Superstructure paint system, looking north

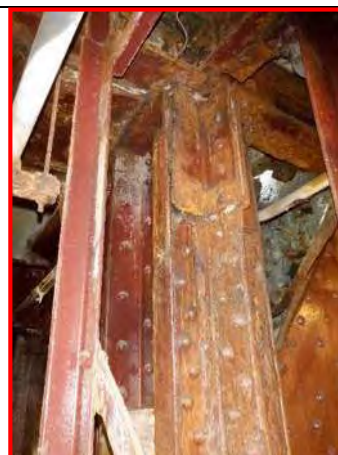
- The paint system on the anchor and sidewalk columns has isolated areas of moderate to heavy deterioration.

96. Sidewalk column paint system, looking north

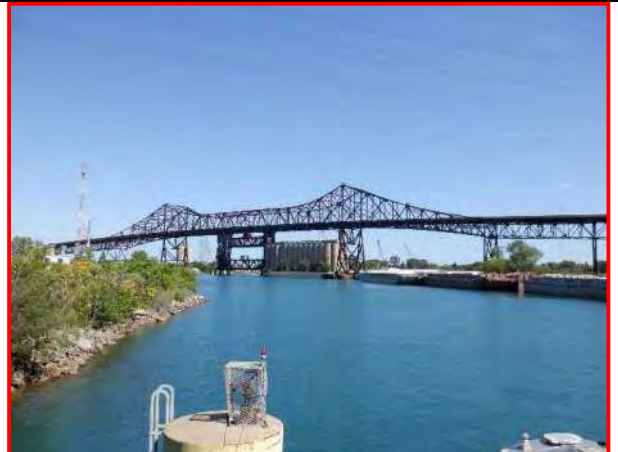
97. Upstream, looking north
