**CITY OF CHICAGO - DEPARTMENT OF TRANSPORTATION
BRIDGE INVENTORY REPORT**

Structure No. 016-6042

**100th Street
over
the Calumet River**

Inspection Date: August 16, 2021

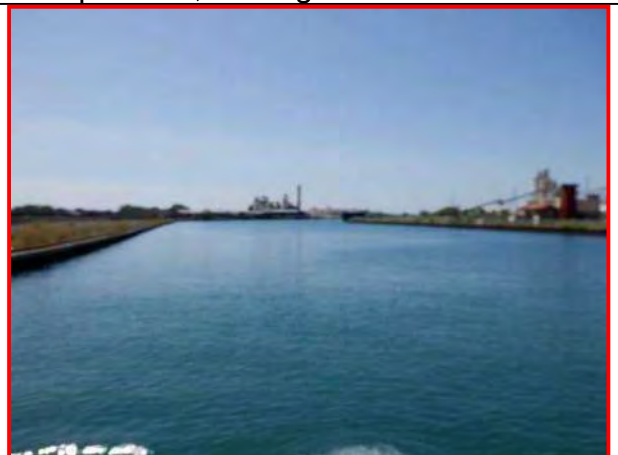
98. Downstream, looking south
