**CITY OF CHICAGO - DEPARTMENT OF TRANSPORTATION
BRIDGE INVENTORY REPORT**

Structure No. 016-6043

**106th Street
over
the Calumet River**

Inspection Date: August 12, 2021

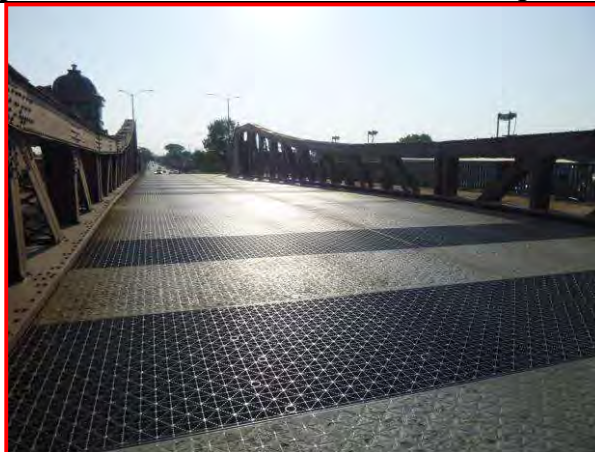
1. Overall top of deck, looking southeast

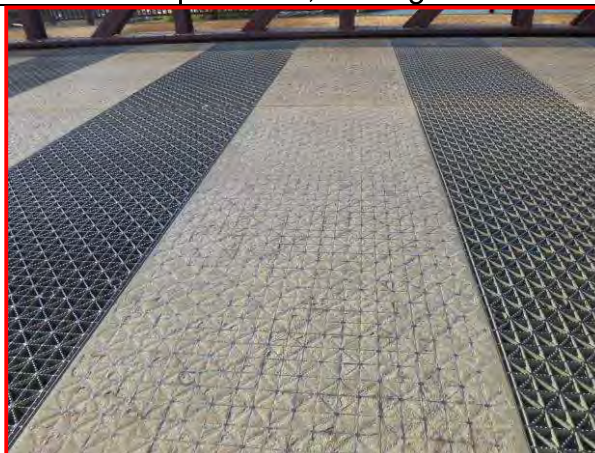
- In the movable span, the open steel grating wearing surface exhibited minor corrosion.
- The concrete-filled portions of the deck have minor deterioration of the concrete and an exposed grid with coating loss and minor surface corrosion (see Photograph 2).
- The concrete wearing surface in west fixed spans exhibited partial depth asphalt patching (see Photograph 3).
- The east fixed spans exhibited approximately (20) spalls less than 1 inch in diameter.
- East fixed span has 11-foot by 11-foot area of wide map cracking, spalling, and failure of the deck overlay (see Photograph 4)
- The pavement markings are not visible.

2. Typical movable wearing surface, looking south

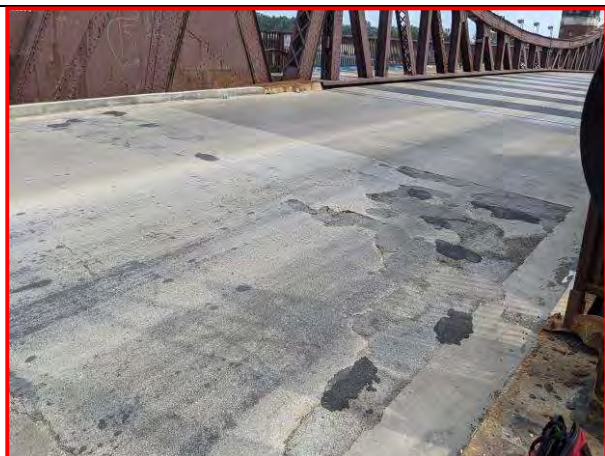
3. West fixed span wearing surface, looking northeast

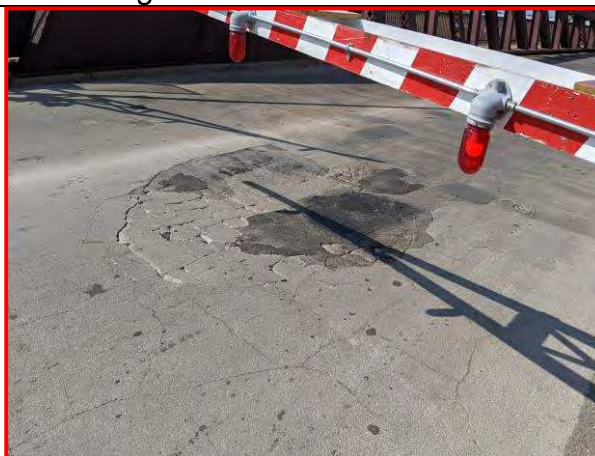
4. East fixed span wearing surface, looking southwest

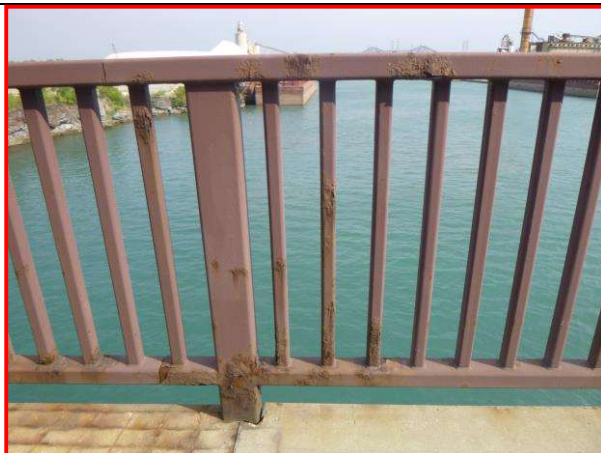
- The steel bridge railings in the moveable span have scattered areas of minor to moderate corrosion and initial section loss (see Photograph 5).
- The railing bases in the moveable spans have heavy corrosion and moderate section loss at the connection to the sidewalk bracket (see Photograph 6).
- The stone parapets in the fixed spans, exhibited isolated cracked, deteriorated stones, deteriorated joint mortar, and exposed embedded anchor bolts.
- At the southeast parapet there is an area of unsound concrete patch.

5. North steel rail, looking north

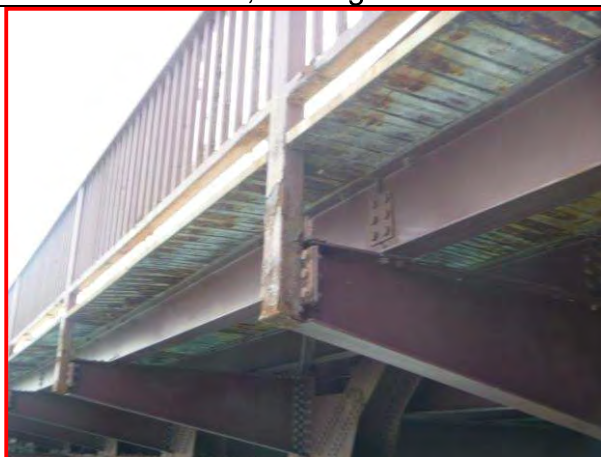
6. Typical railing base, looking southeast

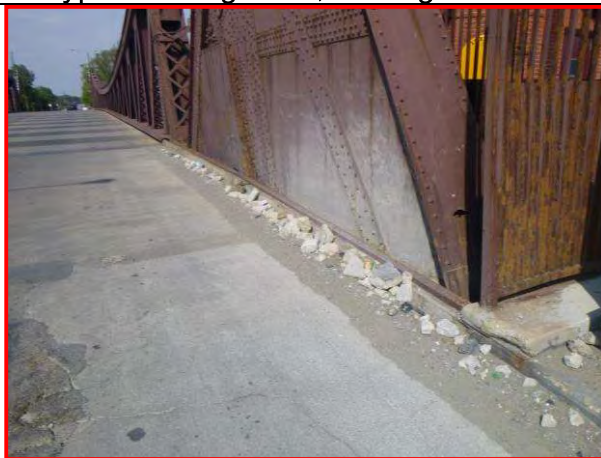
- In the moveable span the steel curbs exhibit minor surface corrosion.
- Span 2 north curb spalled and deteriorated full length of span (see Photograph 7).
- In the fixed spans, the concrete curbs have hairline to narrow cracks, small spalls, and deteriorated metal plates.
- A section of the northwest and southwest curbs has been repaired.

7. Curb in Span 2, looking north

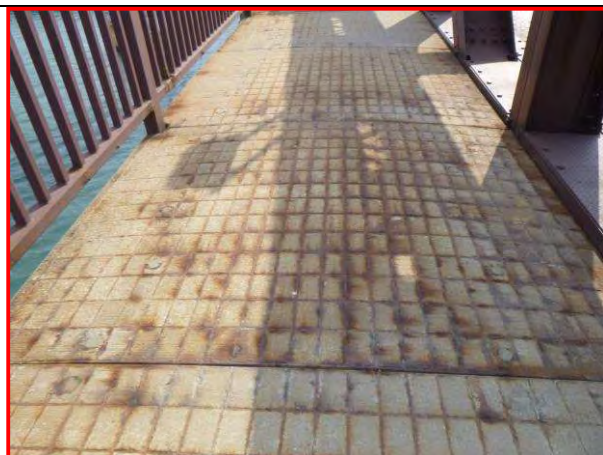
- The sidewalks in the movable span exhibit minor concrete surface section loss, minor to moderate corrosion of the steel grid, and a small hole in the concrete fill in the south sidewalk near the west end (see Photograph 8).

8. South sidewalk, looking west

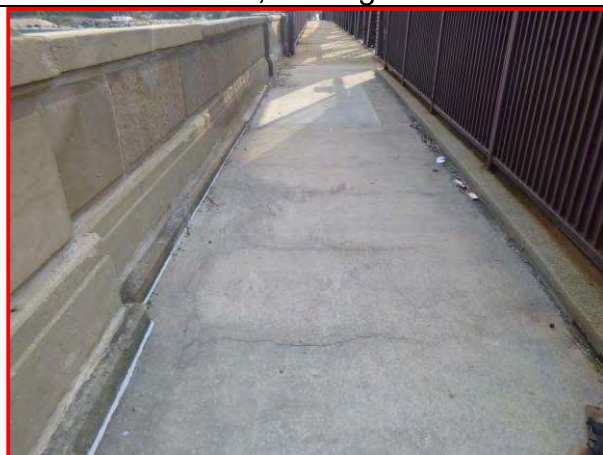
- The sidewalks in the fixed spans have surface spalls, delaminations, patches, and hairline to narrow transverse, longitudinal, and diagonal cracks (see Photograph 9).

9. Northwest sidewalk, looking east

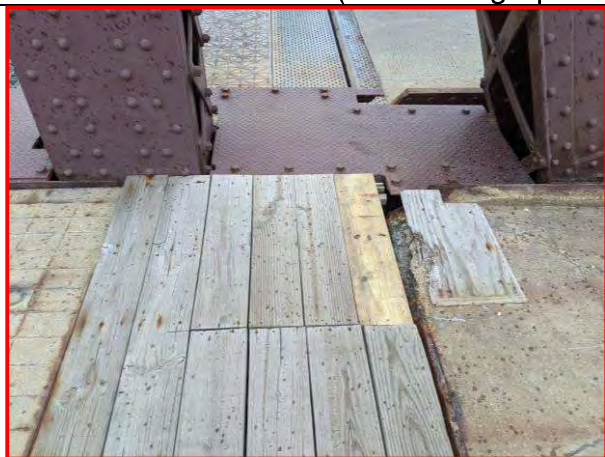
- There are two spalls along the interface of the fixed sidewalk and the moveable span at the northeast, southeast, and southwest sidewalks both corners have timber planks covering a portion of the spall (see Photograph 10).

10. Span 2 south sidewalk, looking west

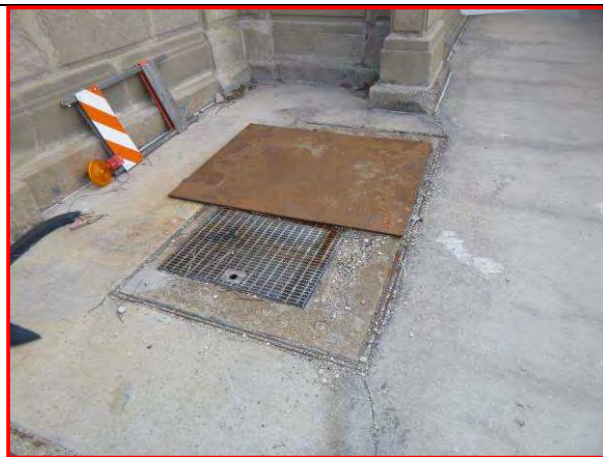
- The southwest and southeast sidewalk exhibit areas of delamination, transverse and longitudinal hairline to narrow cracking, and spalling.
- A steel plate is covering an access hatch in the northwest sidewalk (see Photograph 11).

11. Steel plate in the northwest sidewalk, looking west

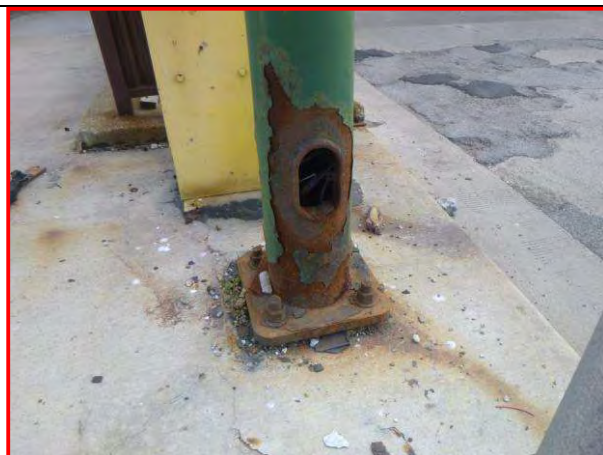
- The light standards exhibit moderate corrosion near the bases, deteriorated or missing grout pads, missing hand hole covers with exposed wiring, and missing anchor bolt covers (see Photograph 12).
- In Span 1, the south light standard has a missing luminaire cover, and the north light standard luminaire cover is heavily corroded. In Span 5, all the light standards are missing luminaire covers.
- The southwest light standard exhibits one under engaged anchor rod nut.

12. Northwest light standard, looking east

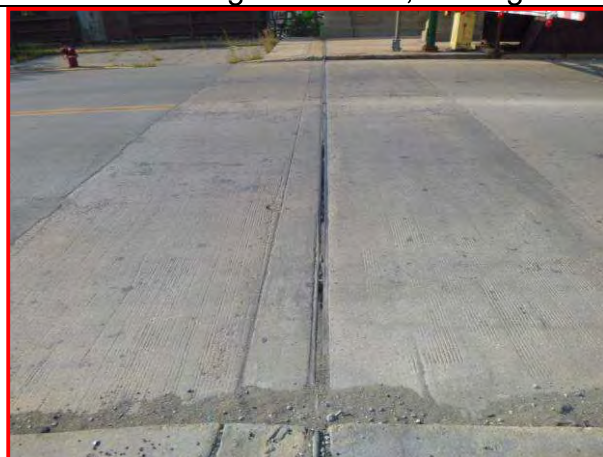
- The west expansion joint has a few torn, bulging, and depressed sections.
- The east expansion joint has a couple missing gland sections, adding up to about 20-feet in length (see Photograph 13).
- The center and rear breaks have faded paint (see Photograph 14).
- At the north sidewalk, the center break is ¼-inch low on the east side.

13. East preformed joint, looking south

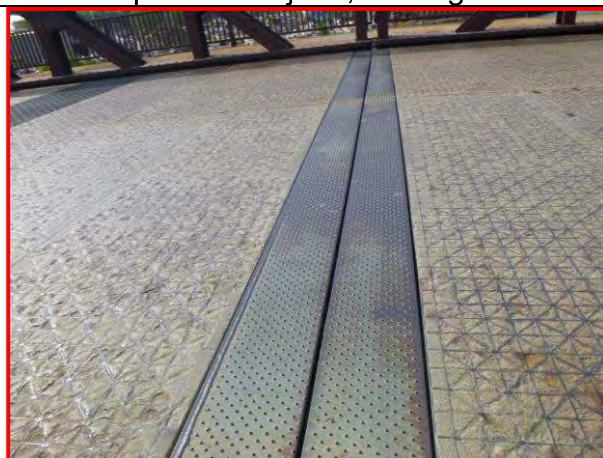
14. Center break, looking south

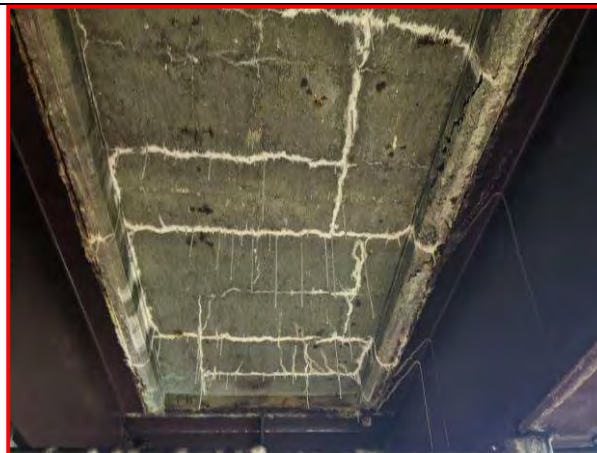
- In the east fixed spans, the underside of the deck has hairline longitudinal and transverse cracks with efflorescence (see Photograph 15).
- In the west fixed spans, the underside of the deck has isolated hairline longitudinal and transverse cracks with efflorescence.
- The sidewalk soffits in Spans 2 and 4 have scattered hairline cracks, some with efflorescence, and areas of poor consolidation which have resulted in exposed rebar. The soffits have delaminations, and timber formwork left in place.
- Various fillets in the fixed spans are chipped or broken.
- In the movable span, the open steel grating exhibits minor corrosion and a few isolated missing deck-to-stringer connection bolts.
- In the movable span, the deck pans in the deck and sidewalk have heavy corrosion, section loss, and scattered corrosion holes (see Photograph 16).

15. Span 1 soffit, looking east

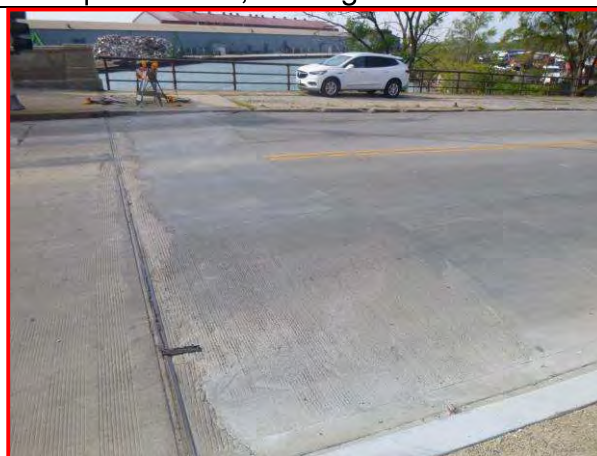
- The west approach has been recently repaired (see Photograph 17).
- The east approach has been recently repaved.
- The north and south sidewalks at the bridge approaches have wide cracks, large spalls, and vegetation growing in the cracks.

17. West approach, looking southwest

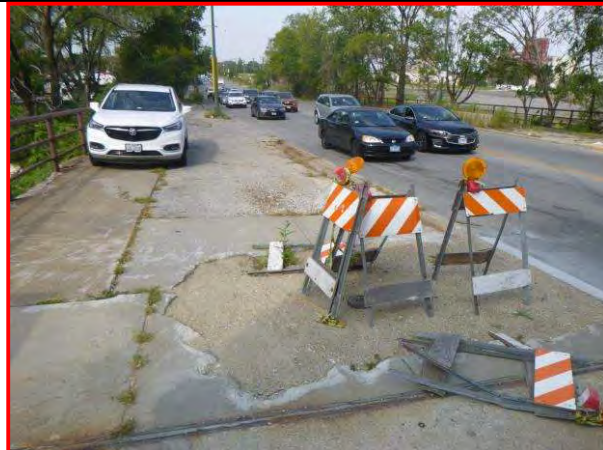
- The southwest approach sidewalk has a large area of concrete missing (see Photograph 18).

18. Edge of the southwest approach sidewalk, looking east

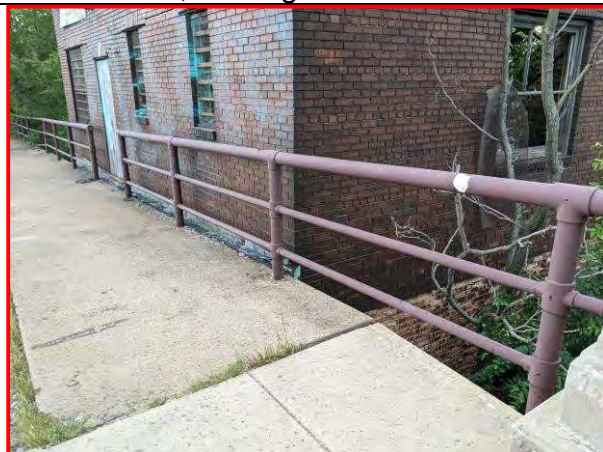
- Approach railings typically exhibit minor surface corrosion (see Photograph 19).

19. Guardrail at the southeast sidewalk, looking southeast

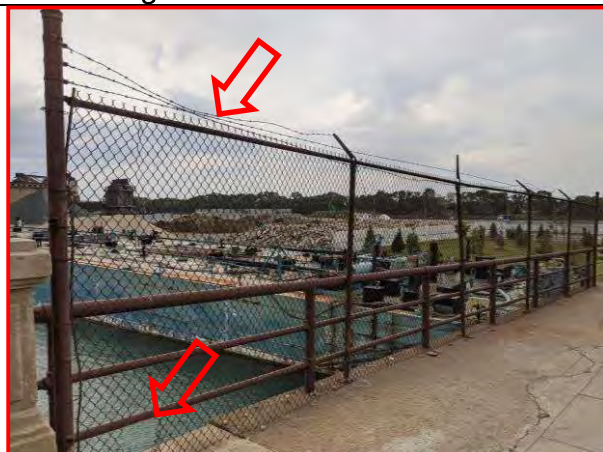
- A chain-link fence is present in the northeast approach. The fence exhibits a 3 SF hole in the mesh, has detached barbed wire, and the mesh is detached from several posts (see Photograph 20).
- Northeast truss access fence exhibits impact damage on the northeast corner.

20. Northeast approach fence, looking northeast

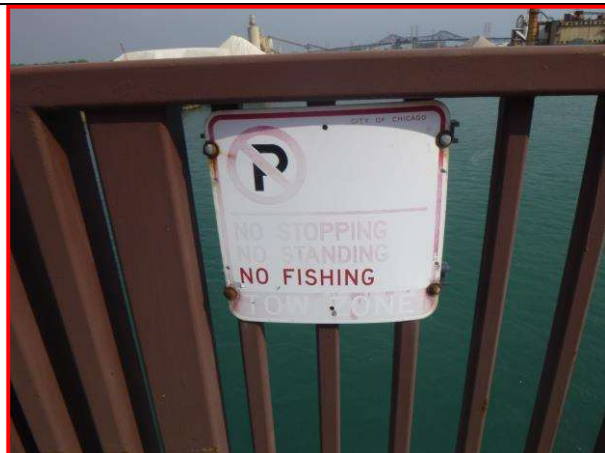
- The signage at the center break is fading (see Photograph 21).

21. Tow zone sign, looking south

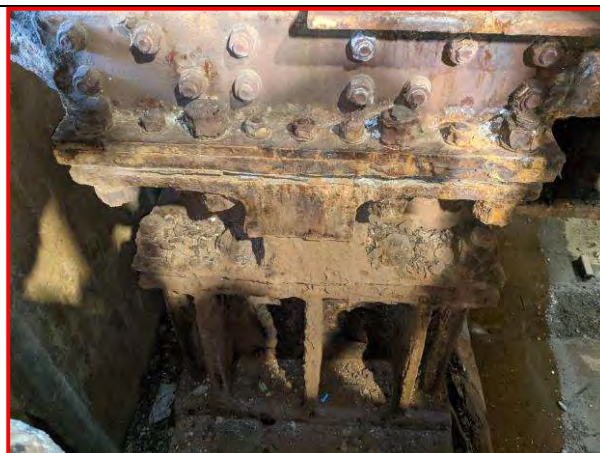
- The live load bearings have heavy debris surrounding the base, heavy corrosion, and moderate to heavy section loss. On the southwest live load bearing, there are two 1-inch diameter corrosion holes in the lower casting.

25. NW live load bearing, looking southeast

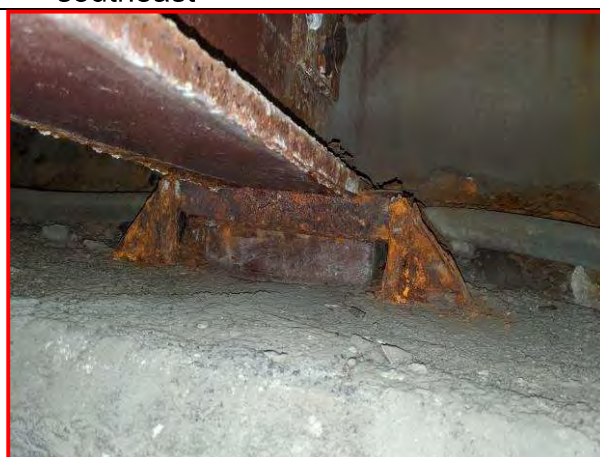
- The southwest live load bearings have an ⅛-inch gap between the upper and lower castings.
- The bearings at the abutments have heavy debris accumulation, surface corrosion, and minor section loss (see Photograph 26).

26. East Abutment bearing, looking northeast

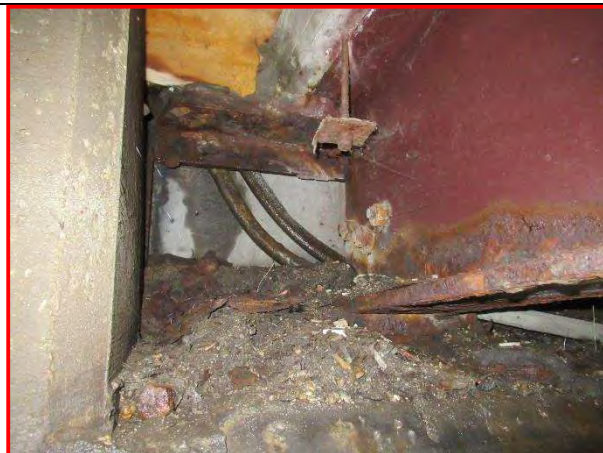
- In Spans 1 and 5, the stringer ends exhibit corrosion and minor section loss on the bottom flange. The webs have minor corrosion near the bottom flange (see Photograph 28).

28. Span 5 stringer ends, looking west

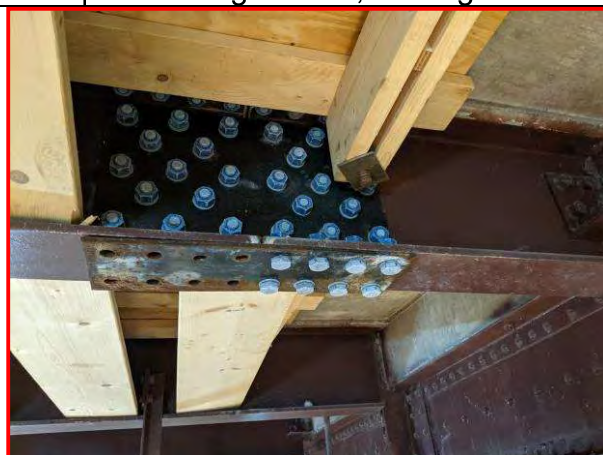
- In Span 4, there is a north sidewalk stringer missing all 8 bolts in the south half of the bottom flange splice (see Photograph 29).
- In the movable span, the roadway and sidewalk stringers typically have minor surface corrosion and peeling paint in the bottom flange.

29. North sidewalk stringer in Span 4, looking south

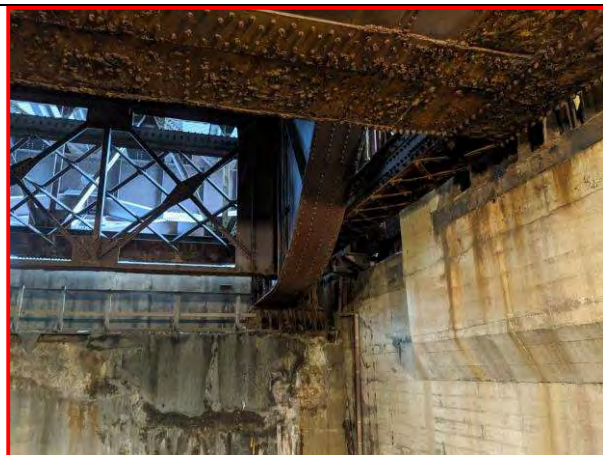
- The trunnion girders have heavy corrosion and section loss below the bottom chord of the trusses and near the trunnion girder support column (see Photograph 30).
- In Span 4, the northwest trunnion girder has corrosion holes near the column connection.
- The middle portion of the trunnion girders have minor corrosion and section loss, primarily in the flanges.

30. SW trunnion girder at river pier, looking east

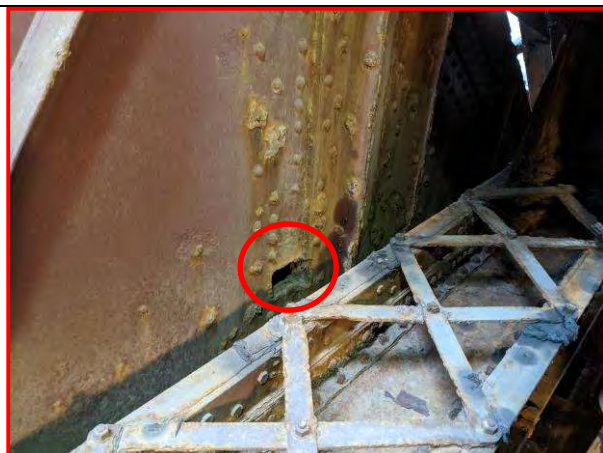
- Northeast trunnion girder has cut holes with sharp edges in the web even with the trunnion bearing (see Photograph 31).
- The bearing stiffeners at the trunnion girder bearings typically have pack rust between the stiffener angles and heavy section loss.

31. NE trunnion girder, looking southwest

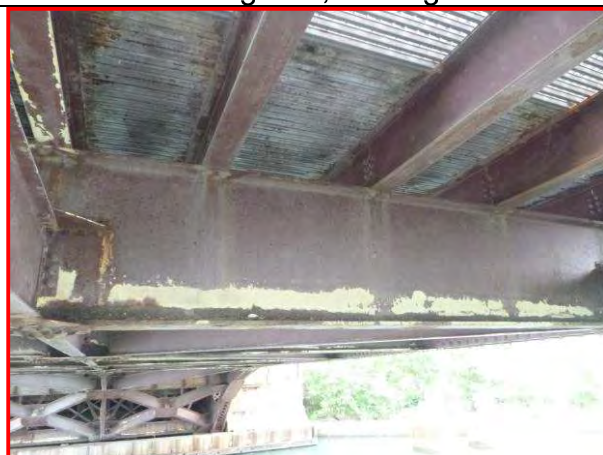
32. Typical floorbeam, looking southeast

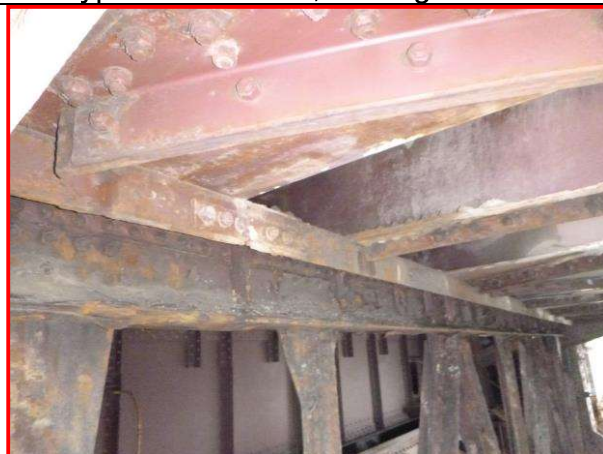
- The movable span floorbeams typically exhibit minor to moderate corrosion on the top and bottom flanges, minor to moderate flaking along the bottom flanges, and heavy debris on the east face of the west leaf and west face of the east leaf (see Photograph 32).
- The sidewalk brackets in the movable span have minor debris on the bottom flange at the connections to the trusses.
- Floorbeam 14-14E exhibits moderate to heavy corrosion, moderate pitting along the bottom flange and section loss on the vertical stiffeners along the bottom of the web plate and bottom flange, particularly on the west face. In the bottom of the web, there are (3) corrosion holes in the southern half of the floorbeam that are up to 6-inches in length (see Photographs 33).

33. Floorbeam 14-14E, looking east

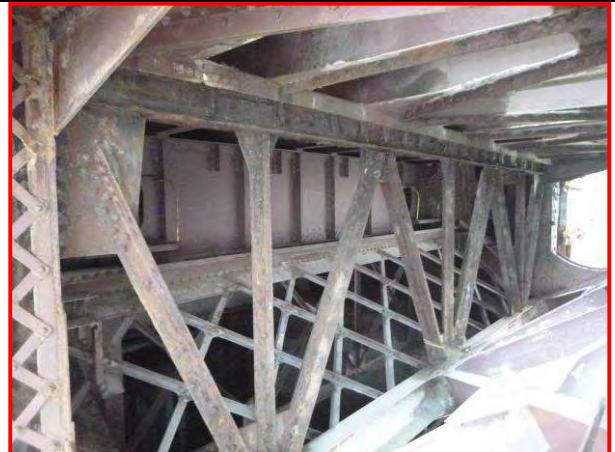
- Floorbeams 16-16E and 16-16W have moderate to heavy corrosion and minor to moderate section loss in the top chord, verticals, and diagonals. The bottom chord has been replaced and has peeling paint and isolated locations of heavy corrosion in the top flange and web (see Photograph 34).
- Floorbeams 18-18E and 18-18W, the trunnion cross girders, have heavy corrosion and moderate section loss on the bottom chord angles.
- In Span 4, there is graffiti on the east face of Floorbeam 18-18W.
- Floorbeam 8-8W has one missing bolt at the south truss connection.
- The web stiffeners on Floorbeams 0-0 under the center breaks have minor corrosion along the welds.
- Floorbeams 21-21 could not be inspected at an arm's reach but were visible when the bridge was in the open position.

34. Floorbeam 16-16E, looking southeast

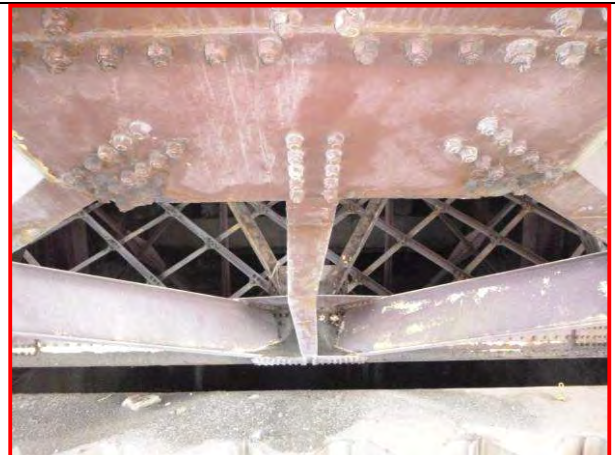
- The diaphragms in the fixed spans exhibit minor to moderate corrosion along the top and bottom flanges.
- In the movable span, the lateral bracing typically exhibits scattered areas of peeling paint and minor surface corrosion.
- Impact damage was noted at lateral bracing between Floorbeams 12E and 14E (see Photograph 35).

35. Lateral bracing between Floorbeam 12E and 14E, looking east

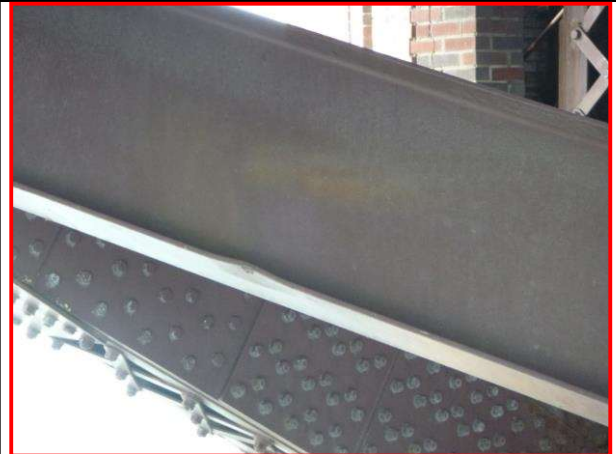
- Impact damage was noted at lateral bracing between Floorbeams 14W and 16W (see Photograph 36).
- In Panel 1, the center lateral bracing member is bent.
- In Panel 5, north lateral bracing member exhibits minor out of plane bending.
- The lattice trusses have no notable defects.
- The lateral bracing to bottom chord connection plates typically exhibits moderate to heavy corrosion, pitting and flaking (see Photograph 37).

36. Lateral bracing between Floorbeam 14W and 16W

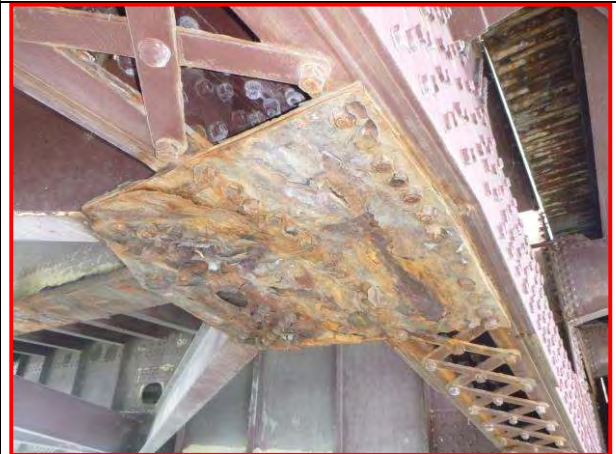
37. Lateral brace connection plate, looking southwest

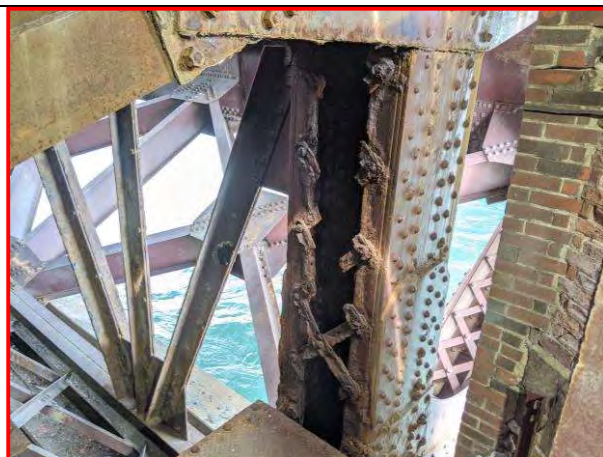
- Lacing bars are disconnected in all vertical members 16-17 (see Photograph 38).
- A 10-foot long area along the bottom chord 2-4 NW is bent 3-inches out-of-plane. Five missing bolts and deformation up to approximately 3-inches out of plane are present in the outside web, gusset plates, and lattice bars (see Photographs 39 and 40). At other scattered locations, the bottom chord has impact damage.

38. Lacing bars 16-17 SW, looking northeast

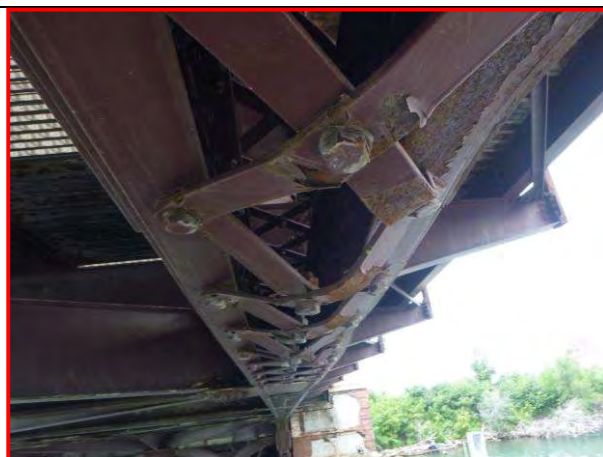
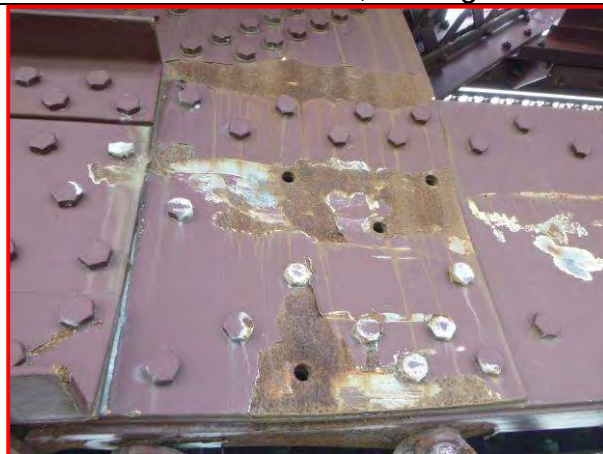
39. Bottom chord 2-4NW, looking south

40. Bottom chord 2-4NW, looking south

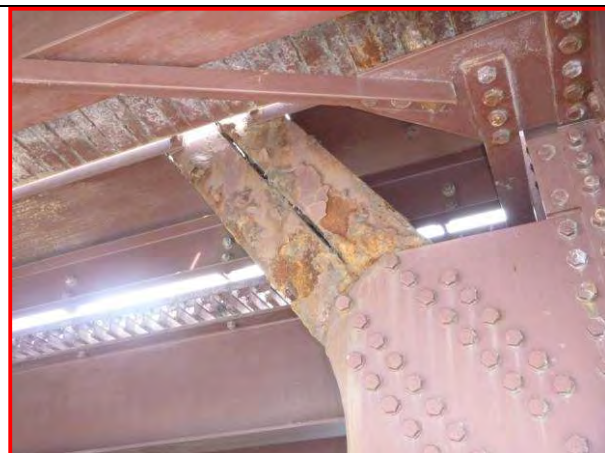
- The truss diagonal members have areas of flaking paint, minor to moderate corrosion, corrosion holes, and moderate pitting near the bottom chord gusset plates, as well as areas of heavier corrosion and minor section loss along the deck interface (see Photograph 41). There is also minor to heavy section loss along some of the lacing bars.

41. Diagonal 12-15SW, looking northwest

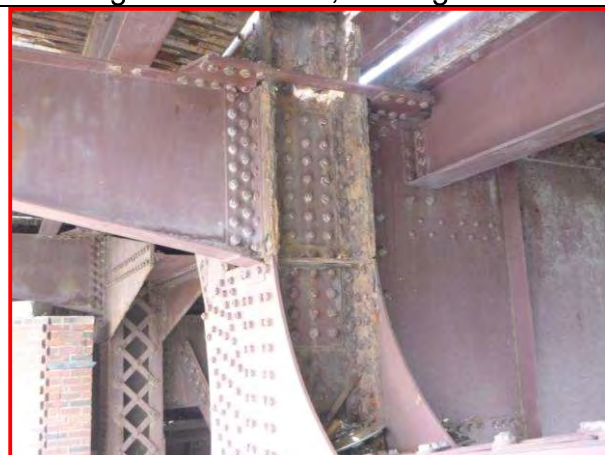
- The truss vertical members typically exhibit minor to moderate corrosion, flaking paint along the flanges, plate repairs, and heavy debris on the east face of the west leaf and west face of the east leaf (see Photograph 42).

42. Vertical 14-15NW, looking northwest

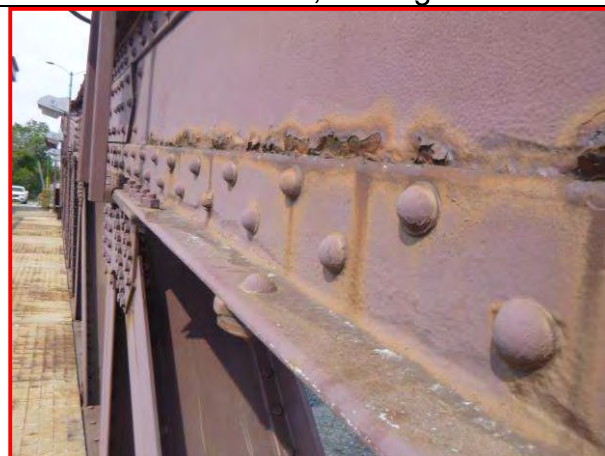
- The top chord truss members have localized areas of moderate corrosion, pack rust, heavy pitting, and flaking paint (see Photograph 43). The corrosion was typically worse between Panel Points 5 and 13. There are also several missing bolts or rivets, welded attachments (some welds are cracked), and minor section loss in the batten plates.

43. Typical above deck truss member condition, looking northeast

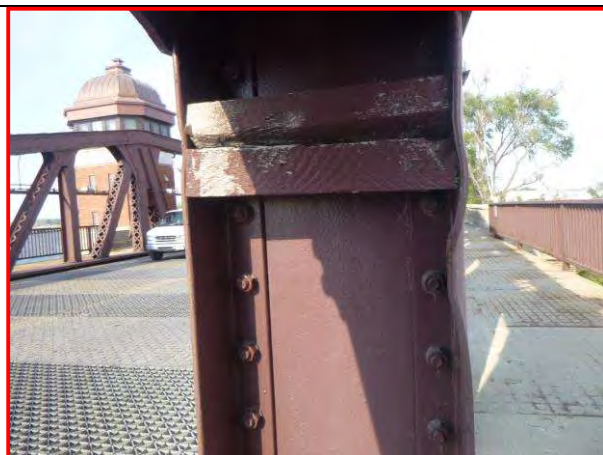
- At multiple locations the top chord flanges and the vertical member flanges have impact damage with deformations up to 3/8-inch (see Photograph 44).
- Truss cover plates typically exhibit deformation, minor pitting, corrosion, and section loss (see Photograph 45).

44. Vertical 8-9NW, looking west

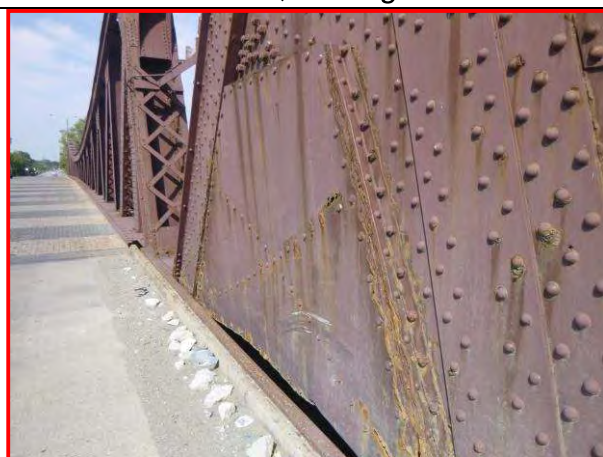
45. Northeast truss cover plate, looking west

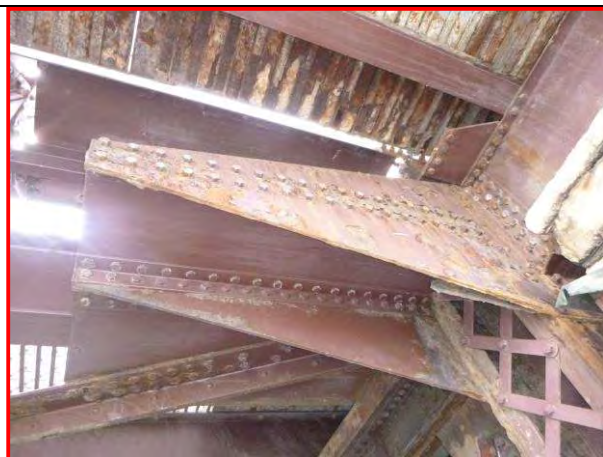
- The top chord lacing bars between Panel Points 1 and 5 of all trusses have scattered deformations up to 1/2-inch out of plane.
- The truss gusset plates typically have minor corrosion and minor to moderate pitting (see Photograph 46).

46. Gusset plate 16A NW, looking southwest

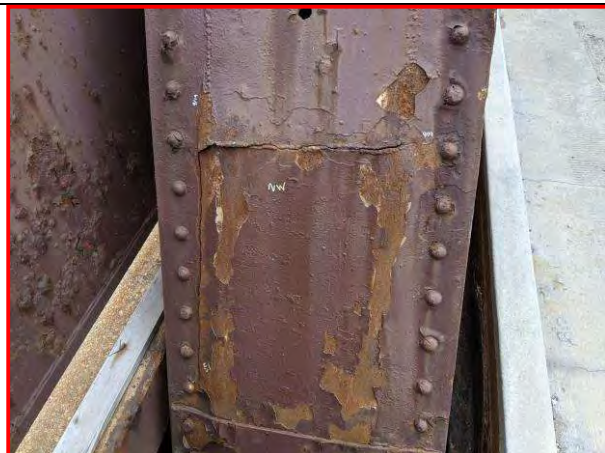
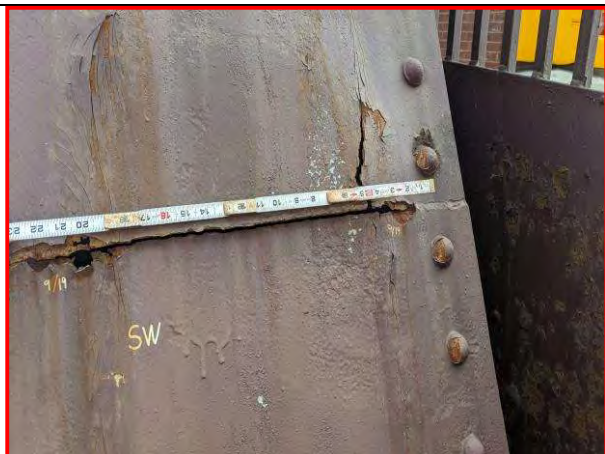
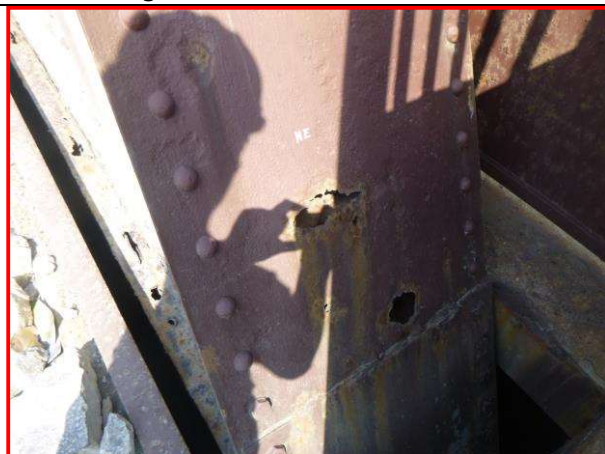
- The curved plates beyond truss member 19-23 have large cracks and/or corrosion holes. The southwest truss has a 24½-inch horizontal crack. The northwest truss has a 23-inch horizontal crack and a 33-inch vertical crack. The northeast truss has 6-inch, 4-inch, and 1-inch diameter holes (see Photograph 47 thru 49).

47. Northwest curved truss member, looking east

48. Southwest curved truss member, looking east

49. Northeast curved truss member, looking west

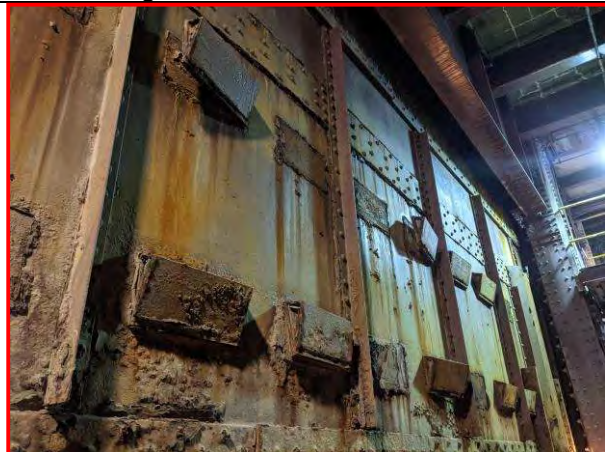
- The counterweight steel framing exhibits heavy corrosion and section loss along the steel plates, and several stiffener angles have moderate to heavy section loss (see Photograph 50).

50. East counterweight framing, looking northwest

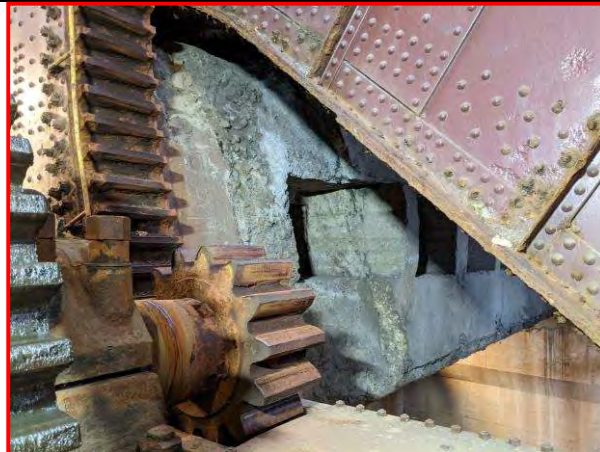
- The exposed concrete surfaces of the counterweight box exhibit medium to wide cracks and heavy spalling at the upper and lower corners of the box (see Photograph 51).

51. West counterweight box concrete, looking northwest

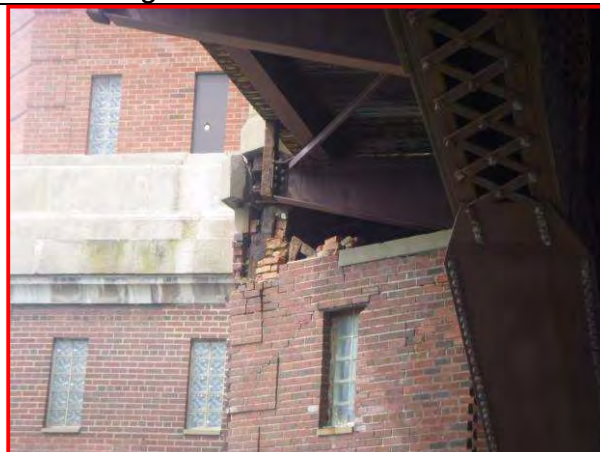
- The bridge houses have missing or spalled brick, loose concrete, and wide vertical cracks (see Photographs 52 and 53).
- The northeast and southeast enclosure walls have broken glass block windows.
- Various railing posts have broken from the base or lost all bearing area.
- The bridge house railings have heavy corrosion, section loss, and missing toe guards. Some of the handrails are fractured or missing.

52. West bridge house, looking west

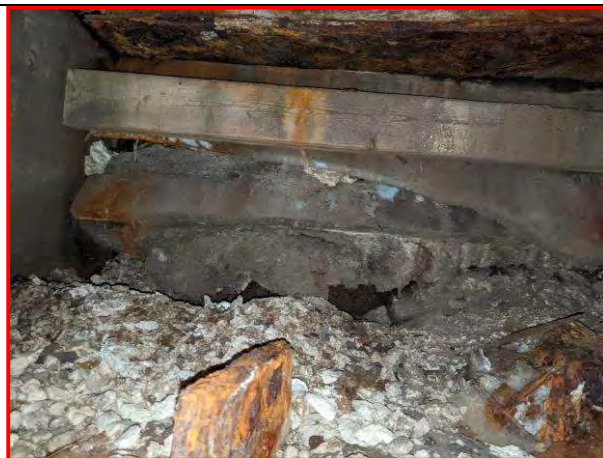
- The East and West Abutments exhibit hairline vertical cracks with efflorescence spaced approximately 3-foot on center along the stem wall, with the fixed span formwork left in place.
- The abutment bearing seats have heavy debris accumulation.
- The East Abutment backwall has hairline vertical cracks at approximately 5-foot to 10-foot on center.
- The West Abutment backwall concrete is poorly formed, sections of the backwall have failed, and the concrete appears to have been overpoured in sections (see Photograph 56).

56. West Abutment backwall, looking west

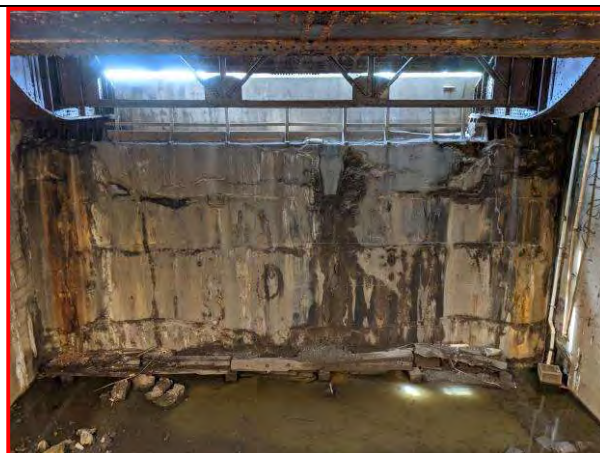
- The east face of the east river pier and the west face of the west river pier exhibit several areas of heavy spalling, hairline to narrow vertical cracks, water, and delaminations (see Photograph 57).

57. East river pier, looking west

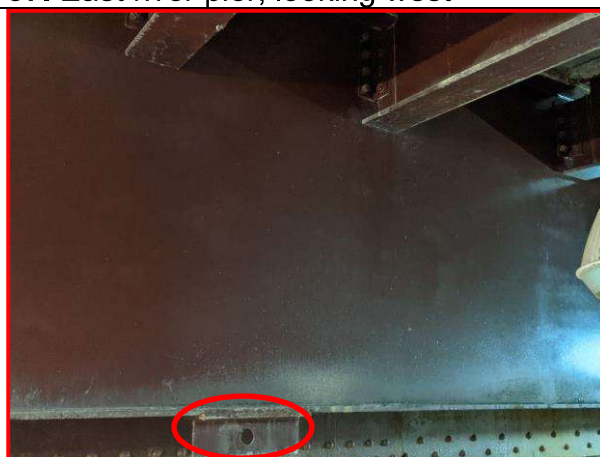
- The river side of the river piers has been repaired and only has scattered hairline vertical cracks.
- In Span 2, the floorbeam spanning the trunnion girder columns (Floorbeam 23-23E) has a field welded attachment on the bottom flange near mid-span (see Photograph 58).

58. Floorbeam 23-23E, looking northwest

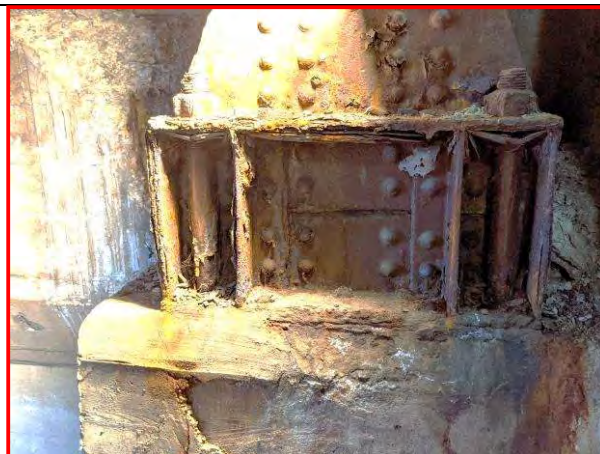
- The trunnion girder support columns have heavy corrosion and section loss along the bases as well as moderate section loss of the anchor bolts, and narrow cracks in the concrete pedestal (see Photograph 59).
- The north and south faces of the northeast and southeast trunnion girder support columns have moderate to heavy flaking

59. NE trunnion girder column, looking northeast

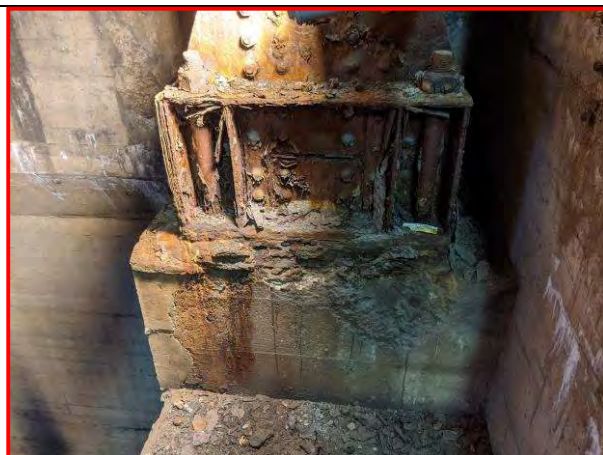
- The northwest trunnion girder support column exhibits heavy corrosion and section loss and, spalled concrete on the concrete pedestal located directly below the casting (see Photograph 60).
- The anchor columns have areas of heavy corrosion, moderate to heavy section loss near the base, rivet head loss, and repair plates on the inside faces and the inside half of the north and south faces.
- The steel sidewalk columns have corrosion and minor section loss at the base and in the anchor bolt nuts, and minor spalls with exposed reinforcement along the concrete pedestals. The sidewalk columns are newer rolled steel members.
- The northeast concrete encased column in the east bridge house has a wide crack.

60. NW trunnion girder column, looking north

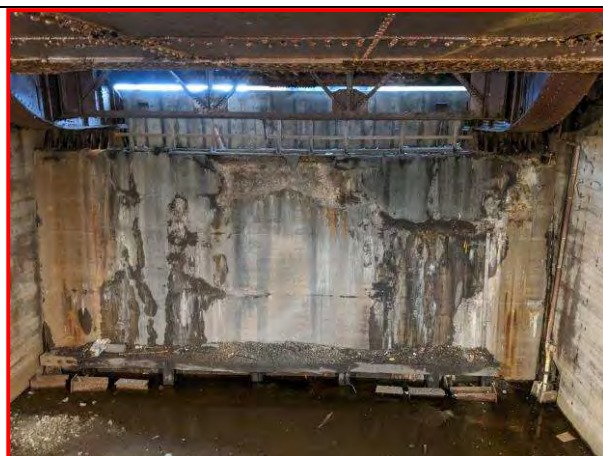
- The pit walls have large concrete spalls with exposed, corroded reinforcement steel along the top of the pit side-walls of both bridge pits and several hairline to medium cracks with efflorescence (see Photograph 61). The spalls have been repaired under the machinery.
- The pit backwalls typically have several hairline to medium vertical and horizontal cracks with widespread efflorescence.
- An area of heavy spalling measuring approximately 20-foot wide by 5-foot high with exposed corroded reinforcing steel is present near the top of the east pit backwall (see Photograph 62).
- Both bridge pits have approximately 1-foot of water and debris present on the pit floor.

61. East face of west pit wall, looking east

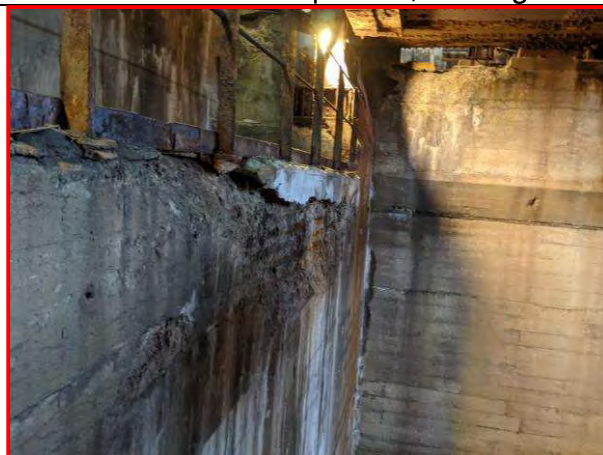
62. East pit backwall, looking southeast

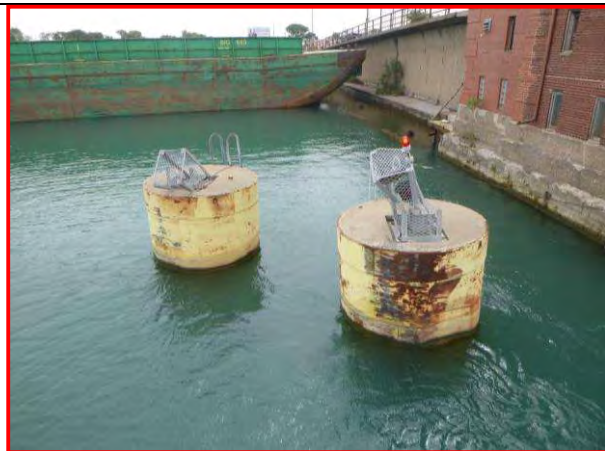
- The timber fender system is in place and functioning.
- The dolphins are in place and functioning, but a few of the dolphins have minor corrosion with scattered areas of heavy corrosion (see Photograph 63).

63. Northeast dolphin, looking east

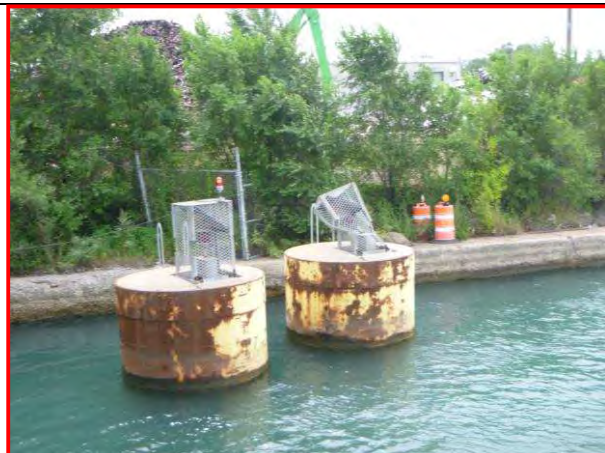
- The red navigational lights above the river piers are in place and functioning.
- On the northeast, southwest, and southeast dolphins, and cages are bent (see Photograph 65).

65. Southeast light cages, looking southeast

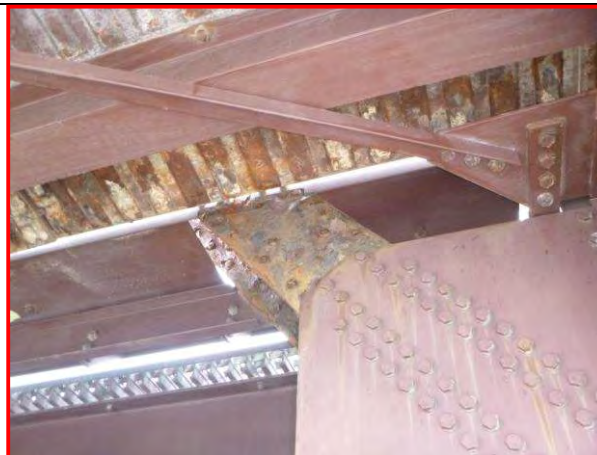
- The trunnion girders, bridge house truss members, various truss diagonals, and Floorbeams 14-14 and 16-16 have a failed paint system and varying degrees of corrosion (see Photograph 66).
- The remaining superstructure members have peeling paint and minor deterioration.

66. Southwest truss diagonal and gusset plate, looking north

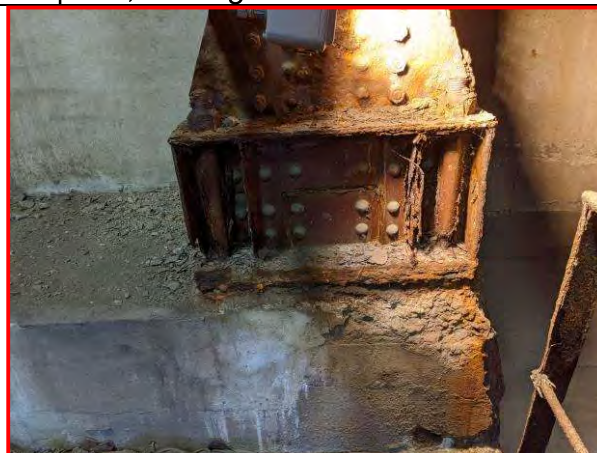
- The painted substructure members (steel columns) typically exhibit scattered areas of flaking paint, and the exposed steel has areas of heavy deterioration especially near the bases (see Photograph 67).

67. Northwest trunnion girder column base, looking north
