**CITY OF CHICAGO - DEPARTMENT OF TRANSPORTATION
BRIDGE INVENTORY REPORT**

Structure No. 016-6037

**Ewing Avenue (US41 – 92nd Street)
over
the Calumet River**

Inspection Date: August 10, 2021

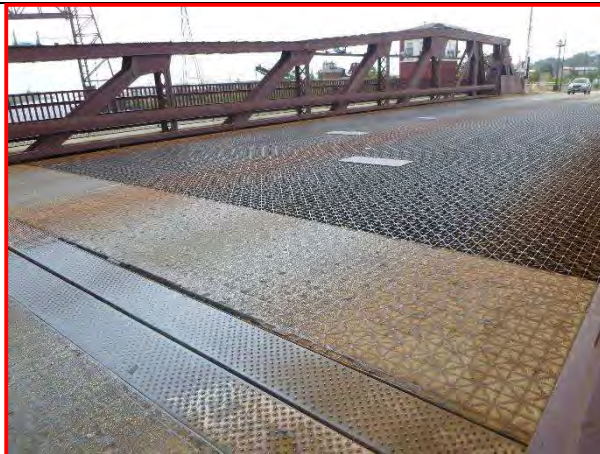
1. Overall movable span roadway, looking southeast.

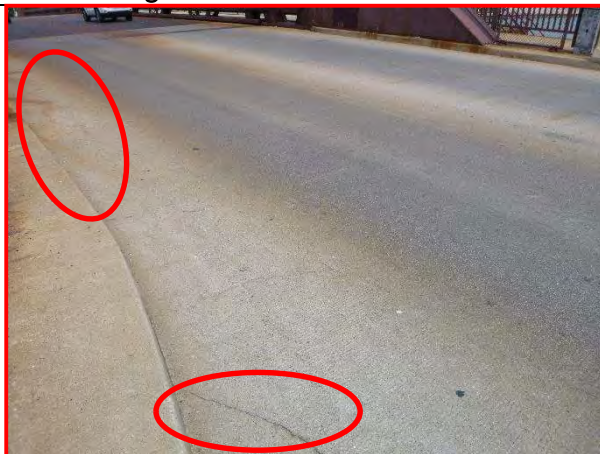
2. Typical bare concrete deck, fixed span, looking southeast.

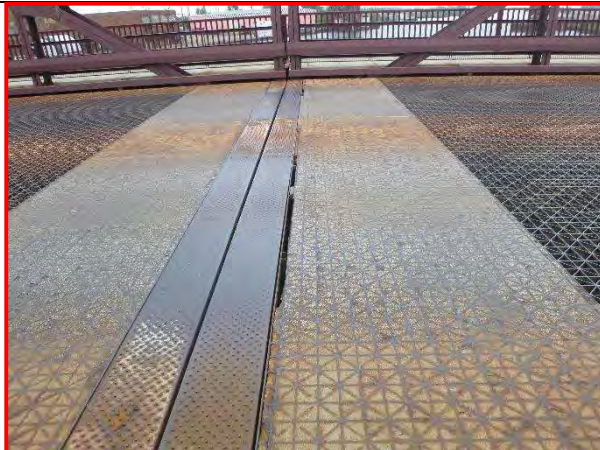
- The concrete filled section along the center break exhibits missing sections of concrete up to 10' in length (see Photograph 3).
- Pavement markings are typically heavily worn and fading.

3. Concrete filled section along center break, looking east.

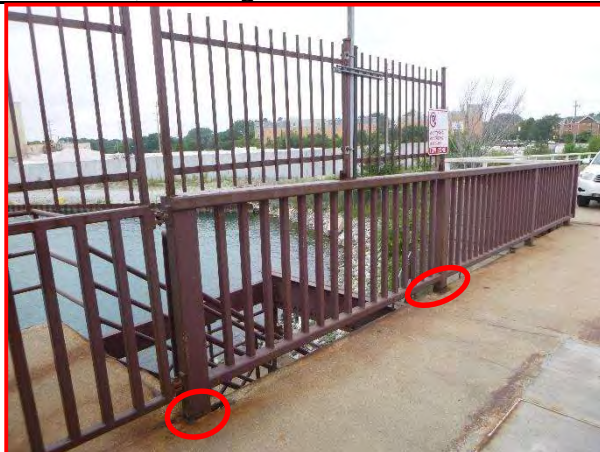
- The bridge railing posts along the fixed spans exhibited areas of 50% to 100% section loss (see Photographs 4 and 5).
- The west brush rail in Span 2 exhibits a full-length vertical crack (see Photograph 6).

4. Northwest railing, looking west.

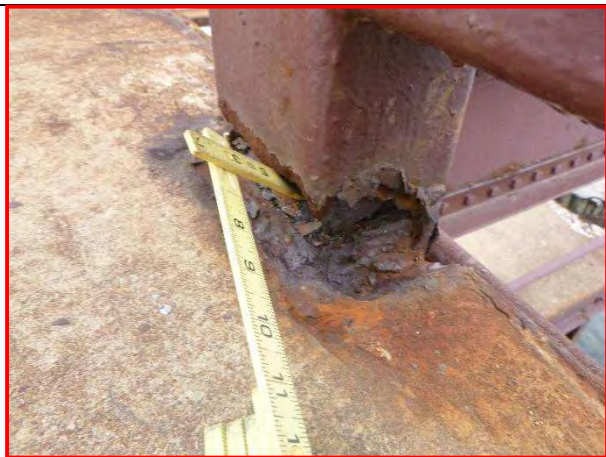
5. Northwest rail post, looking south.

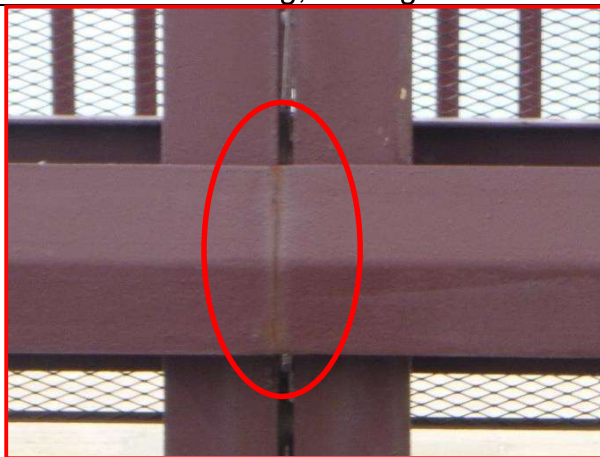
6. West brush rail, Span 2, looking west.

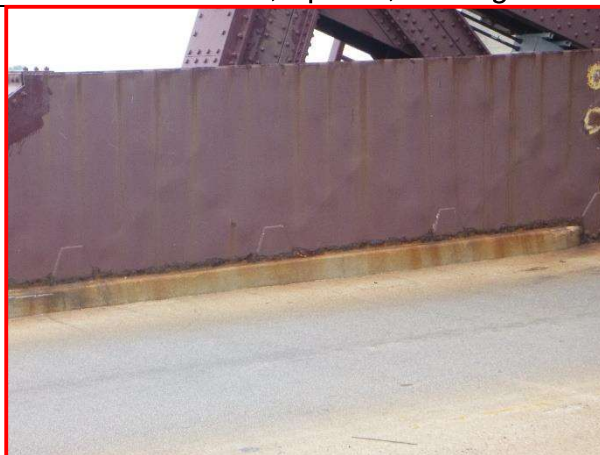
- The curbs in the fixed and movable spans exhibited rust staining, minor edge spalls, and vertical hairline cracking at 3'-4' spacing (see Photograph 8).

8. East curb, Span 1, looking east.

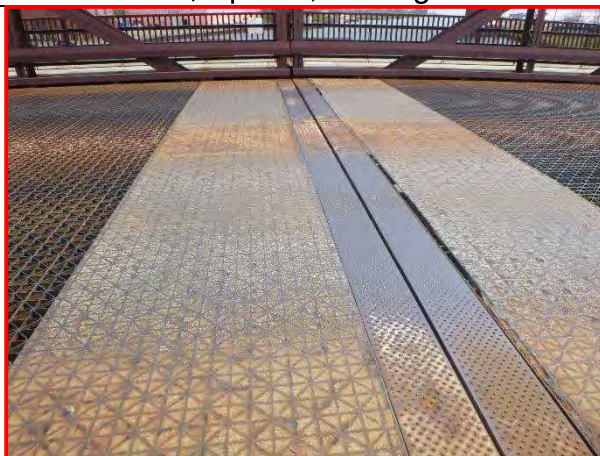
- The striped median along Span 3 exhibits heavy fading (see Photograph 9).

9. Median, Span 3, looking east.

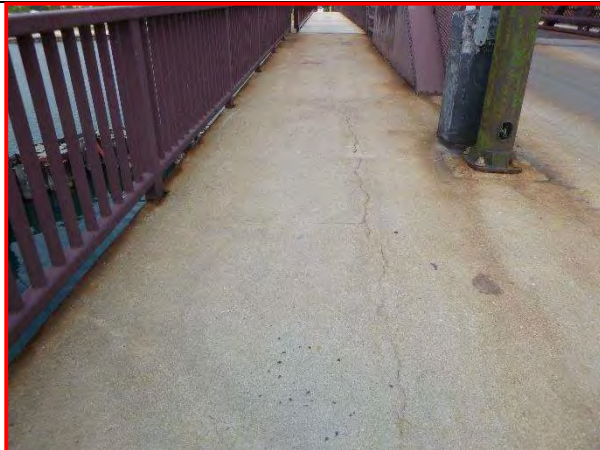
- The sidewalks in the fixed spans exhibit scattered longitudinal and transverse narrow cracks as well as minor spalls near the expansion joints (see Photograph 10).
- The sidewalks in the movable spans exhibit no notable defects.

10. Southwest sidewalk, looking north.

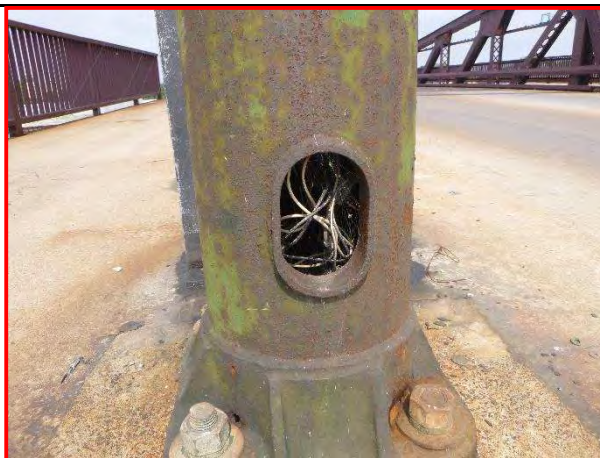
- The light standards exhibit minor to moderate corrosion, missing handhole covers, and missing anchor bolt covers (see Photographs 11).
- Multiple light standards exhibited missing sunshades (see Photograph 12).
- The southwest light standard base exhibited a 7"x1" hole (see Photograph 13).

11. Typical light standard base, southwest corner, looking north.

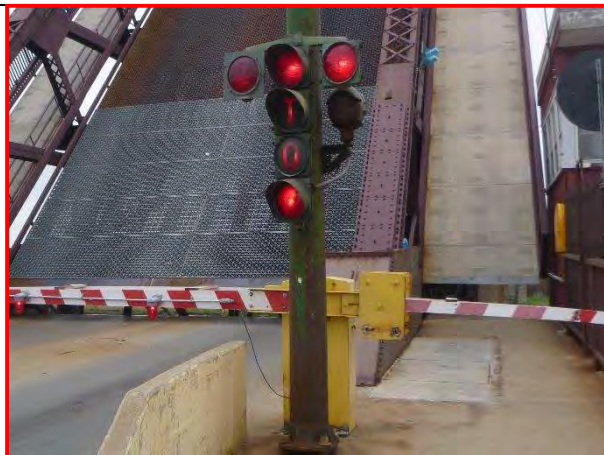
12. Northwest light standard, looking south.

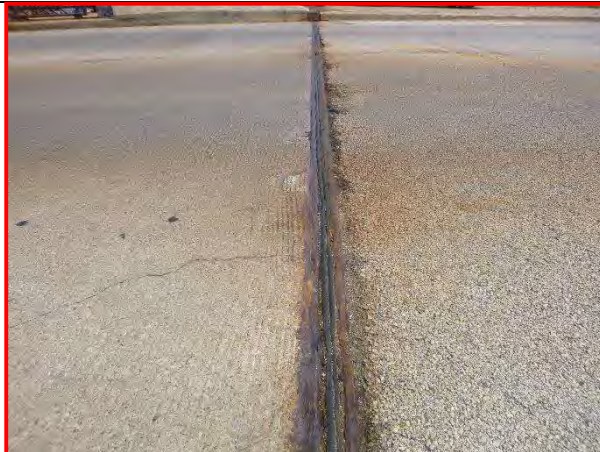
- The expansion joints exhibit sections of depressed and torn glands, moderate to heavy corrosion of the steel rails, and moderate debris accumulation (see Photograph 14).
- The sidewalk expansion joints exhibited heavy corrosion and debris buildup (see Photograph 15).
- The center and rear breaks along Span 3 exhibit moderate corrosion (see Photograph 16).
- At 85° Fahrenheit, the center break at the east sidewalk has a 1.75" gap, and the west sidewalk has a 2.125".
- The north center plate at the east sidewalk exhibits a 1" vertical distortion (see Photograph 17).

14. Typical south expansion joint, looking east.

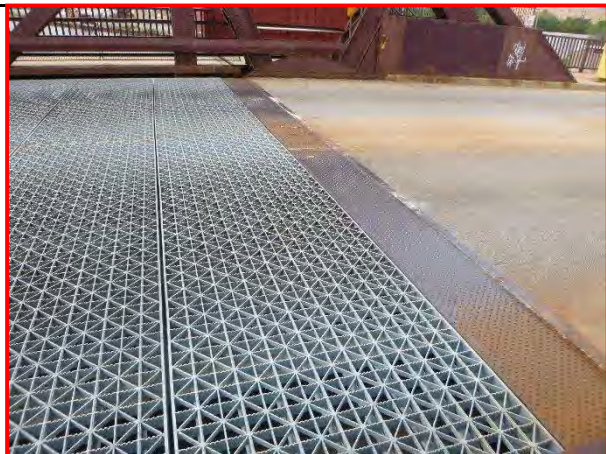
16. North break joint, looking northwest.

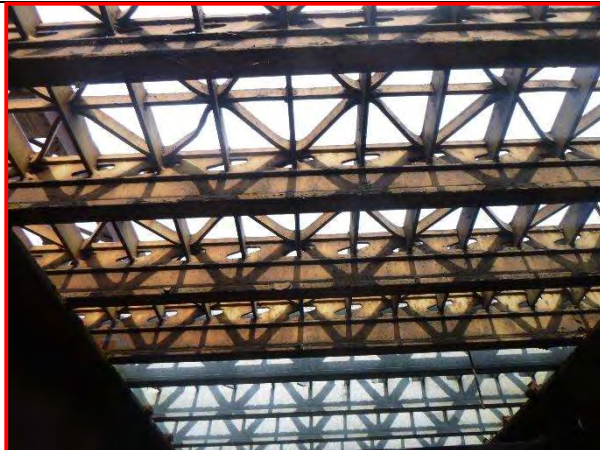
- The underside of the movable spans exhibit minor to moderate corrosion (see Photograph 18).
- The underside of the sidewalk movable spans exhibit no notable defects (see Photograph 19).
- The underside of the fixed spans exhibit hairline transverse and longitudinal cracking (see Photograph 20).

18. Span 3 underside, looking north.

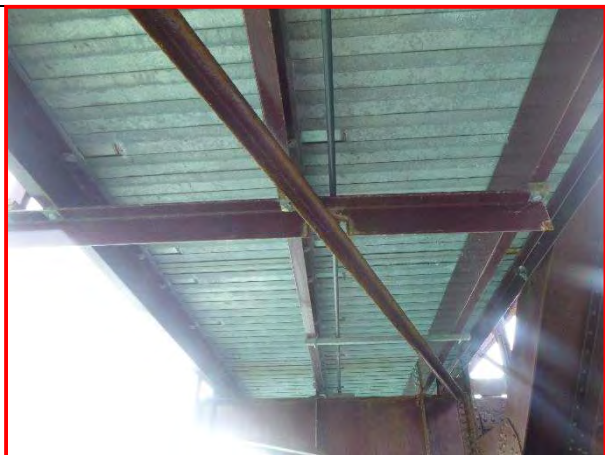
19. Sidewalk underside, looking south.

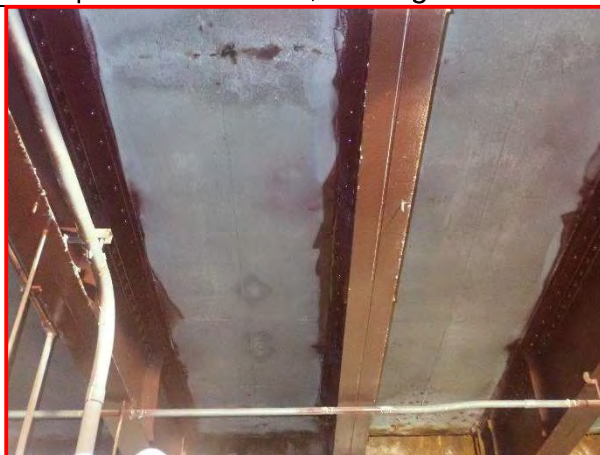
20. Typical transverse cracks in underside of fixed spans, looking south.

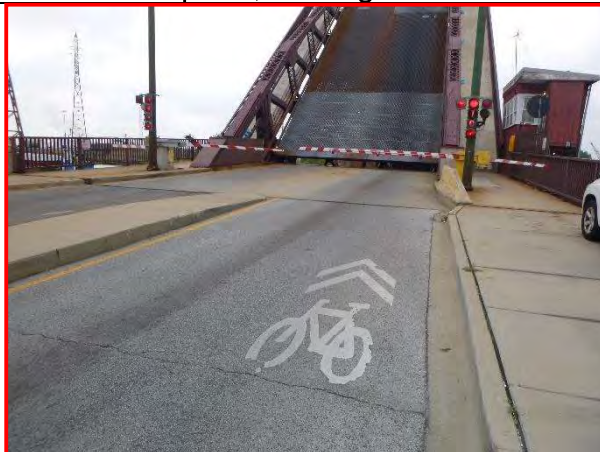
- The asphalt approaches exhibit scattered hairline to narrow transverse and longitudinal cracking throughout (see Photograph 21).
- The approaches have settled $\frac{1}{2}$ " to $\frac{3}{4}$ " in reference to the structure (see Photograph 22).
- The sidewalk approaches exhibit moderate to heavy narrow to wide cracking and spalling (see Photograph 23).

21. Typical approach condition, looking South.

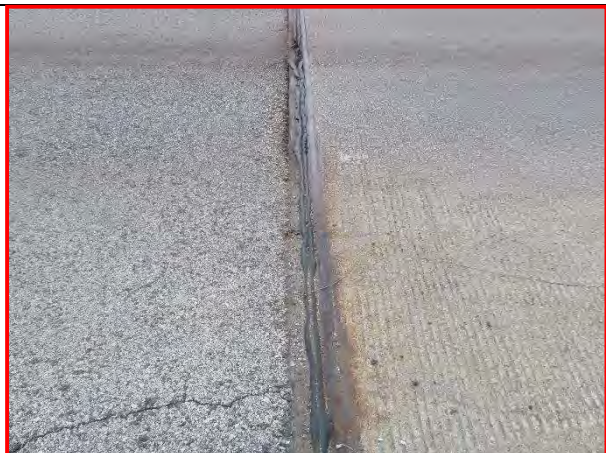
22. North approach expansion joint, looking northeast.

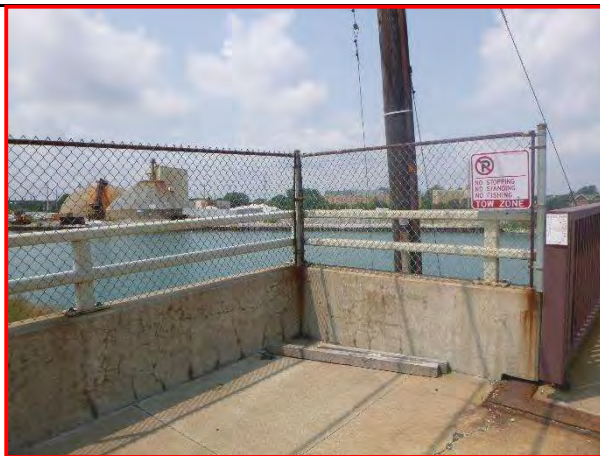
- The fencing at the southwest corner of the bridge exhibits no notable deficiencies (see Photograph 24).

24. Southwest fence, looking northwest.

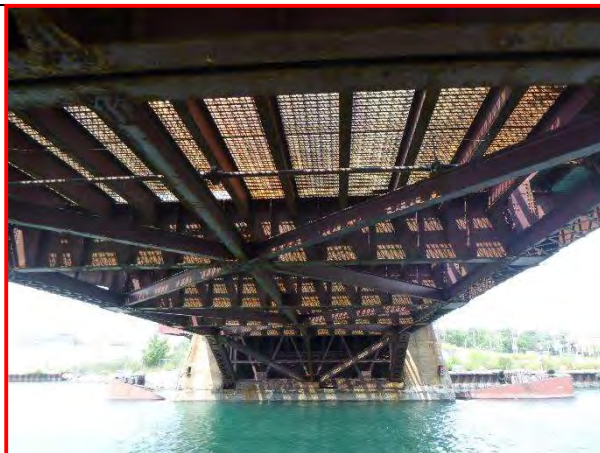
28. Overall underside, looking north.

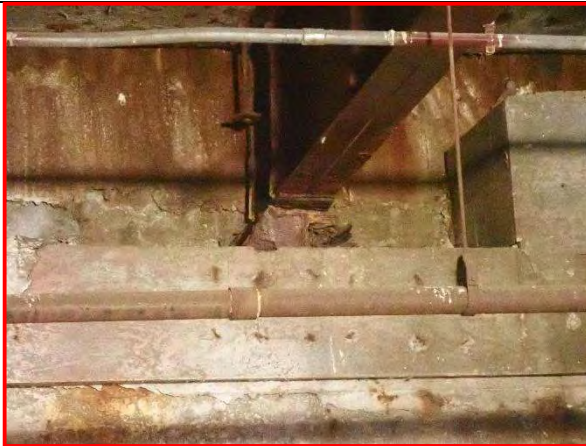
- The bearing at Stringer 9 at the South Abutment is heavily deteriorated and crushed (see Photograph 29).
- The bearing at Stringer 3 at the South Abutment is rotated west.

29. Stringer 9 bearing at South Abutment, looking south.

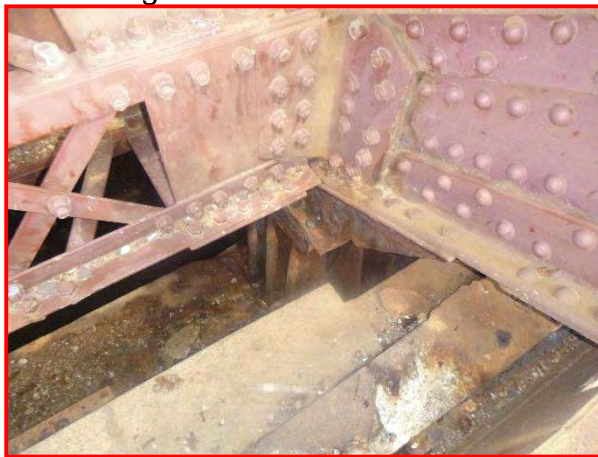
- The sidewalk stringer bearings exhibit several cracked and broken castings and several missing anchor bolts.
- The live load bearings typically exhibit heavy corrosion and minor section loss. (See Photograph 30).

30. Northeast live load bearing, looking north.

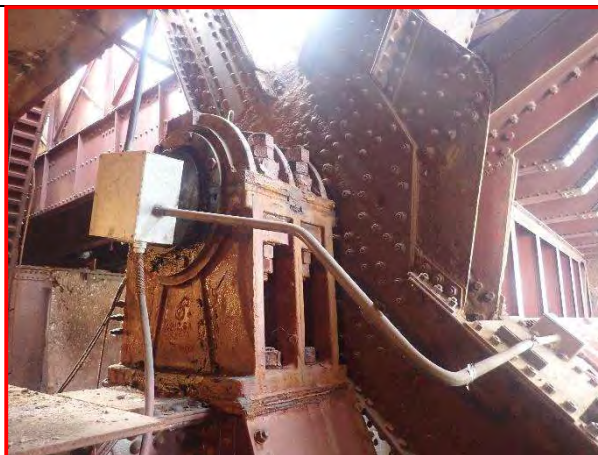
- The trunnion bearings typically exhibit areas of minor corrosion and pitting (see Photograph 31).

31. Typical trunnion bearing, looking southwest.

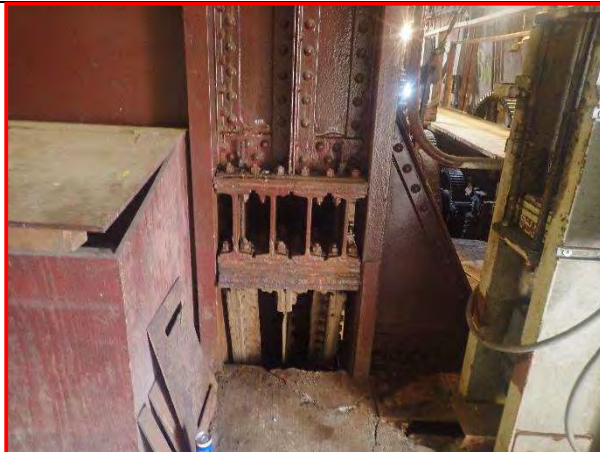
- Trunnion bearing anchors exhibit minor to moderate section loss, predominately at the bottom.
- The secondary live load bearings have a gap between bumper and anchor shoe of approximately 1/16" to 1/2".
- The secondary live load bearings exhibit moderate to heavy corrosion. (See Photograph 32).

32. Northwest secondary live load bearing, looking south.

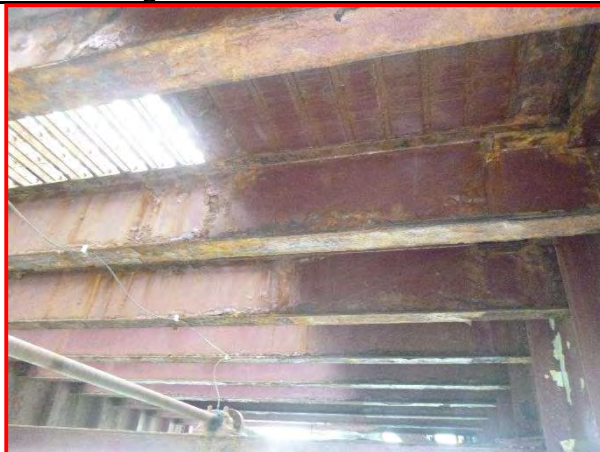
- The roadway stringers in the movable span exhibit heavy corrosion and moderate section loss on the bottom flange, moderate areas of corrosion and section loss in the web, and moderate corrosion with moderate to heavy section loss in the top flange (see Photograph 33).
- Stringers along the moveable and fixed spans typically exhibit heavy deterioration (see Photograph 34).
- The stringers in the fixed spans have drilled holes in the bottom flanges.
- The sidewalk stringer by the west curb at the South Abutment exhibits heavy corrosion and a corrosion hole above the bearing.

33. Typical movable span roadway stringer, looking east.

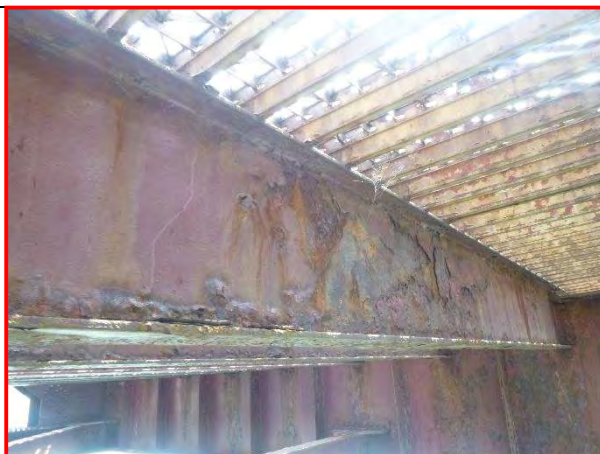
34. Stinger 8, north leaf, between floorbeams 4 and 6, looking south.

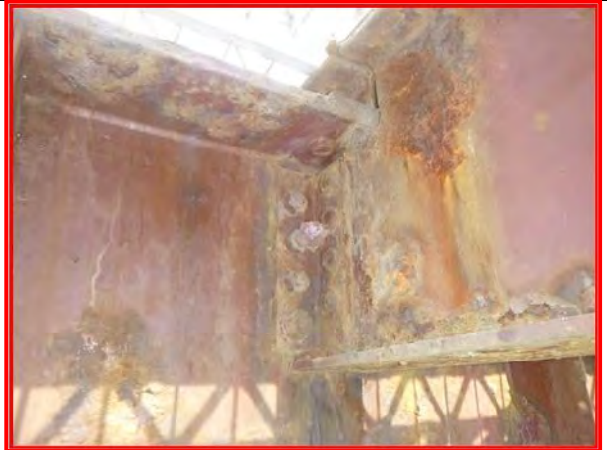
- The floorbeam to stringer connection typically exhibits heavy corrosion and minor section loss (see Photograph 35).
- Stringer 5 exhibits a bent bottom flange near the anchor column floorbeam in Span 5. (See Photograph 36.)
- The sidewalk framing in the fixed span has no notable defects.
- The stringers in panel 1 have been replaced (see Photograph 37).

35. Typical stinger to floorbeam connection, looking north.

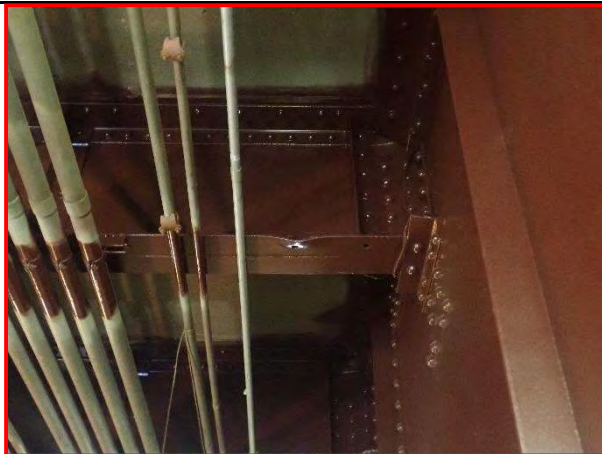
36. Span 5, Stringer 5 at anchor column girder, looking west.

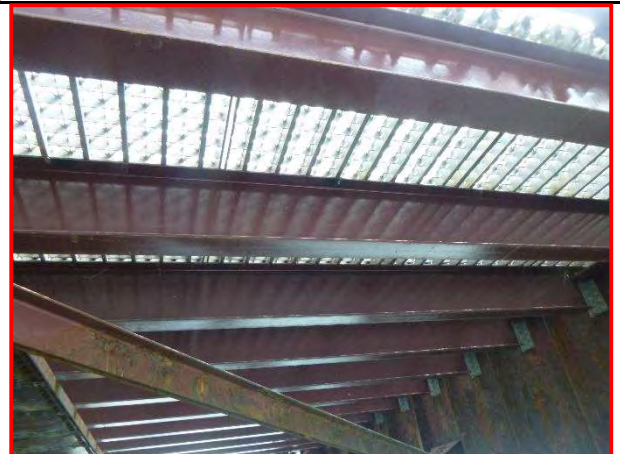
37. Panel 1, between floorbeam 8 and 10, looking northeast.

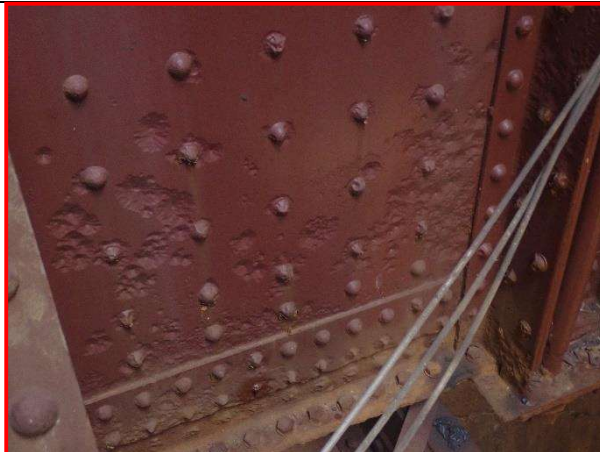
- The trunnion cross girders exhibit minor to moderate pitting in the end bays for the full height of the web (See Photograph 38).
- From the river pier to the trunnion cross girder the longitudinal trunnion girders exhibit minor to moderate section loss (See Photograph 39).
- From the trunnion cross girder to the pinion, the longitudinal trunnion girders exhibit moderate to heavy section loss.
- From the pinion to the back of the truss, the longitudinal girders exhibit moderate corrosion and minor section loss.
- The northwest longitudinal girder exhibits a 1' by 3" hole under the pinion in the east web (See Photograph 40).
- The longitudinal girders have limited access.

38. Moderate pitting to end bay of trunnion cross girder, looking south.

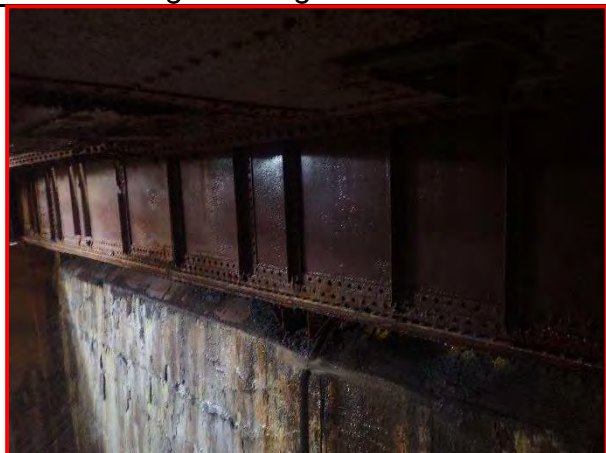
39. Southeast longitudinal girder, looking northeast

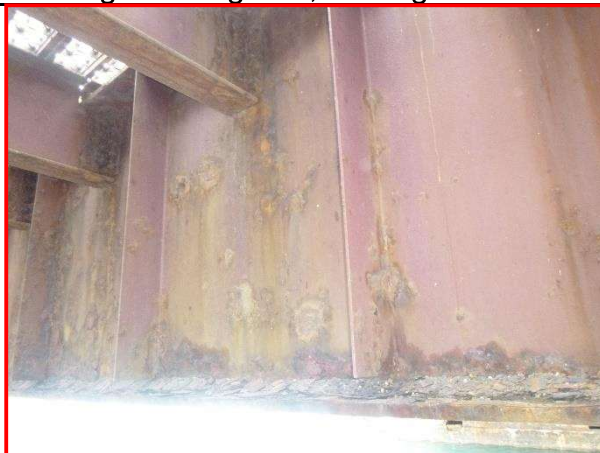
- The floorbeams in the movable span exhibit heavy corrosion, moderate debris, heavy section loss, and web holes measuring 1/2" to 4" in diameter (see Photograph 41).

41. Typical moveable span floorbeam condition, looking north.

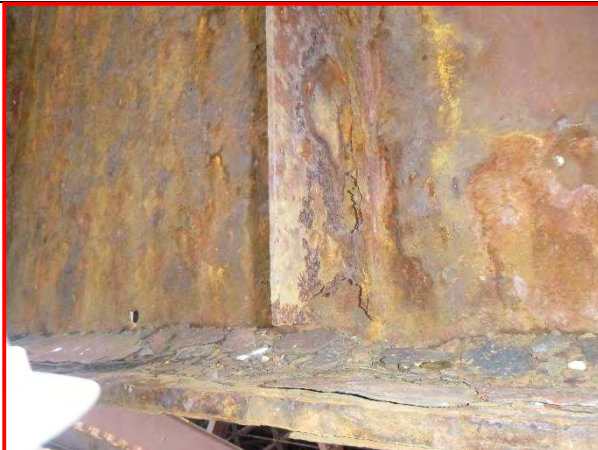
- The floorbeam stiffeners exhibit moderate to heavy corrosion and scattered areas of section loss (see Photograph 42).
- Floorbeam 8-8N exhibits several web holes measuring 1" to 3" in diameter (see Photograph 43).
- The floorbeam to truss connection exhibits minor to moderate corrosion and isolated areas of holes measuring up to 2" (see Photograph 44).

42. Floorbeam 8-8S stiffener, looking south.

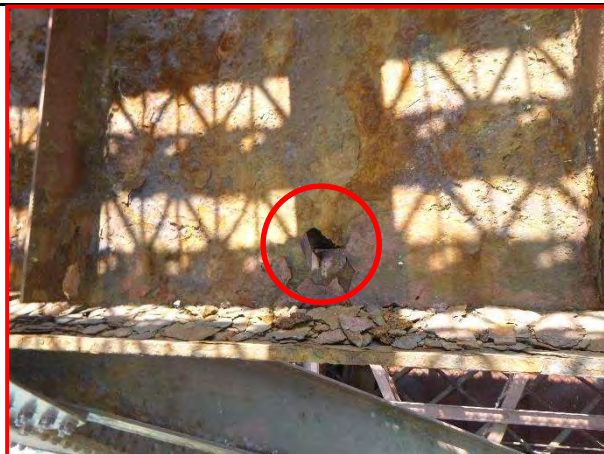
43. Floorbeam 8-8N, looking northwest.

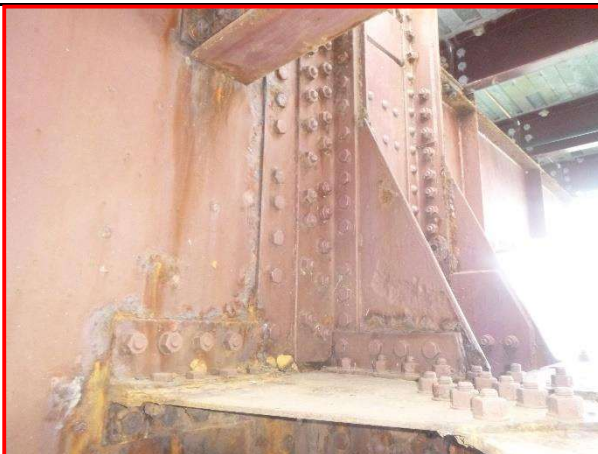
44. Typical condition of anchor column floorbeam, looking northwest.

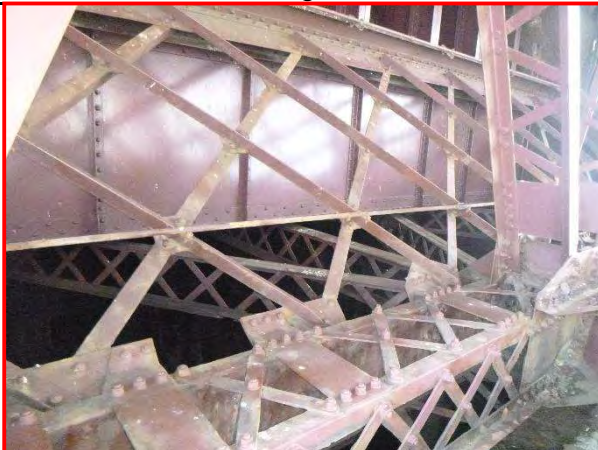
- The lattice trusses exhibit minor corrosion (see Photograph 45).

45. Southwest lattice truss, looking south.

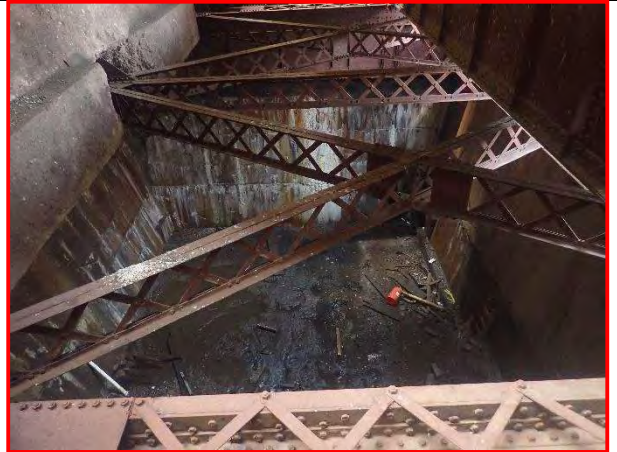
- The lateral bracing in the fixed and movable spans exhibit heavy corrosion and minor section loss throughout (see Photographs 46 and 47).
- The lateral bracing connections exhibit scattered areas of moderate corrosion and small holes.

46. Typical lateral bracing over counterweight pits, looking west.

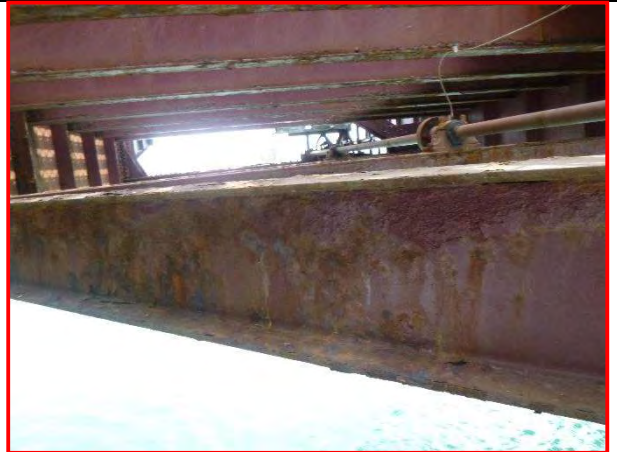
47. Lateral bracing, north leaf, looking east.

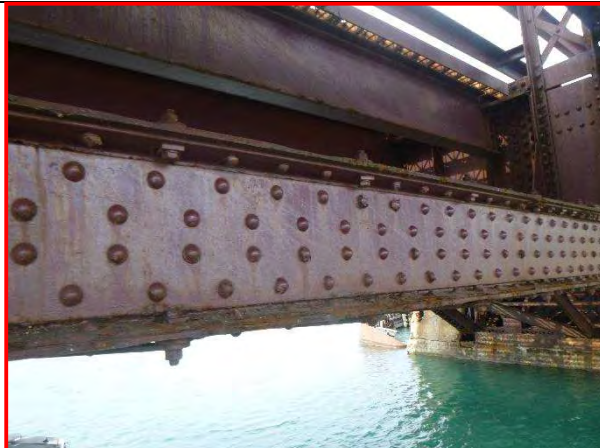
- The trusses typically exhibit scattered areas of minor to moderate corrosion, scattered holes in some members, and section loss of various rivet heads and welded attachments (see Photograph 48).
- Bottom chord member 4-6 at the northeast truss, bottom chord member 6-8 at the northeast truss, and bottom chord member 2-4 at the southeast truss exhibits impact damage with the greatest deflection noted at member 2-4SE (See Photograph 49).
- The lacing bars on the bottom chords exhibit minor to moderate corrosion, isolated areas of bending, and broken bars throughout (see Photograph 50).
- Truss members 2-3NW, 4-6NW, 0-2NW, 4-5NW, 4-6NE, 8-10NE, 4-6SE, and 0-2SW are slightly bent out-of plane (see Photograph 51).

48. Bottom chord, northeast truss, looking northwest.

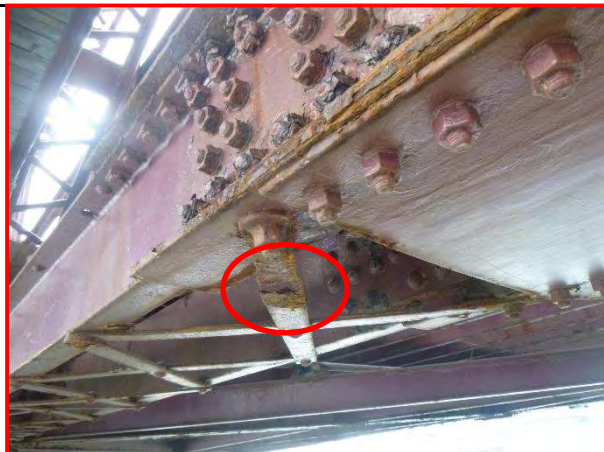
50. Typical lacing bars, looking southwest.

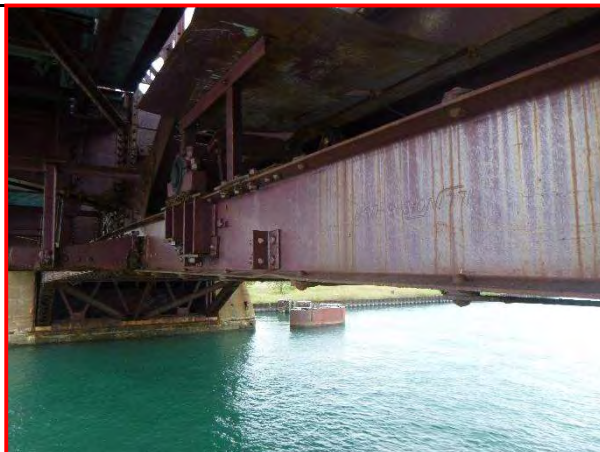
51. Northeast truss, member 0-2, looking southwest

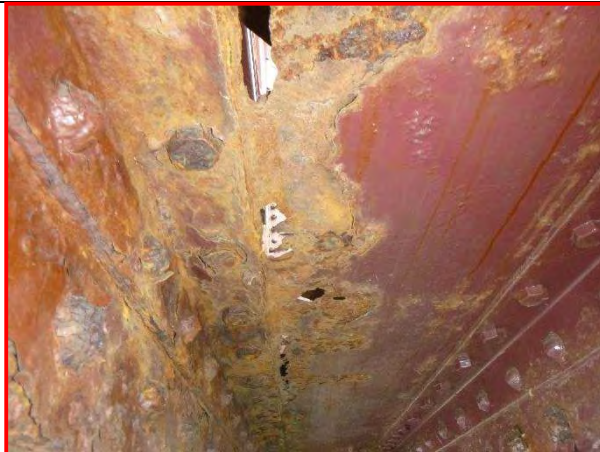
- The batten plate of bottom chord 4-6 at the northwest truss exhibits multiple holes up to 3” in diameter and moderate section loss (see Photograph 52).
- The lateral bracing and bottom chord 0-2 connection at the southwest truss exhibits a ½” diameter hole, moderate section loss, and moderate to heavy corrosion (see Photograph 53).
- The gusset plates typically exhibit heavy corrosion and minor to moderate section loss (see Photograph 54).
- The batten plate on bottom chord 6-8 at the southwest truss exhibits heavy section loss and moderate deterioration (see Photograph 55).

52. Batten plate of bottom chord 4-6, northwest truss, looking north.

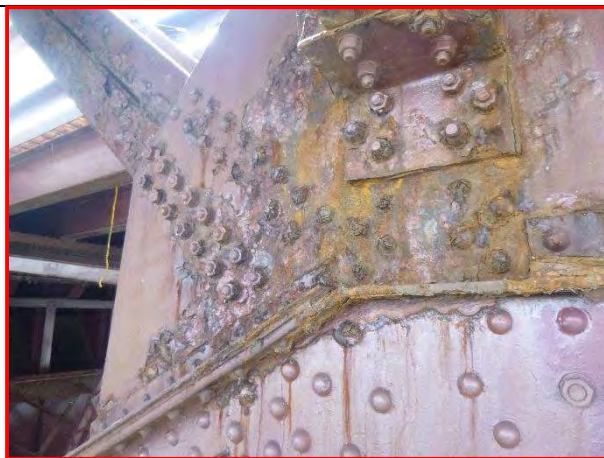
54. Gusset plate 8, southeast truss, looking west.

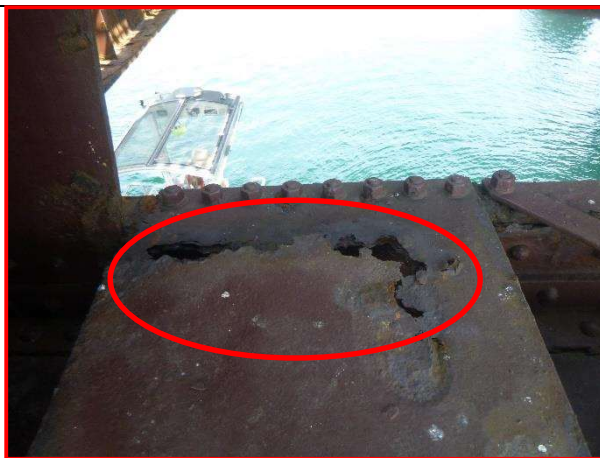
55. Batten plate, southwest truss, looking southeast.

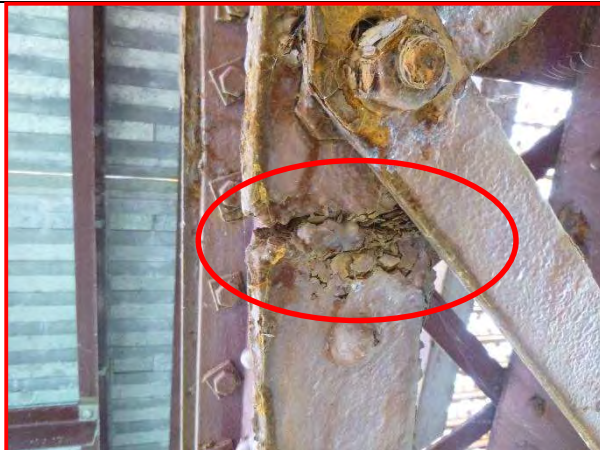
- The bottom chord 2-4 at the southeast truss exhibits a vertical stress crack and moderate corrosion (see Photograph 56).
- Truss member B-12 at the southeast truss exhibits concrete spalling of the counterweight as well as minor to moderate corrosion (see Photograph 57).
- The top chord exhibits poor quality field welds and torch-cut holes for the welded attachments including the brush rails and light fixtures (see Photograph 58).
- The top and bottom of the top chords exhibit 1”-2” strip of minor corrosion along all four trusses for full length (see Photograph 59).

56. Bottom chord 2-4, southeast truss, looking up.

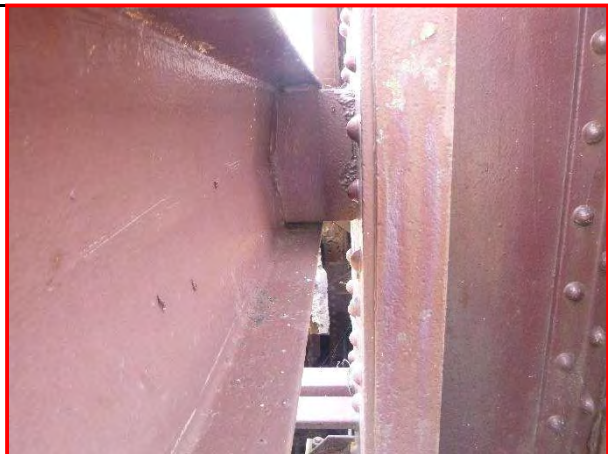
58. Truss and steel angle connection, looking southeast.

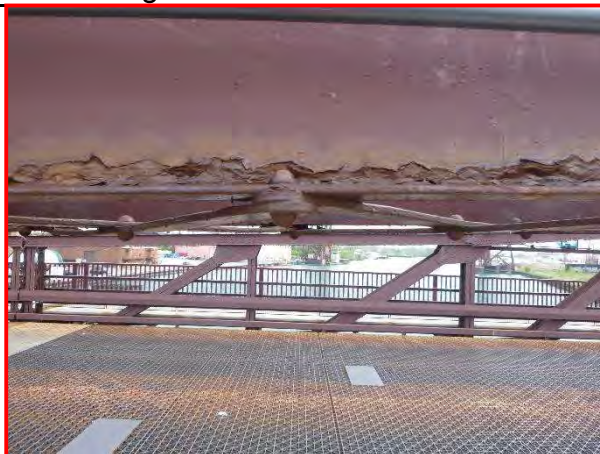
59. Typical top chord member, west truss, looking east.

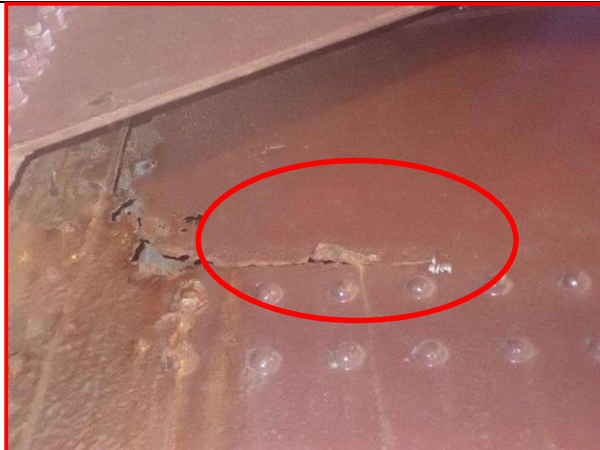
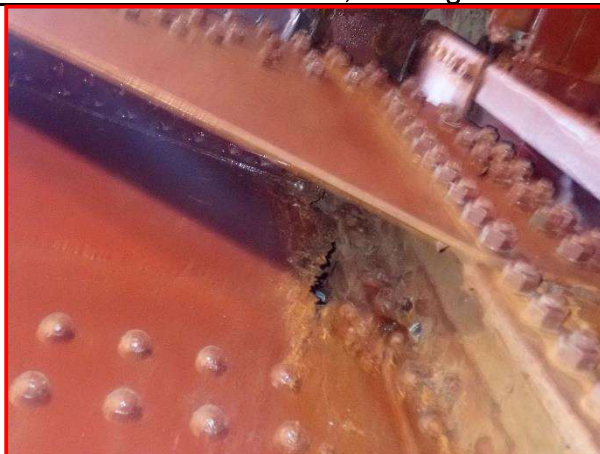
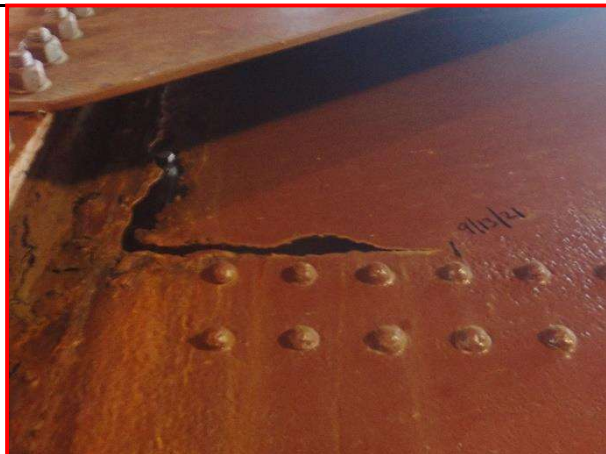
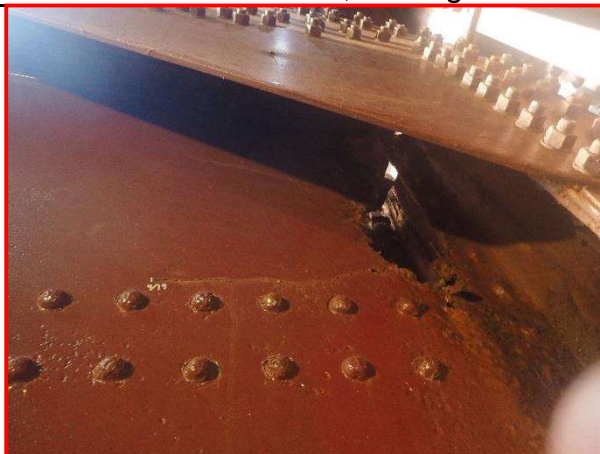
- The rear arms of the trusses between Nodes A, 14, and 15 exhibit large cracks/corrosion holes. The southeast truss exhibits a 22 ½" horizontal crack from the face of member 14-15SE and 30" vertical crack along the connection of the plate and member 14-15SE. The southwest truss exhibits a 25" by 3" corrosion hole. The northeast and southwest trusses exhibit a horizontal 25" corrosion hole/crack from the face of member 14-15NE / 14-15SW. (No change since previous inspection). (See Photographs 60 thru 63).

60. Southeast truss rear arm crack/corrosion hole, looking west.

61. Southwest truss rear arm crack/corrosion hole, looking east.

62. Southwest truss rear arm crack/corrosion hole, looking west.

63. Northeast truss rear arm crack/corrosion hole, looking southwest

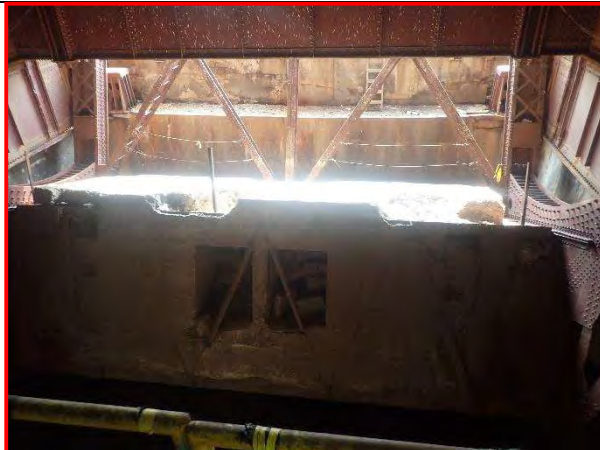
- Counterweights exhibit heavy concrete spalling with exposed steel framing and narrow to wide cracks. (See Photograph 64.)
- The steel plates exhibit heavy corrosion and section loss.

64. Top of north counterweight, looking south.

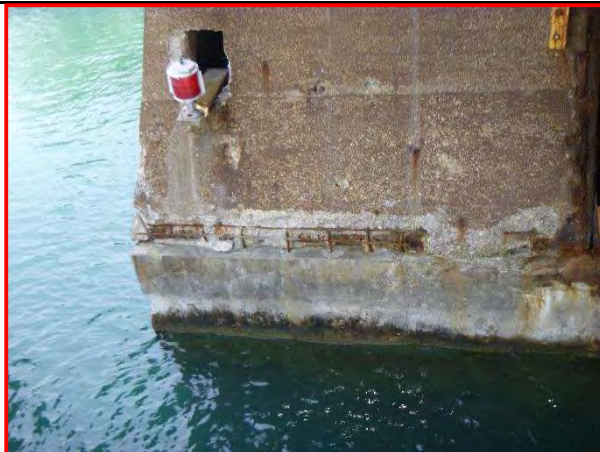
- The bridge houses have spalling around the waterline with exposed rebar (see Photograph 65).
- The exterior bridge house stairs exhibit heavy corrosion on the support members, and the concrete stairs exhibit cracks and spalls (see Photograph 66).
- The bridge house enclosure walls exhibit rust stains and spalls at the edge of the sidewalk (see Photograph 67).

65. South bridge house at the water line, looking south.

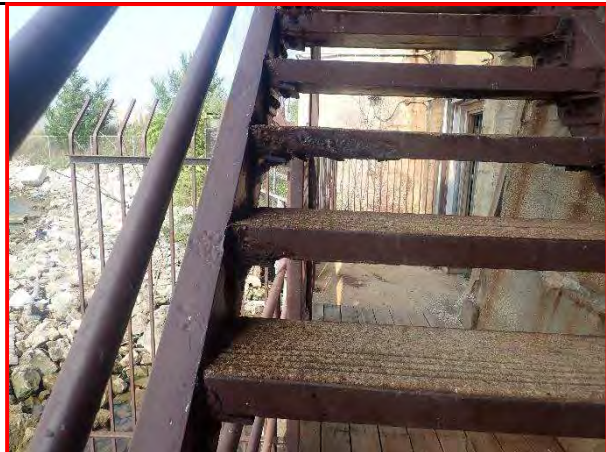
66. Northwest stairwell, looking north

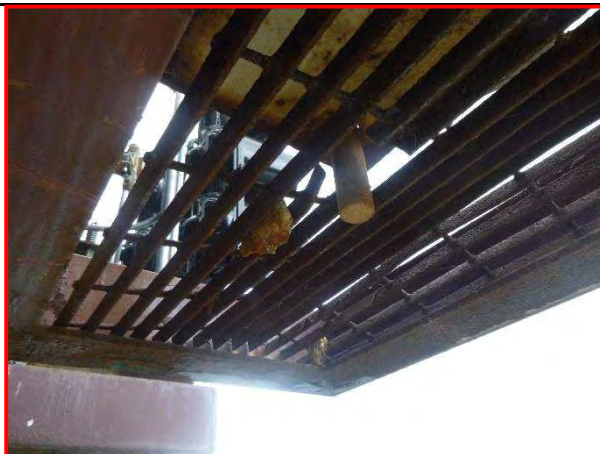
- The southeast catwalks below the center break exhibit minor pitting and corrosion on the grating. In lieu of steel grating, the northeast and southwest catwalks have steel plating installed, and the northwest catwalk has fiberglass grating.
- The southeast catwalk grating is deformed (See Photograph 69).
- The supporting angles for the center break catwalks exhibit minor to heavy corrosion and minor section loss.
- A previously dislodged lens and sun shade, has been repaired.

69. Southeast catwalk, looking north.

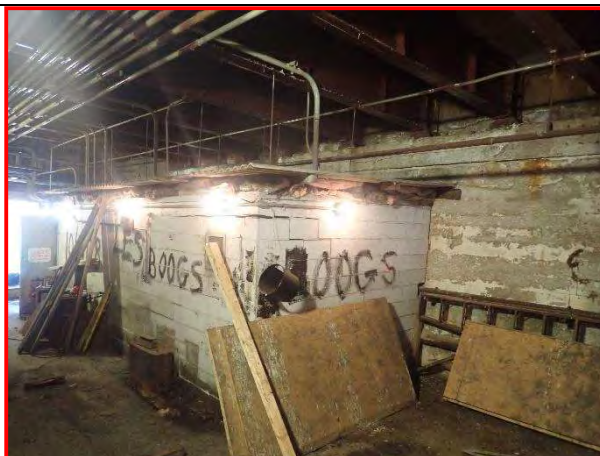
- The visible portions of the abutments exhibit minor to moderate scaling, various vertical leaching hairline to narrow cracks, minor spalling, and horizontal cracks near the base (see Photographs 70 and 71).
- The abutment bearing seats exhibit various sized vertical cracks.
- Between bearing seats 4-7 on the South Abutment, there is a spall (see Photograph 72).
- The North Abutment has delaminations between bearing seats 1 and 2 and 5 and 6.
- The abutment backwalls have isolated areas of rust stains, signs of moisture, leaching narrow cracks, and spalls with exposed and corroded reinforcement

70. South Abutment, Looking southeast.

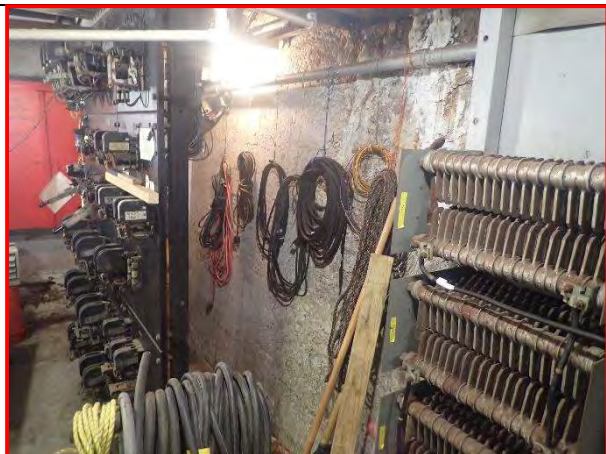
71. South Abutment, Looking south.

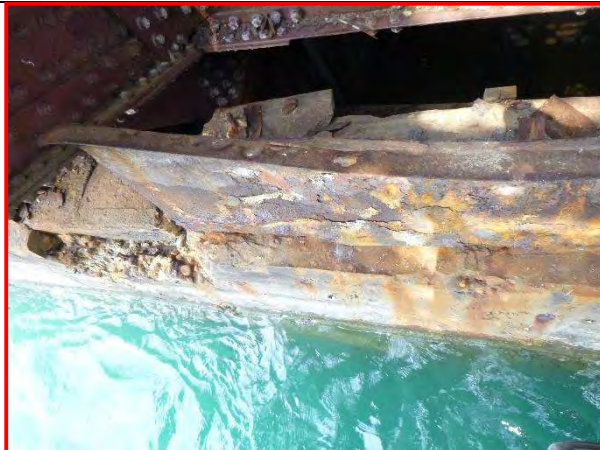
- The north and south river piers have steel guards with heavy corrosion and section loss. The north river pier exhibits impact damage (see Photograph 73).
- The river side of the north river pier exhibits a 6'x3' spall with exposed rebar near the northwest live load bearing.
- The north face of the north river pier exhibits several narrow to wide diagonal, vertical, and horizontal leaching cracks and small spalls (see Photograph 74).
- Both the north and south river piers exhibit narrow leaching cracks, several spalls with exposed reinforcement along the waterline, and a few delaminated areas (see Photograph 75).
- The bottom flange of the north anchor column floorbeam is bent 1¼" near midspan and has a web repair.
- The anchor column floorbeams typically have welded attachments and drilled holes in the bottom flange.
- The south anchor column floorbeam has a bent stiffener.

73. Steel guard rail on the north river pier, looking north.

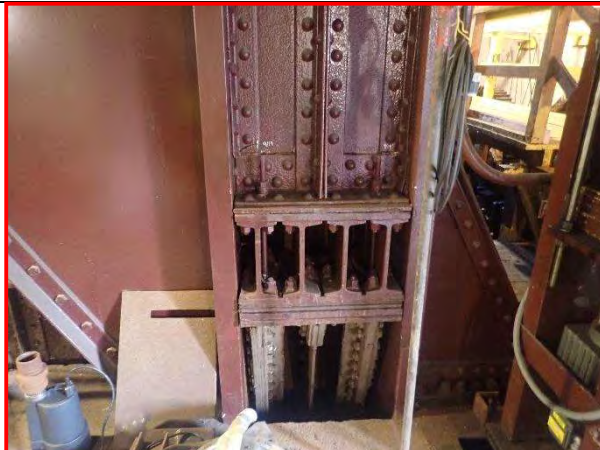
- Southeast anchor column has a 5” long crack in the web and a 2 ¾” long crack in the angle leg above bumper west of the stiffener. On the east side of the stiffener, the web has a vertical 1” crack (see Photograph 76).

76. Southeast anchor column, looking north.

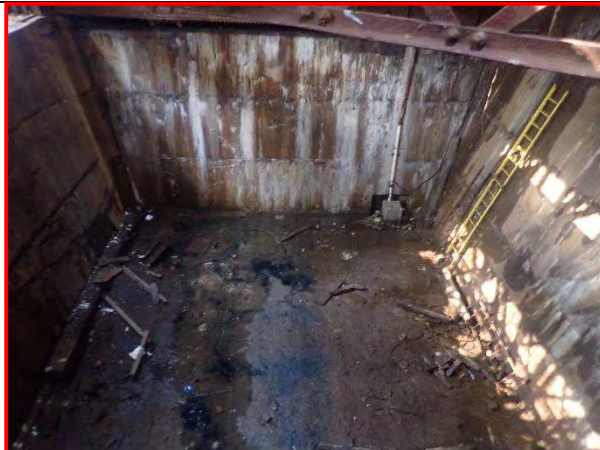
- The counterweight pit walls exhibit several narrow to wide diagonal, vertical, and horizontal leaching cracks and small spalls (see Photograph 80).
- The counterweight pits have shallow water and minor debris accumulation.

80. North counterweight pit walls, looking east.

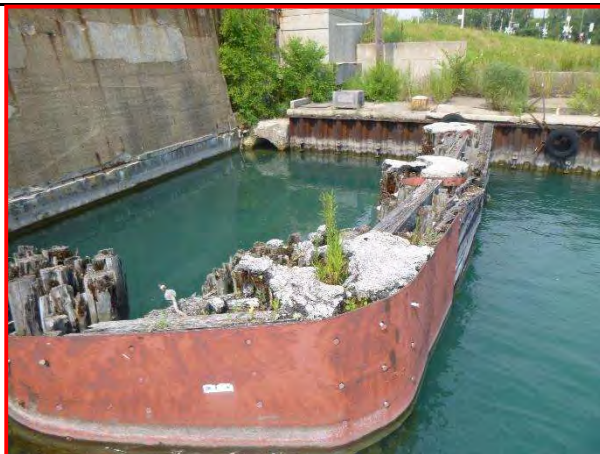
- There are no fenders protecting the river piers. The timber pile and steel plate protection systems are in place but exhibit deterioration. A section of the northeast and northwest timber pile dolphins are broken due to impact (see Photograph 81).

81. Typical condition of timber pile and steel plate protection system, looking north.

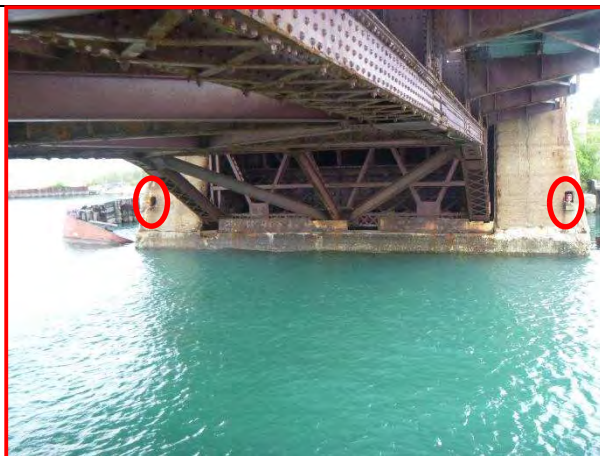
- The navigational lights attached to the substructure are in place and functioning (see Photograph 82).

82. Navigation lights on the south river pier, looking south.

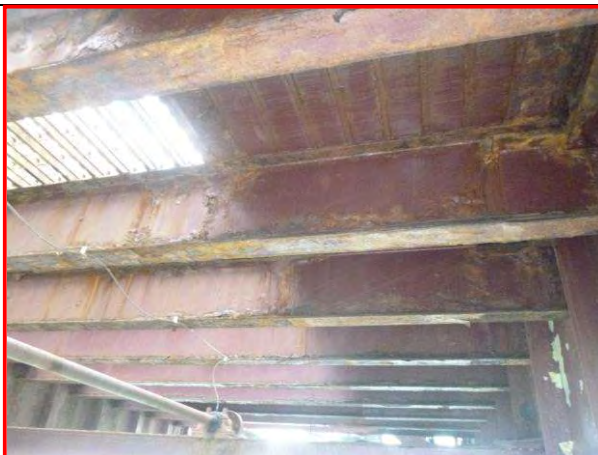
- The paint system has failed in most of the movable span elements below the deck (see Photograph 83).
- The paint system in the truss members above the deck and the fixed spans exhibit minor deterioration with scattered locations of moderate deterioration. The longitudinal trunnion girders exhibit worse deterioration.

83. Superstructure paint, looking east.

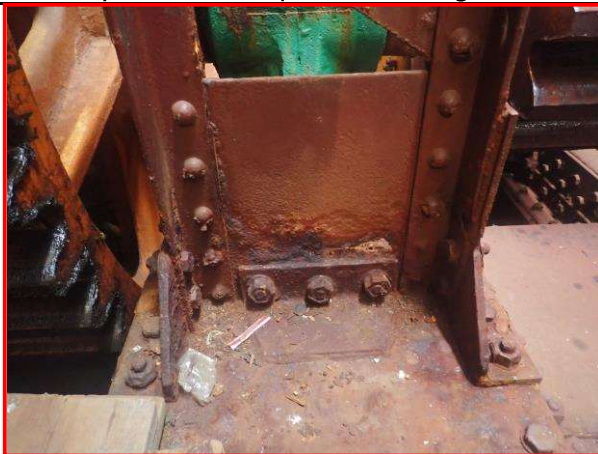
- The paint system exhibits moderate deterioration in the bottom 1’-3’ of the anchor columns and various sidewalk columns (see Photograph 84).

84. Substructure paint system, looking down.
