**CITY OF CHICAGO - DEPARTMENT OF TRANSPORTATION  
BRIDGE INVENTORY REPORT**

**Structure No. 016-6038**

**95<sup>th</sup> Street  
over  
the Calumet River**

**Inspection Date: August 11, 2021**

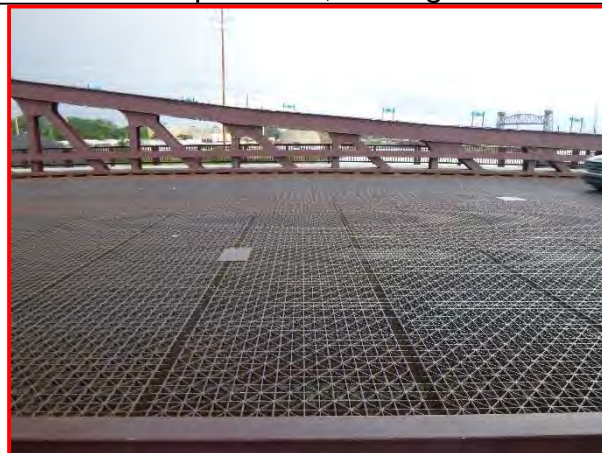
- In Span 3 the open steel grating wearing surface exhibits a few broken top bars and several welded plate repairs (see Photograph 3).

3. Steel plate repairs along the open steel grating, looking northeast.

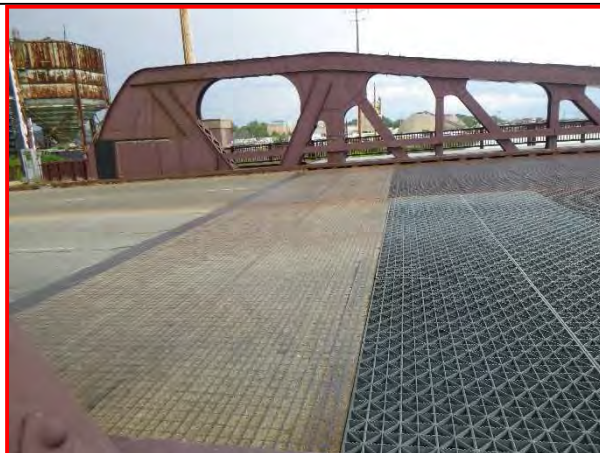
- In Span 3, the concrete-filled portions of the grating near the rear breaks exhibit light scaling, minor concrete pop-outs, minor to moderate corrosion of the steel grating, and a few broken banding bars along the edges (see Photograph 4). Some areas have been covered utilizing welded plate repairs.
- The bituminous wearing surface in the fixed spans exhibits scattered wide diagonal cracks, rutting along the shoulders, and uneven surfaces as well as a few potholes and rough patching (see Photographs 5-7).
- The pavement markings are faded on Span 3 and visible elsewhere.

4. Span 3 interface of concrete filled and open steel grating, looking north.

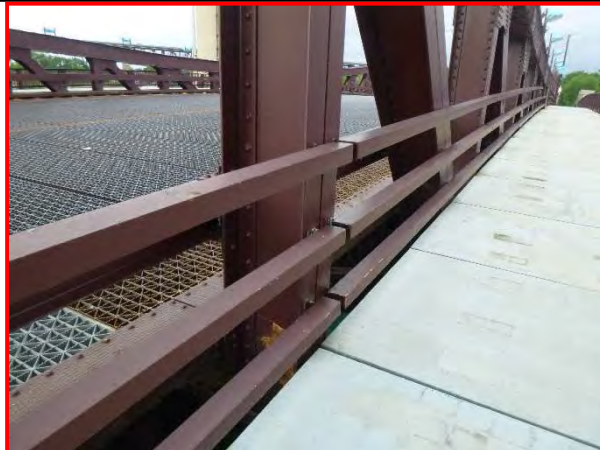
- The railings in Span 3 exhibit isolated areas of moderate corrosion and scattered paint peeling/scrapes throughout (see Photograph 8).
- Span 3, there are steel railings field welded to the outside face of the vertical and diagonal truss members above the sidewalk.
- Sections of the fixed span pedestrian railings have been replaced (see Photograph 9).

8. Typical pedestrian railing, looking southwest.

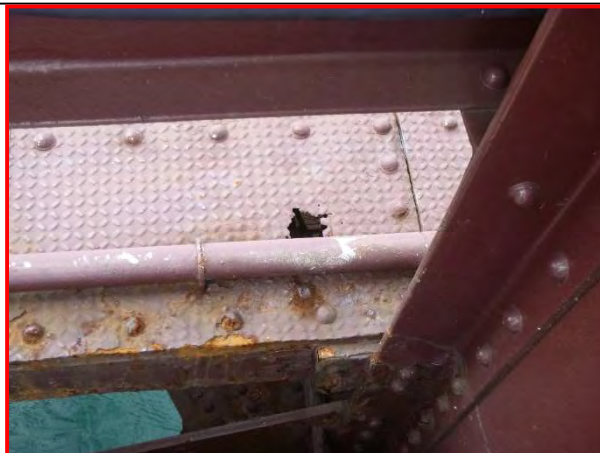
- In the movable span, the steel curbs exhibit areas of minor deterioration and scattered corrosion holes in the cover plate (see Photograph 10).

10. North curb of the east leaf, looking south.

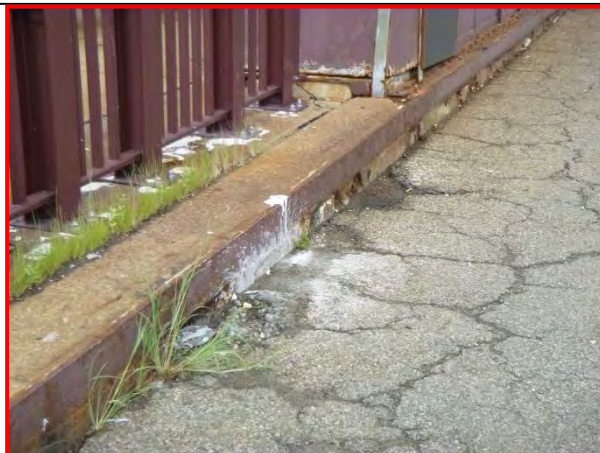
- In the fixed spans, the concrete along the steel curb plates typically exhibits minor spalling (see Photograph 11).

11. Spans 4 and 5 steel curb, looking northeast.

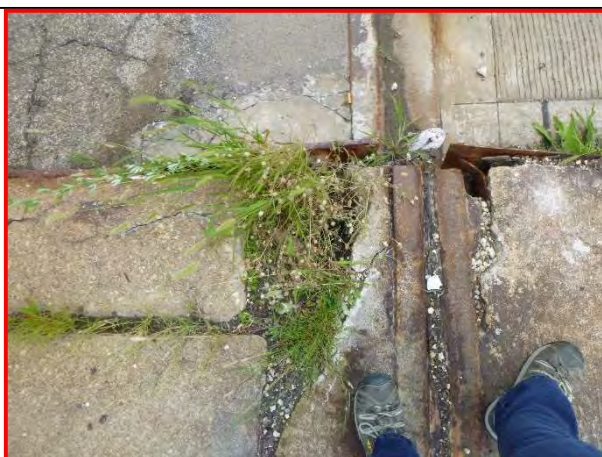
- The Span 3 sidewalks have been replaced (see Photograph 12).
- The north sidewalk exhibits section loss and a bent steel curb with surrounding vegetation at the west expansion joint (see Photograph 13).
- The northwest approach sidewalk exhibits several spalls, and vegetation growth (see Photograph 14).

13. North sidewalk at West Expansion Joint, looking down/south.

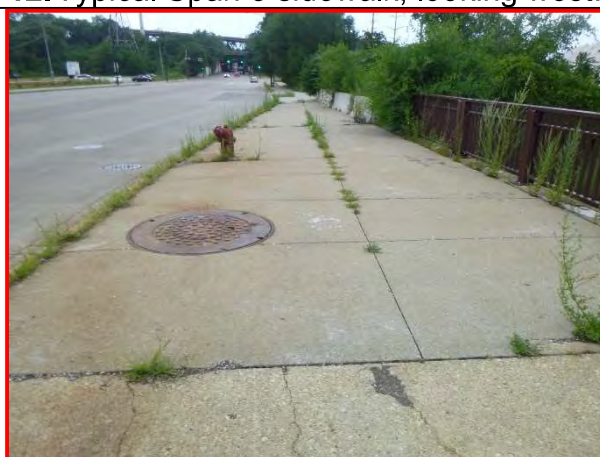
14. Northwest approach sidewalk, looking west.

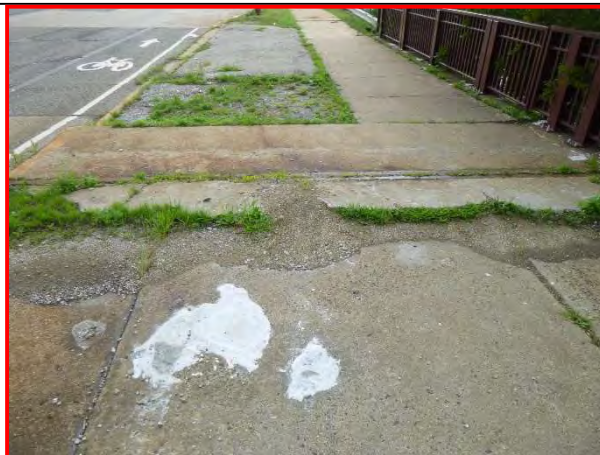
- The south sidewalk at the east expansion joint exhibits heavy spalling, with heaving up to 4” vertically (see Photograph 15).
- The south sidewalk in Spans 1 and 2 exhibits heaving (see Photograph 16).
- There is a concrete patch at the southwest corner of the truss. (see Photograph 17).
- The southwest approach sidewalk has been patched (see Photograph 18).
- The northeast approach sidewalk has a grate approximately 20’ from the east expansion joint that is bent in up to 2” (see Photograph 19).

15. South sidewalk at east expansion joint, looking east.

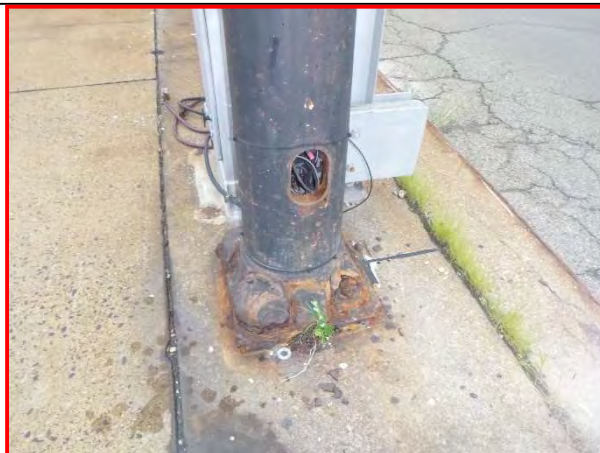
- The light standards exhibit moderate to heavy corrosion near the bases, corroded or missing anchor bolt covers, and missing hand hole covers with exposed wiring at the Southwest Light Standard and the Northwest Approach Light Standard (see Photograph 20).

20. Typical light standard base, looking east.

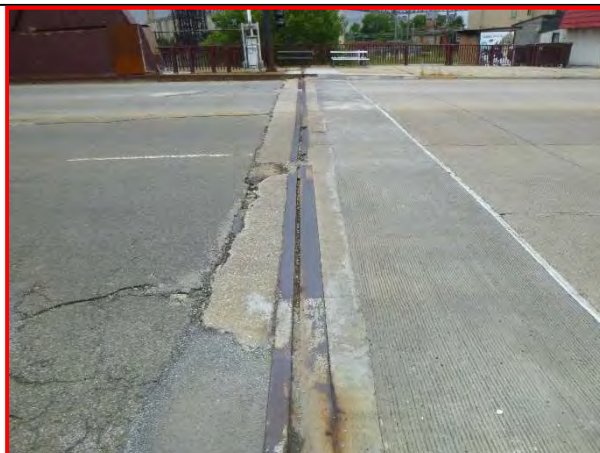
- The West Expansion Joint exhibits missing sections of armor plate in three locations (which have been filled in with bituminous material), debris accumulation, and wide cracks and spalling along the concrete blockout (see Photograph 21).
- The East Expansion Joint exhibits minor debris accumulation and the gland is bulging along  $\frac{3}{4}$  of the length (see Photograph 22).
- Both expansion joints at the sidewalks exhibit heavy corrosion and deteriorated sections of gland with vegetation growth.
- The center and rear breaks have a few areas of minor corrosion and there are polished sections of the steel plates along the wheel lines (see Photograph 23).

21. West joint condition, looking north.

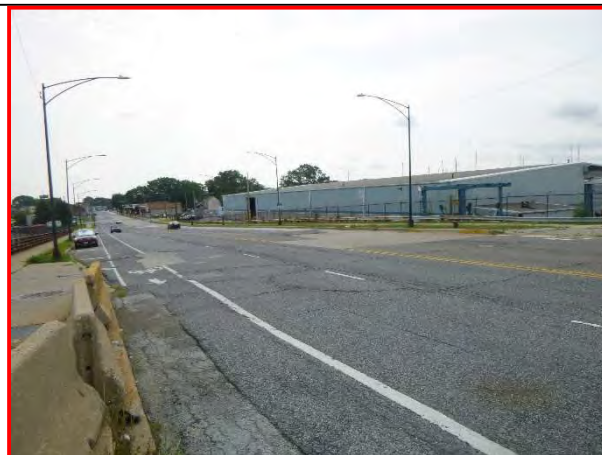
- The concrete and bituminous approaches exhibit scattered hairline longitudinal cracks, with wide cracks in the East Approach (see Photograph 26).

26. East approach, looking east.

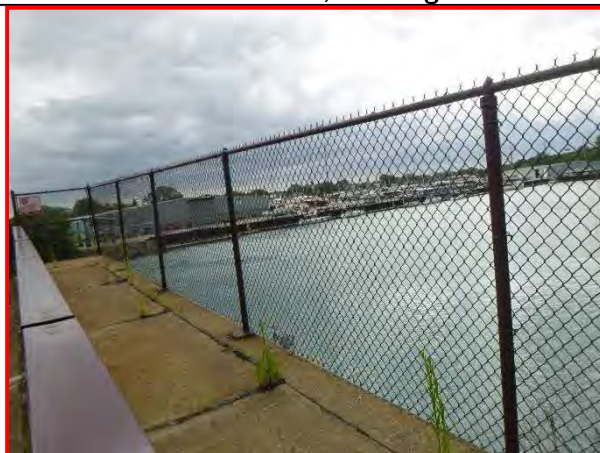
- There is chain link fencing behind the bridge railing along all four corners of the bridge that exhibits corrosion (see Photograph 28).

28. Fence at the southwest corner, looking southeast.

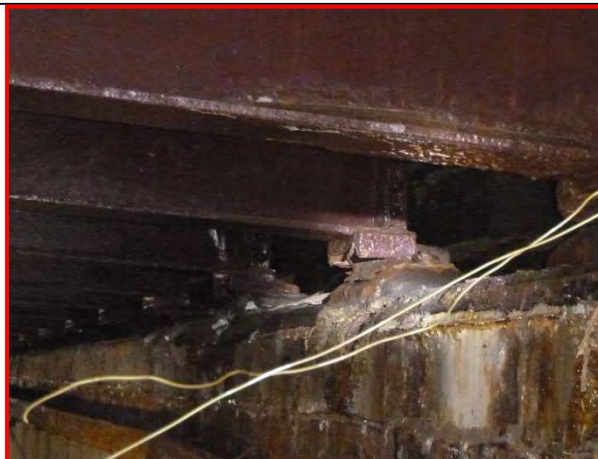
- The abutment bearings exhibit several cracked castings, several missing anchor bolts, and moderate to heavy section loss on the anchor bolt, with up to 3 inches of misalignment to the West Abutment bearings (see Photograph 34).
- The grout pads at the East Abutment bearings are heavily cracked and spalled (see Photograph 35).
- The trunnion bearings in the fixed spans exhibit minor to moderate corrosion with minor section loss (see Photograph 36).
- The live load bearings exhibit moderate corrosion and moderate to heavy section loss and minor debris accumulation. The anchor bolts have moderate section loss (see Photograph 37).

**34.** West Abutment bearings, looking southwest.

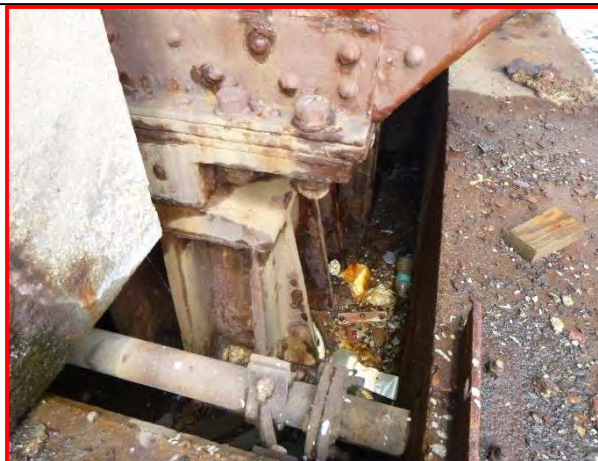
**37.** Southeast live load bearing, looking north.

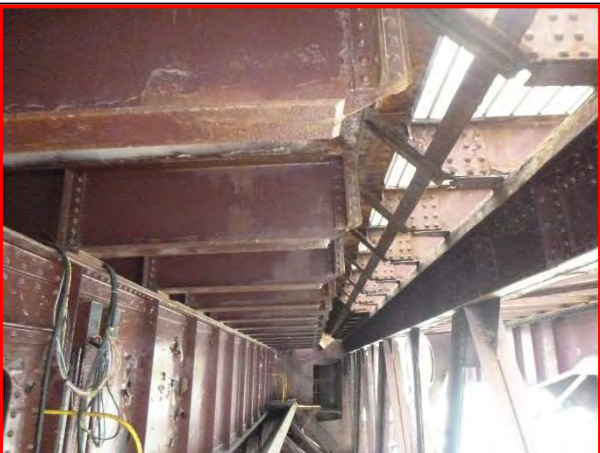
- In the fixed span, the stringers exhibit minor section loss near the abutments and minor section loss with corrosion holes near the rear breaks (see Photograph 40).

40. Stringer ends at east rear break, looking north.

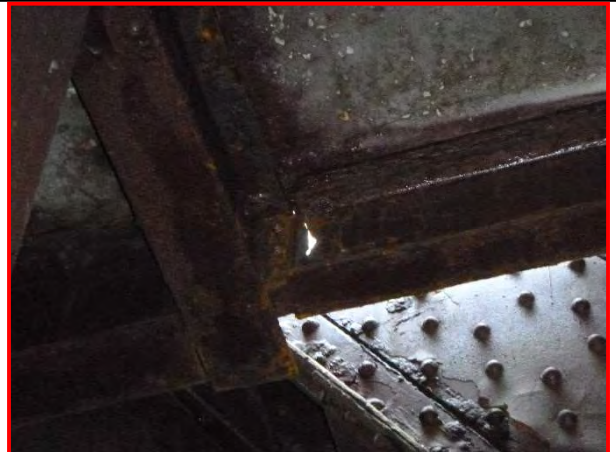
- The sidewalk stringers in the fixed spans exhibit moderate to heavy section loss with a few corrosion holes.
- In the south end of Span 4, a sidewalk stringer exhibits section loss and a 24" by 3" corrosion hole near the connection (see Photograph 41).

41. Span 4 south sidewalk stringer, looking north.

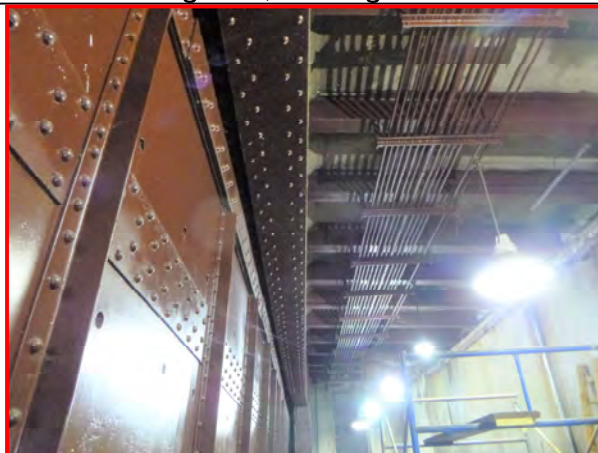
- The fixed span floorbeams exhibit isolated areas of minor corrosion and large areas of paint peeling.
- The bottom flange of the west anchor column floorbeam (FB 21W) is bowed and is displaced towards the river up to 4" at midspan (see Photograph 54).

**54.** West anchor column floorbeam (FB 21W), looking south.

8408	Steel Floorbeam	3	124	LF	120	4	0	0
	Remarks	Slight rotation of web at FB16W; diagonal cracks in top corners at both ends of FB19W.						
8410	Steel Pier or Abutment Cap	3	62	LF	56	6	0	0
	Remarks	FB21W exhibits bowing, and web deformation and top flange tears at both ends.

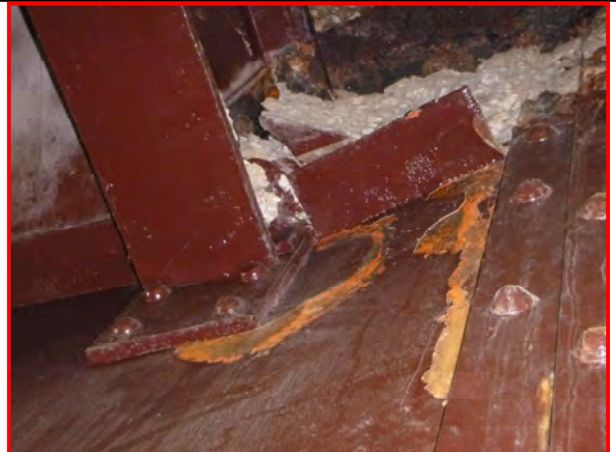
- The top 20” of the web of the west anchor column floorbeam (FB 21W) is bent in up to 2.25” directly below the S1 and S12 connections. Additionally, the top flange is bent and severed (see Photograph 55).
- Floorbeam 19W exhibits cracks approximately 1.5” long starting from the copes in both top corners. Additionally, the web is out of plumb up to approximately 4.5 degrees.
- In the movable span, the floorbeams typically exhibit minor to moderate corrosion with minor to moderate section loss, scattered corrosion holes of varying size (up to 4” x 4”) on the webs, moderate to heavy rivet head loss on the bottom flange, and corrosion holes in the vertical web stiffeners near the bottom flange (see Photograph 56).
- Floorbeams in the movable span typically exhibit minor pitting (see Photograph 57).
- Floorbeam 0W exhibits heavy paint peeling in the web (see Photograph 58).

55. South end of floorbeam 21W, looking northeast.

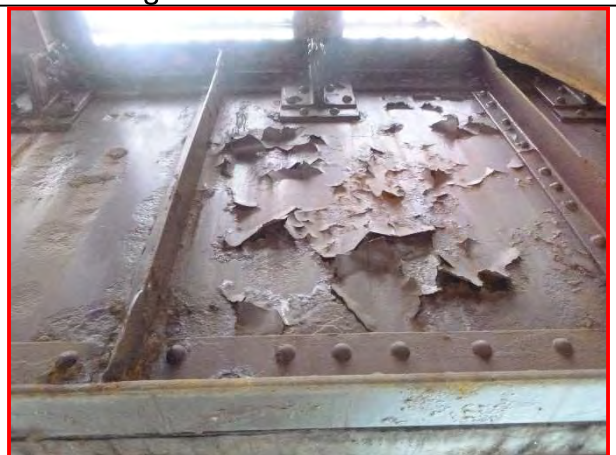
58. West end of FB 0W, looking east.

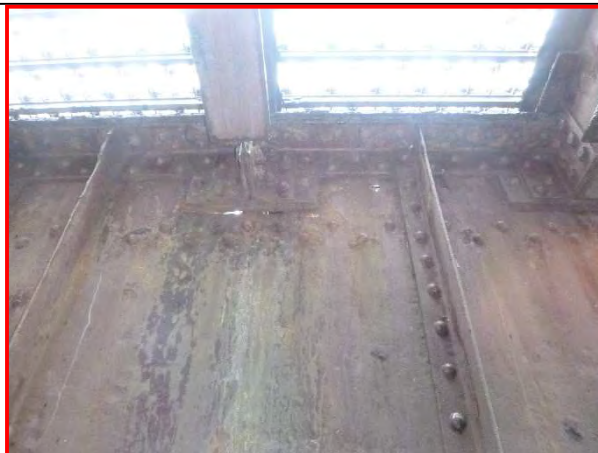
- Several floorbeams have corrosion holes near the stringer and lateral brace connections, as well as near truss connections (see Photographs 59).

59. Typical corrosion hole near stringer connection, looking northwest.

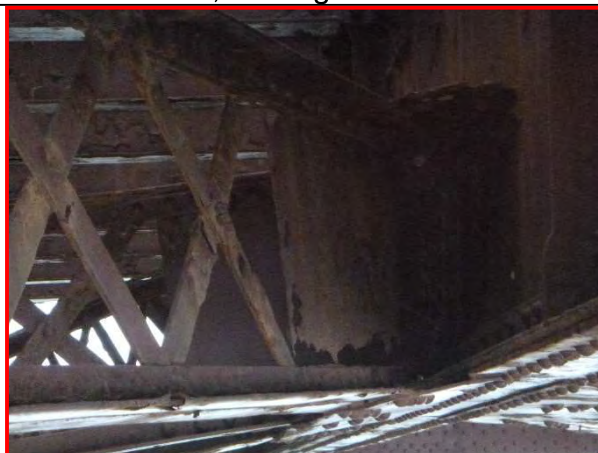
- In the movable span, the lateral bracing exhibits heavy corrosion, corrosion holes, several broken lacing bars, and a few locations of bent flanges (see Photographs 60-62).
- Several sidewalk lateral bracing connection plates have corrosion holes, and some lateral bracing members are also sagging.
- Span 2 and 4, the lattice trusses and connections exhibit moderate to heavy corrosion and scattered corrosion holes.

60. Panel 13 Lateral bracing stiffener plate, looking west.

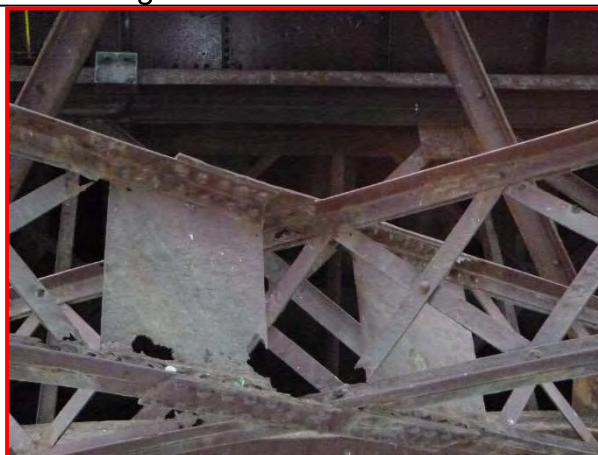
62. Panel 1 lateral bracing, looking east.

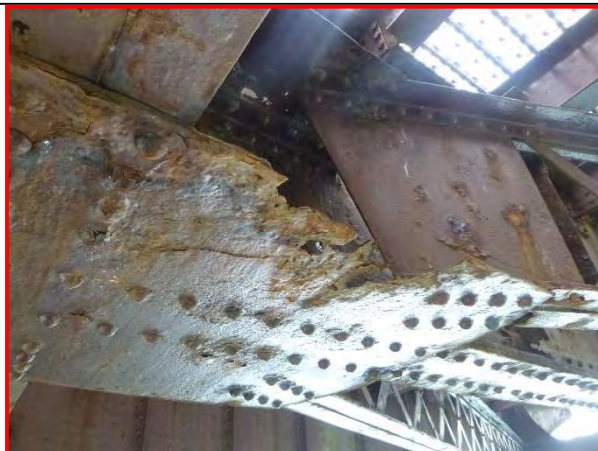
- In the movable span, the lateral bracing connection plates exhibit heavy corrosion with large corrosion holes (see Photograph 63).

**63.** Floorbeam 2W Lateral bracing connection, looking west.

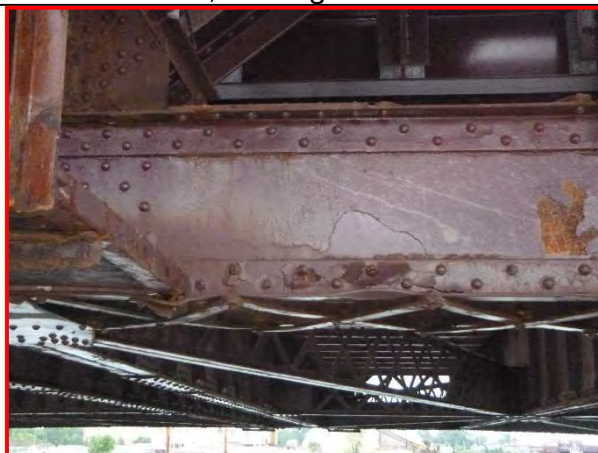
- The bascule trusses exhibit corrosion with scattered areas of minor to moderate section loss, pack rust, and scattered locations of bent members (see Photograph 64).
- In the moveable span, bottom chord members at the northeast and northwest supports exhibit bent flanges (see Photographs 65-66).
- Near the rear end of the trusses over the counterweight pits, the truss bottom chords exhibit minor to moderate corrosion along the bottom flanges with moderate rivet head loss.
- Pack rust is typically present along the bottom chord and fill plate interface.

**64.** Panel 7, south bottom chord member, looking north.

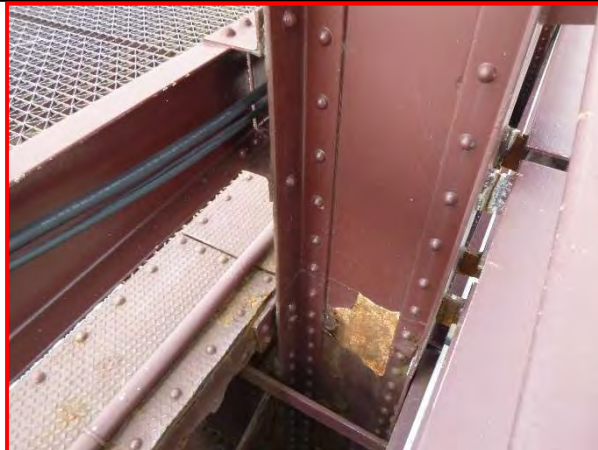
- The truss diagonals and verticals typically exhibit minor corrosion and minor paint peeling along the deck interface (see Photograph 67).

**67.** Bottom chord member at northwest support, looking west.

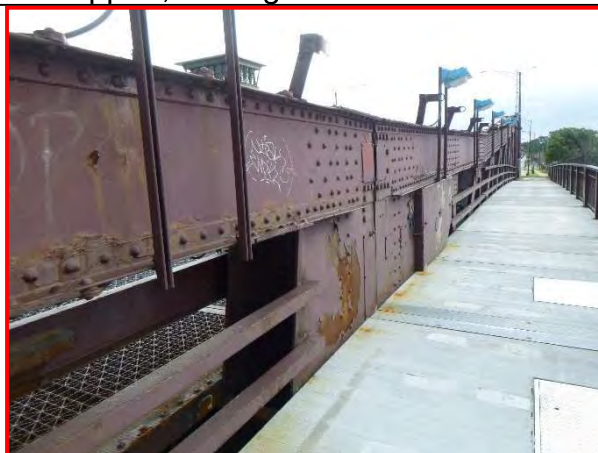
- Truss top chord members typically exhibit moderate pitting, corrosion, and paint peeling (see Photograph 68).
- Counterweight blocks are located on the north and south top chords of the east leaf (see Photograph 69).

**68.** Top chord of south truss, looking northeast.

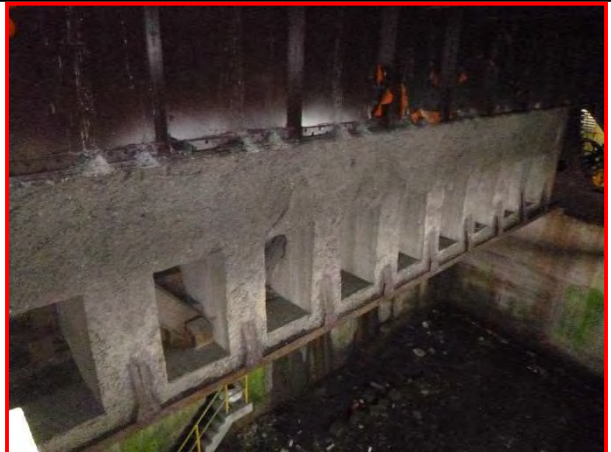
- Concrete spalls are present throughout the front face of the counterweight box (see Photograph 70).
- The counterweights exhibit light corrosion on the steel framing plates (see Photograph 71).

70. East counterweight box, looking east.

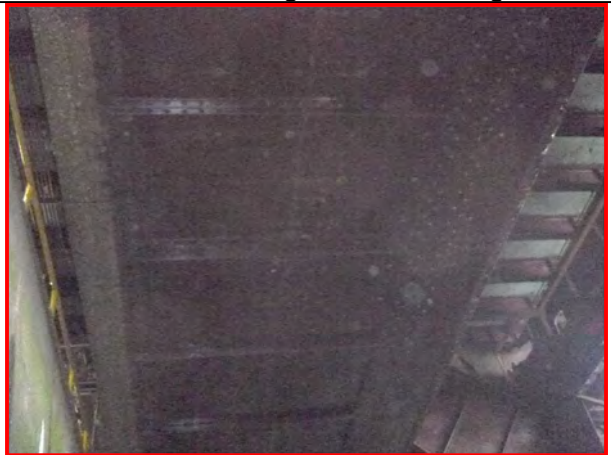
71. Bottom of west counterweight box, looking north.

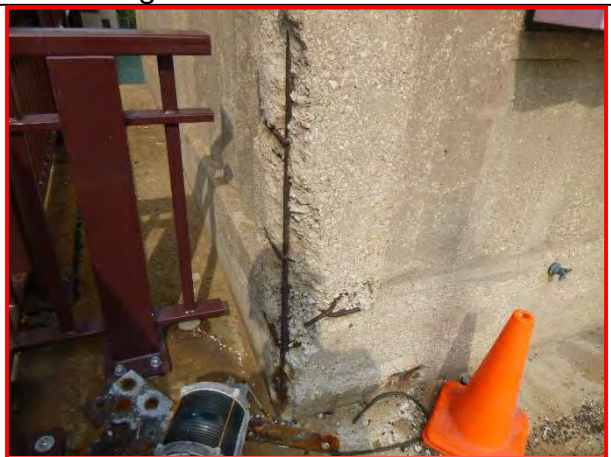
- At the East Bridge House, the exterior faces of the enclosure walls above the deck exhibit several spalls with exposed reinforcement (see Photograph 72).
- At the East Bridge House, the exterior face of the north enclosure wall has a large spall along the east construction joint.
- At the East Bridge House, there is a storage room in place along the south half of the East Abutment.
- At the East Bridge House, several of the steps leading down to the East Counterweight Pit are spalled and have cracks.

72. Northeast bridge house, looking west.

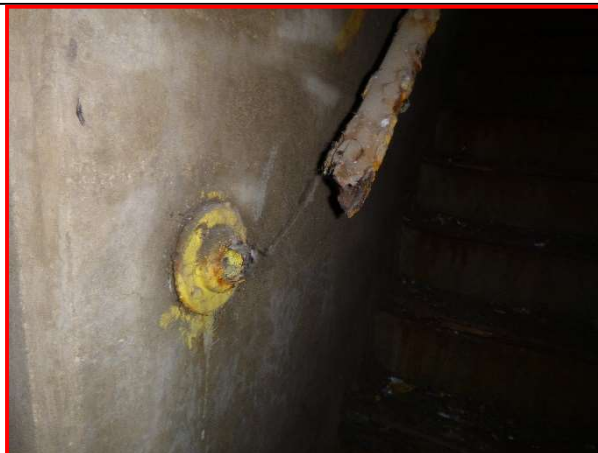
- The support towers below the exterior trunnion bearings in both bridge houses exhibit large areas of paint peeling.
- At the West Bridge House, the exterior face of the south enclosure wall above the deck exhibits a spall with exposed reinforcement.
- At the West Bridge House, the steel staircase leading down to the bridge house floor has been repaired.
- West Bridge House, the railing along the steps leading down to the West Counterweight Pit have a fully corroded out connection at the bottom and several of the steps have loose tread plates (see Photograph 73).

73. Railing in west bridge house, looking southeast.

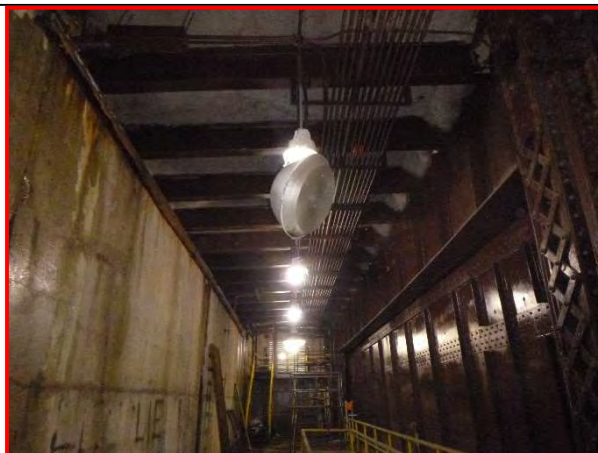
- There are several utilities attached to the bottom flanges of the stringers in the fixed spans. Several of the conduits exhibit heavy corrosion (see Photograph 74).
- In the movable span there are several utilities attached to truss members and along the center break floorbeams.
- In the movable span, the light fixtures attached to the superstructure have no noted deficiencies.

74. Span 5 utilities looking north.

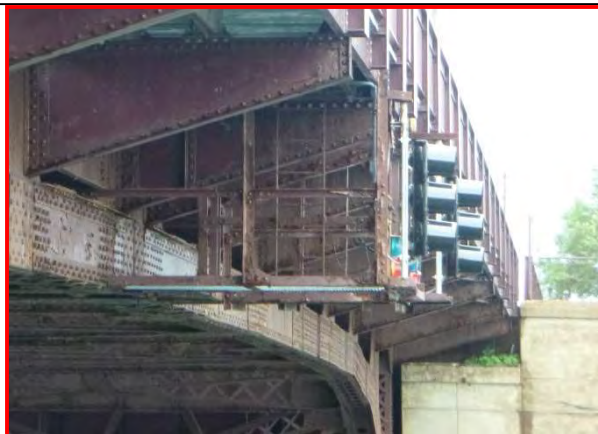
- The catwalks below the center break exhibit moderate pitting, rust packing, and some corrosion holes (see Photograph 75).
- The red and green navigational lights are in place and functioning; Red navigation light at the southeast catwalk has a cracked housing.

75. Catwalk on south truss, looking east.

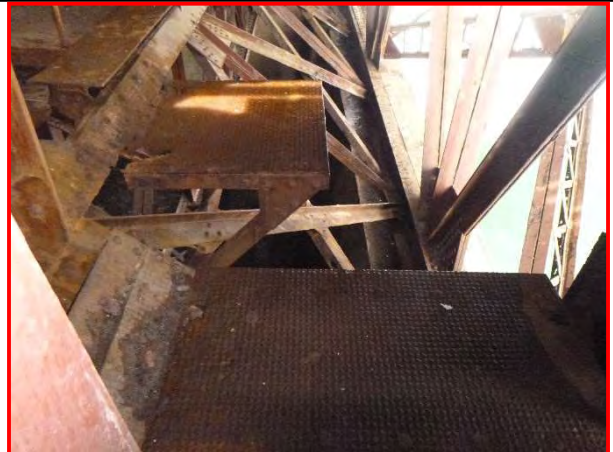
- The catwalks in the west pit exhibit heavy section loss (see Photograph 76).

76. West pit catwalk steel plating, looking north.

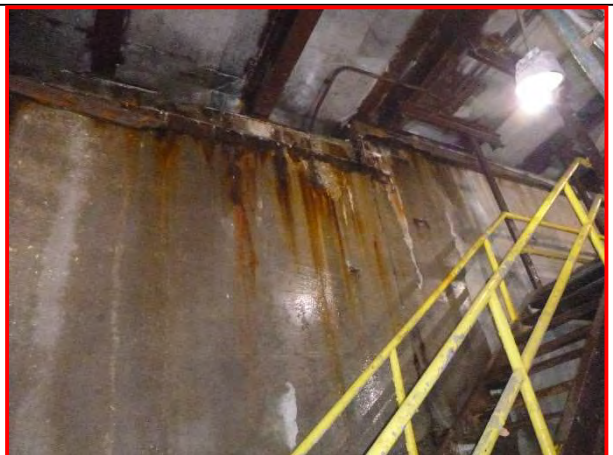
- At the West Abutment, the bearing seats and abutment back wall exhibit delaminated and spalled areas throughout, debris accumulation, signs of leakage, as well as spalled and cracked grout pads (see Photograph 77).
- The East and West Abutment stems exhibit scattered hairline to narrow cracks and a few spalls (some with exposed and corroded reinforcement).
- At the West Abutment, the bearing seats and abutment backwall exhibit heavy deterioration with delaminated and spalled areas and some debris accumulation (see Photograph 78).

77. West Abutment stem and bearing seat, looking southwest.

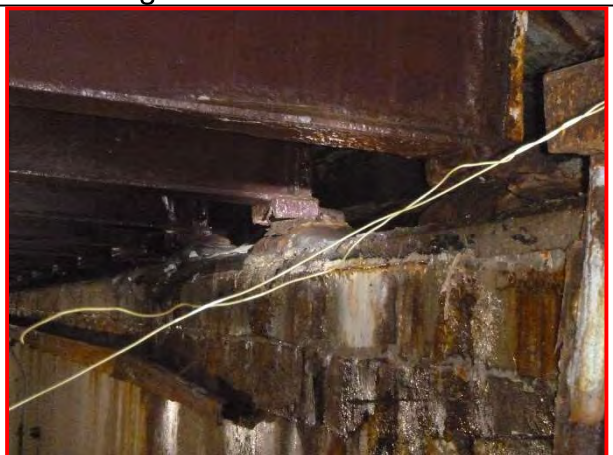
78. West Abutment bearing seat, looking southwest.

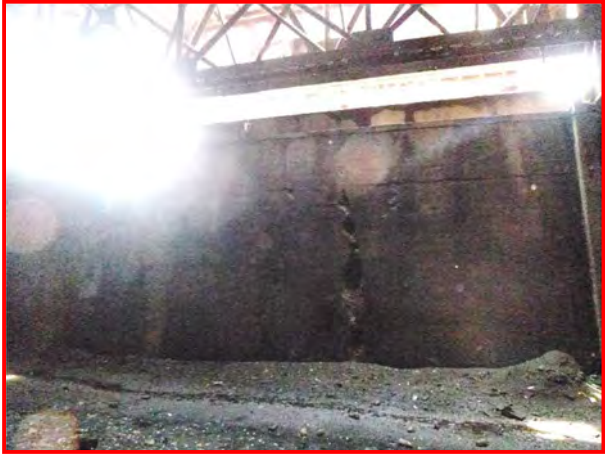
<p><i>Piers</i></p> <ul style="list-style-type: none"><li>• The East and West River Piers both exhibit large spalls with penetrations up to 1' deep. Concrete cracking and leaching with some widespread leakage (see Photograph 79).</li><li>• The east face of the East Pier exhibits several wide vertical cracks with associated spalls up to 8" depth and heavy scaling below the north live load bearing.</li><li>• The Steel Pier Caps exhibit isolated areas of minor corrosion with paint peeling.</li></ul>

<p>79. East face of river pier wall, looking west.</p>
<p><i>Columns</i></p> <ul style="list-style-type: none"><li>• The batten plates near the base of the anchor columns are heavily corroded with corrosion holes (see Photograph 80).</li><li>• The trunnion girder columns exhibit areas of minor section loss with corrosion holes in the lacing bars, as well as heavy rivet head loss.</li><li>• The sidewalk columns exhibit minor section loss near the bases. The grout pads of the sidewalk columns are cracked and spalled.</li></ul>

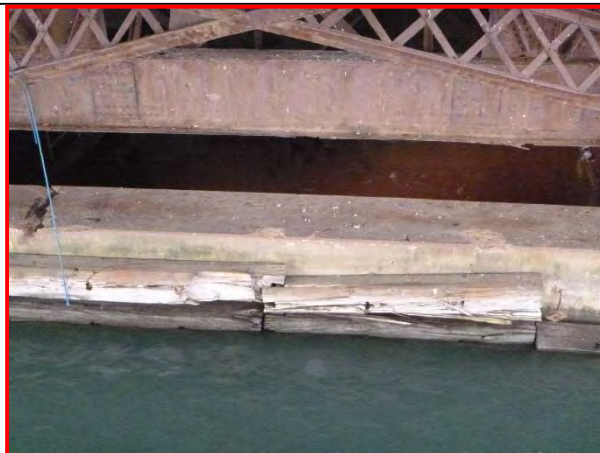
- The fender system is in place with damaged sections on the East and West River Piers (see Photograph 82).
- The dolphins located in the northwest, southwest, and southeast corners of the bridge are in place and functioning, and the timber piles exhibit deterioration.

82. West fender, looking west.

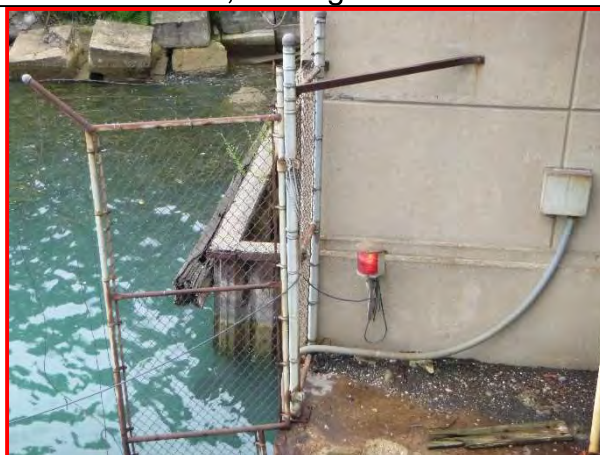
- The red navigation lights attached to the substructure are in place and functioning. The south navigation light on the West River Pier has a broken housing.

83. Southwest navigation light, looking west.

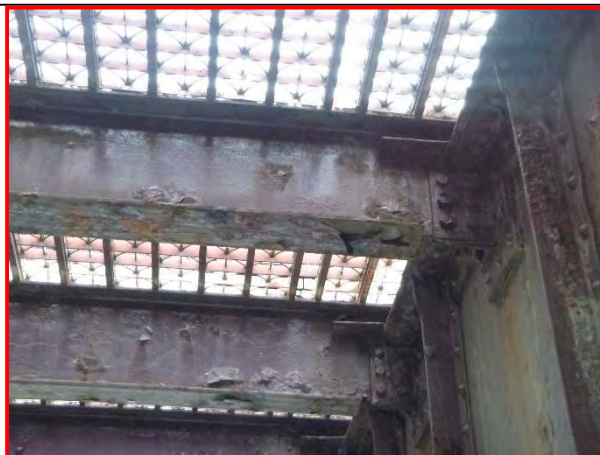
- On a scale of 5 to 1 (5 being new; 1 being failed), the paint system for this structure is rated a 2 (poor).

- The paint system has extensive deterioration along the movable span stringers and floorbeams (see Photograph 84).

84. Typical moveable span paint system, looking north.

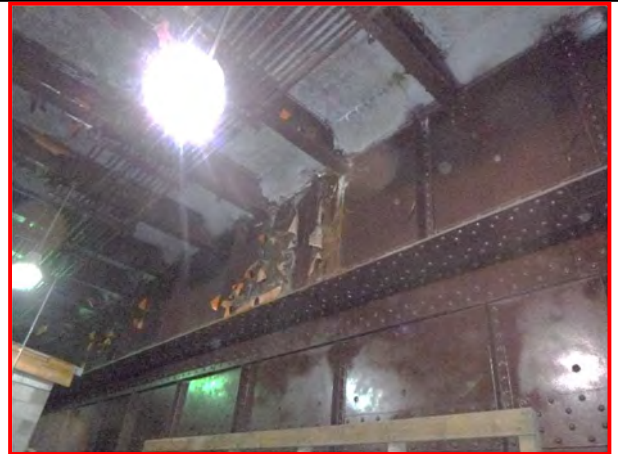
- The fixed span stringers and floorbeams have scattered large areas of paint system failure (see Photograph 85).

85. Typical fixed span paint system, looking southeast.

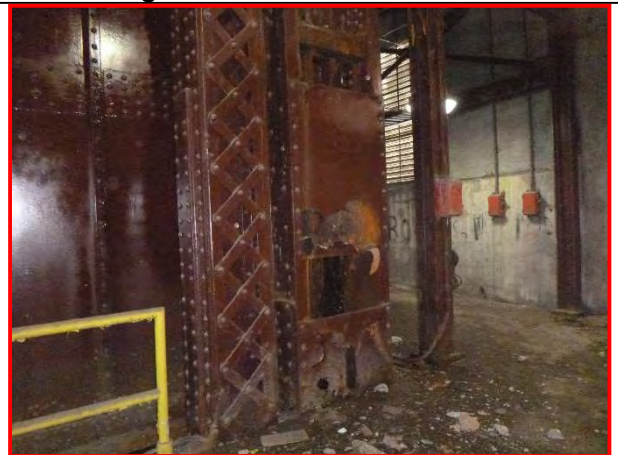
- The paint system on the anchor columns and trunnion girder columns have minor to moderate deterioration at the bases (see Photograph 86).

86. Typical substructure paint system, looking southeast.

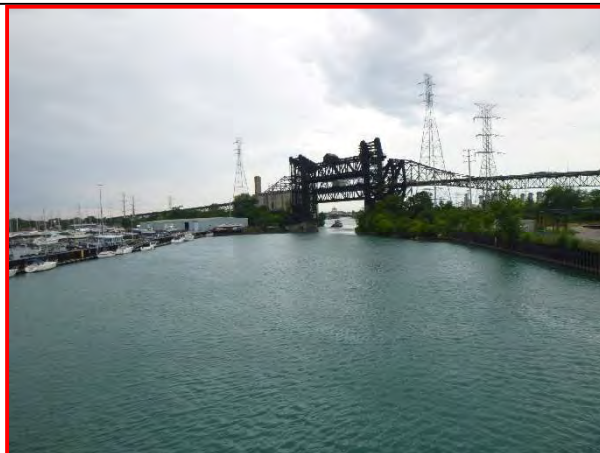
- The channel is in satisfactory condition which corresponds to a NBIS and IDOT general condition rating of 6.
- The west bank adjacent to the structure is beginning to slump.

87. Downstream channel, looking south.

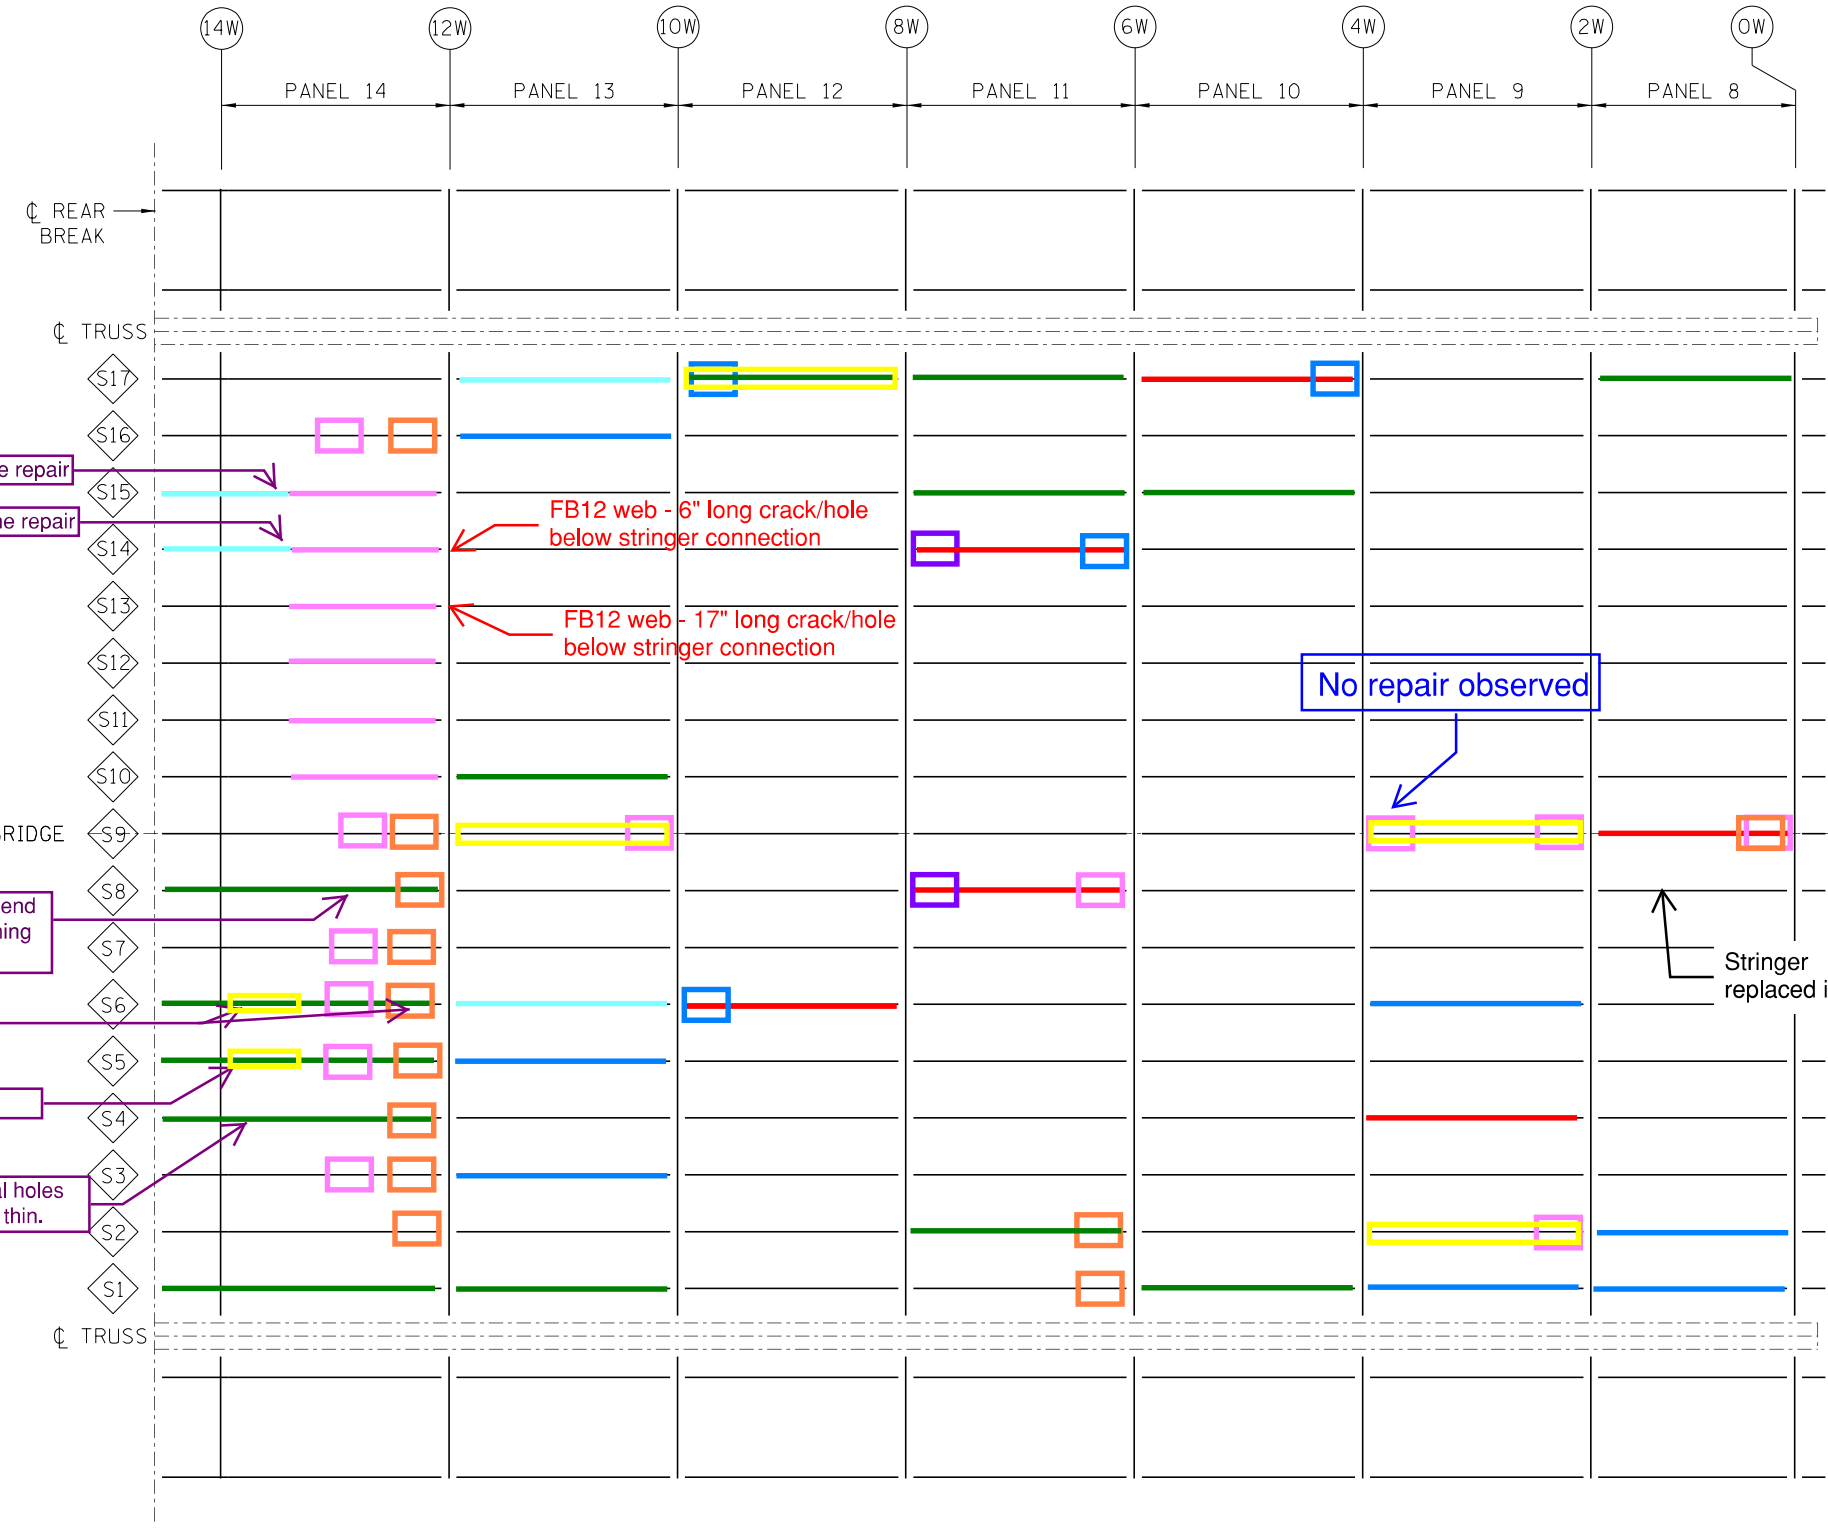
FB12 web - 6" long crack/hole below stringer connection

FB12 web - 17" long crack/hole below stringer connection

No repair observed

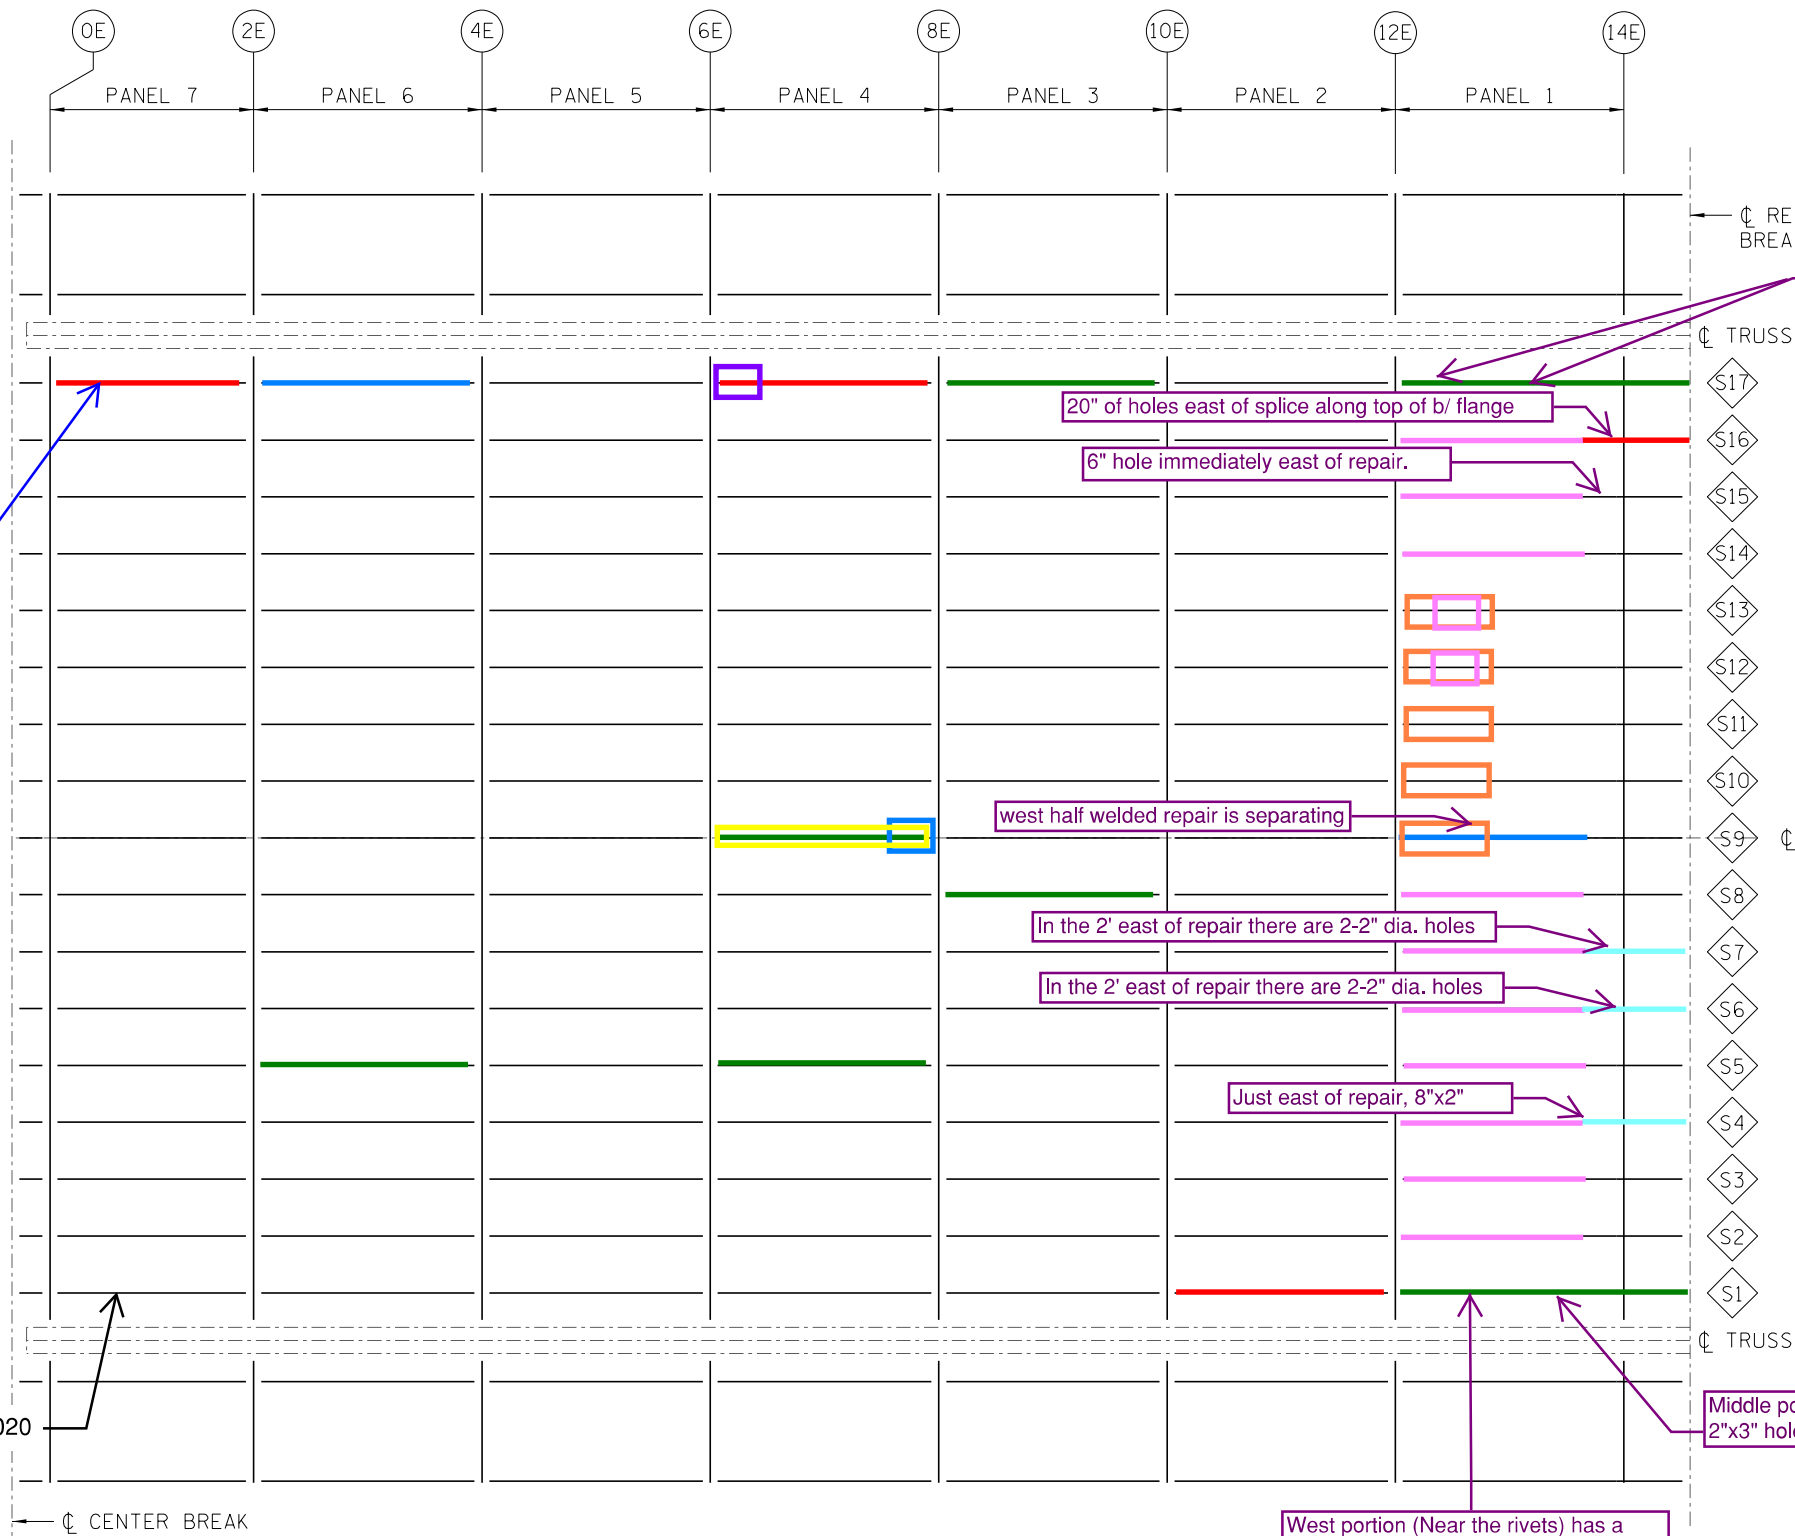
2" dia. hole just east of west rivets. 1" dia. hole just east of the middle rivets

6" hole immediately east of repair.

west half welded repair is separating

In the 2' east of repair there are 2-2" dia. holes

Just east of repair, 8"x2"
