**CITY OF CHICAGO - DEPARTMENT OF TRANSPORTATION
BRIDGE INVENTORY REPORT**

Structure No. 016-6042

**100th Street
over
the Calumet River**

Inspection Date: August 16, 2021

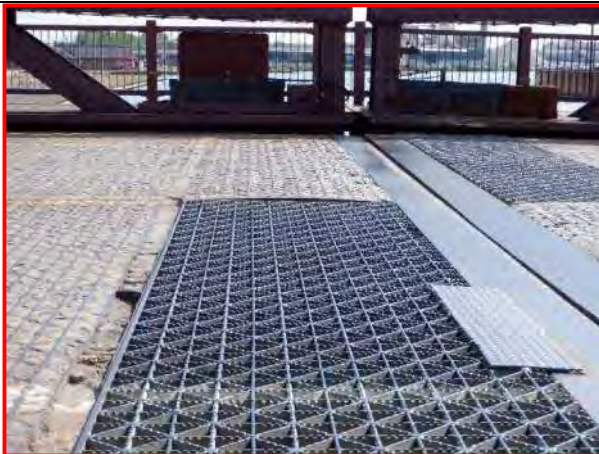
- In Span 3, the concrete-filled steel grating at the center and rear breaks typically exhibit heavy corrosion, scaling and pop-outs.
- The three panels on either side of the center break are heaved (see Photographs 2 and 3).
- In Span 3, approximately 60% of the open grating panels have been replaced since the last inspection. The remaining open panels have minor corrosion.

2. East leaf near the center break in Span 3, looking south

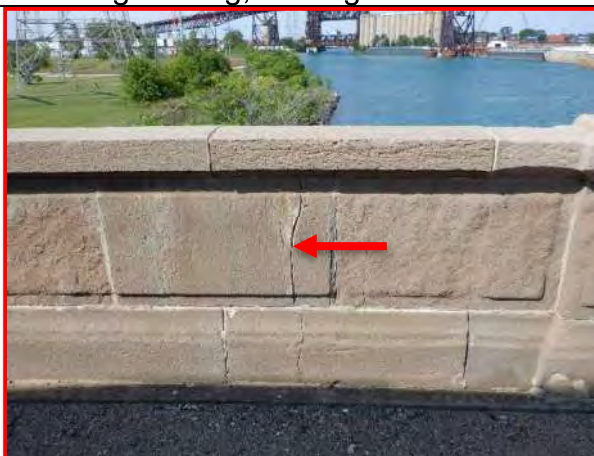
6. Stone parapets, looking north

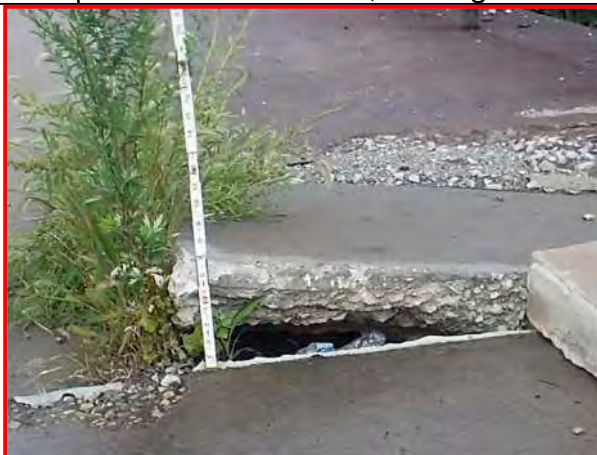
11. Northwest approach sidewalk during the 2019 inspection, looking west

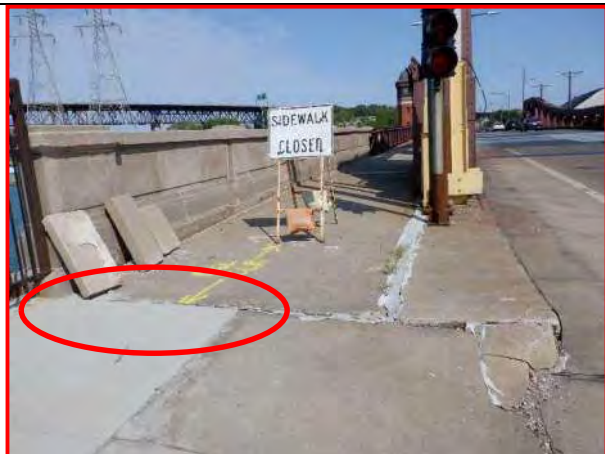
12. Northwest approach sidewalk, looking east

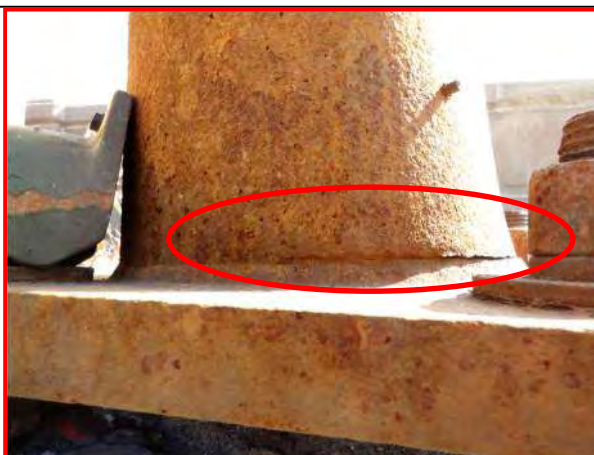
- The light standards typically have moderate corrosion, peeling paint, missing anchor bolt covers, and loose or missing hand hole covers with exposed wiring.
- In Span 5, the south light standard has a dent in the pole near the base and a 10" long crack at the base (see Photographs 14 and 15).
- Span 3, the light standard on the east end of the Southwest Truss is not in place and there are exposed wires.

15. South light standard in Span 5, looking south

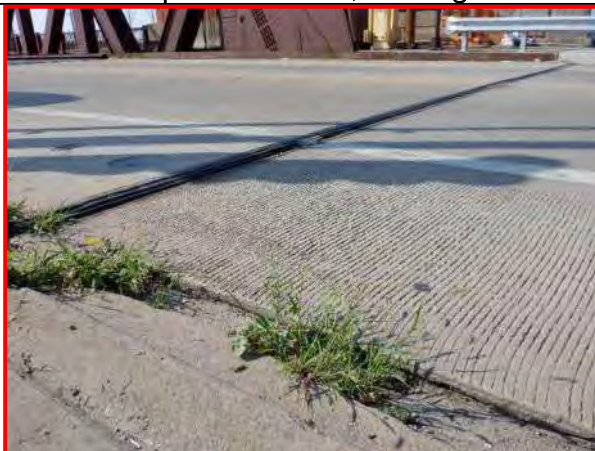
- The bridge side of the East Abutment Expansion Joint is 1½” higher than the approach slab side at the south gutterline. The vertical differential decreases to nearly level at the north gutterline (see Photograph 17 & 18).
- The East Abutment Expansion Joint has tears, a 2’ length of broken rail, moderate corrosion, and gouges.
- The center break has an insufficient gap. In the eastbound lanes, the west leaf is 1½” higher than the east leaf and the steel open grating is another 1” higher than the west plate of the center break (see Photographs 19 & 20). In September, after this inspection was completed, construction began to replace the center break weldments.

18. East Expansion Joint, looking northwest

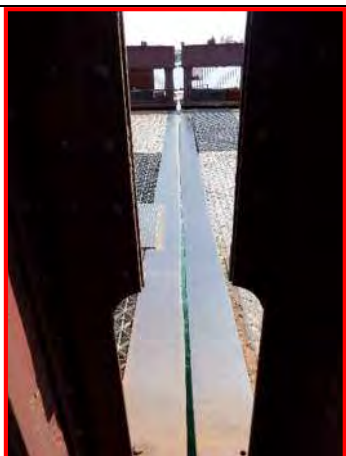
19. Center break, looking south

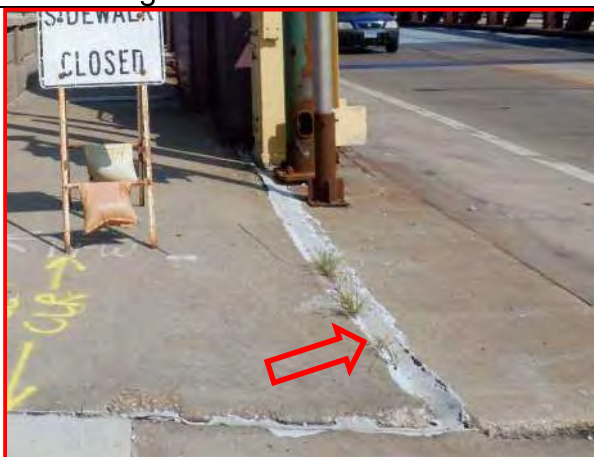
- In the south sidewalk at the center break, the west leaf is resting on top of the east leaf (see Photograph 21).
- At the rear breaks, the fixed spans are between $\frac{1}{8}$ " to $\frac{1}{4}$ " lower than the movable span. The east break weldment is cracked along the centerline of roadway (see Photograph 22).
- The northwest longitudinal sidewalk joint is failing (see Photograph 23).

23. Northwest sidewalk joint, looking east

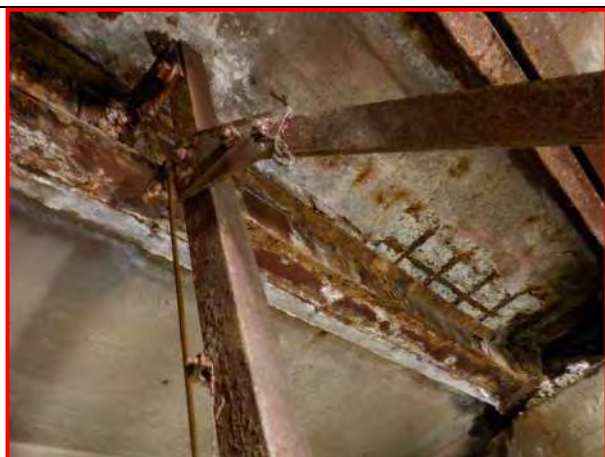
- The metal pans in the filled steel grating portions typically exhibit moderate to heavy corrosion, moderate to heavy section loss, and corrosion holes. Where the concrete is visible through the corrosion holes, it is typically spalled (see Photograph 25).
- In the fixed spans under the roadway, the deck soffit has scattered hairline leaching longitudinal and transverse cracks.
- In the fixed spans under the sidewalk, there is heavy delaminations/spalls up to 50 SF with exposed rebar, heavy scaling, and the remaining stay-in-place forms have corrosion holes (see Photographs 26 & 27). The south sidewalks have more deterioration.
- At the east rear break, the edge of the fixed span soffit is spalled (see Photograph 28).

27. Span 1 sidewalk soffit, looking up

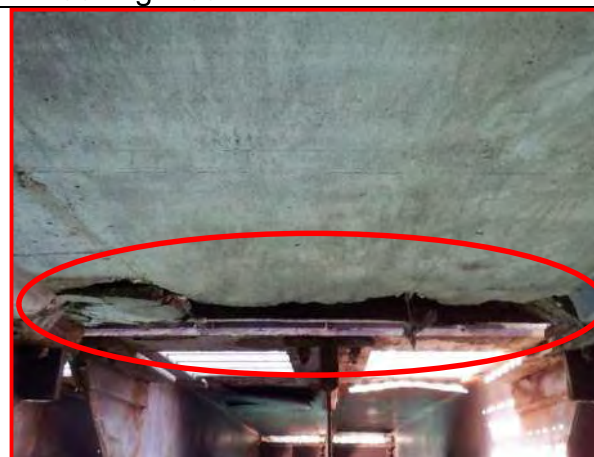
28. Span 2 deck soffit, looking west

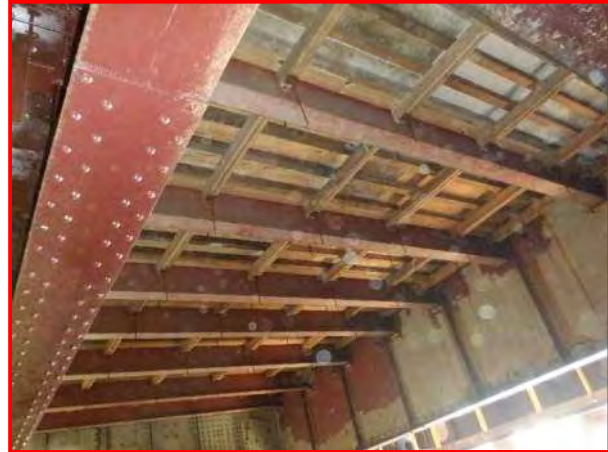
- In Spans 2 and 4 (between Floorbeam 21-21 and Anchor Column Floorbeam), there is timber formwork left in place along the deck soffit (see Photograph 29).

29. Span 4 deck soffit, looking northeast

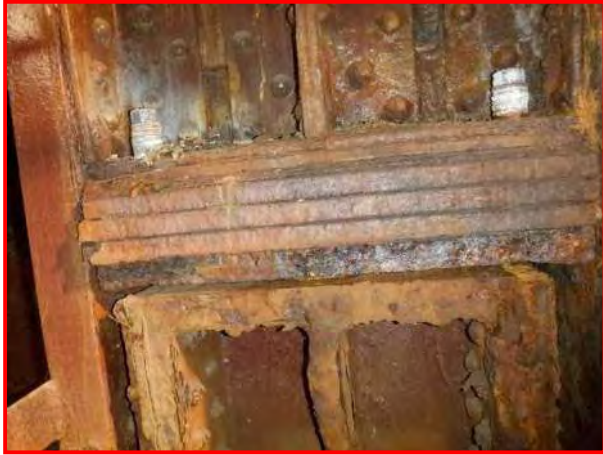
42. Typical secondary live load bearing, looking east

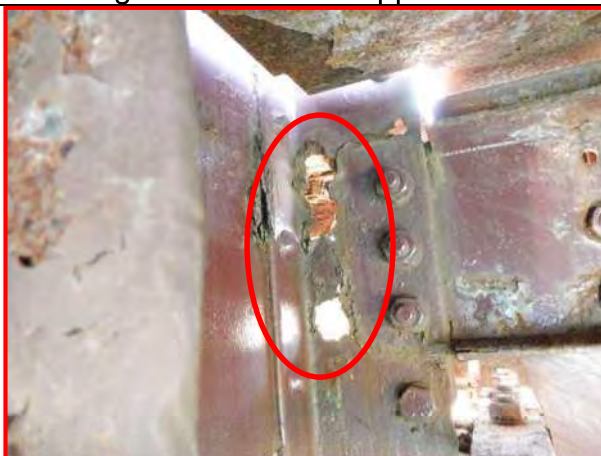
46. Span 3 curb stringer, looking west

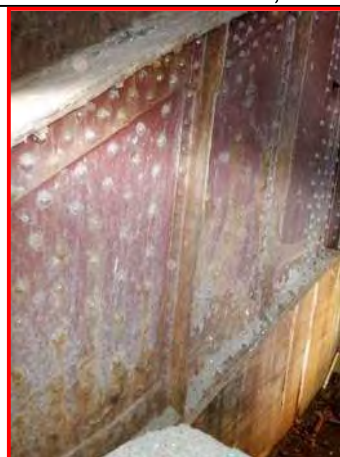
49. Southwest Trunnion Girder end, looking southwest

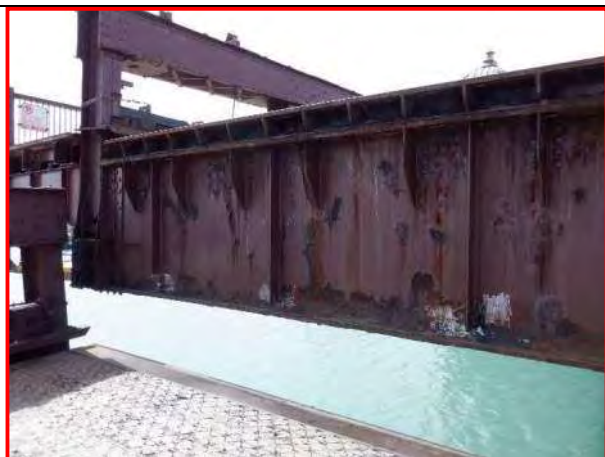
56. FB 0-0W, looking southwest

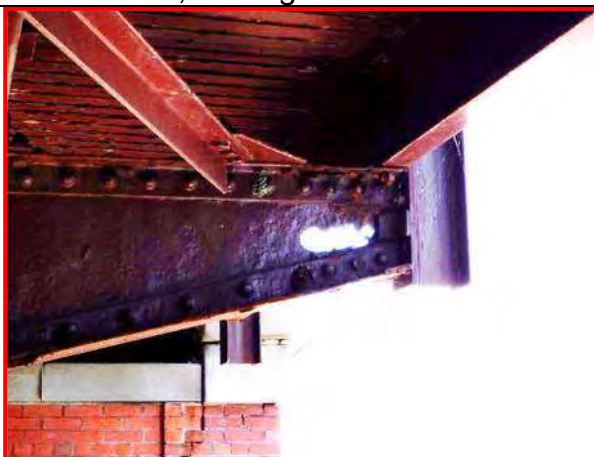
57. Southern sidewalk bracket 12-12E, looking east

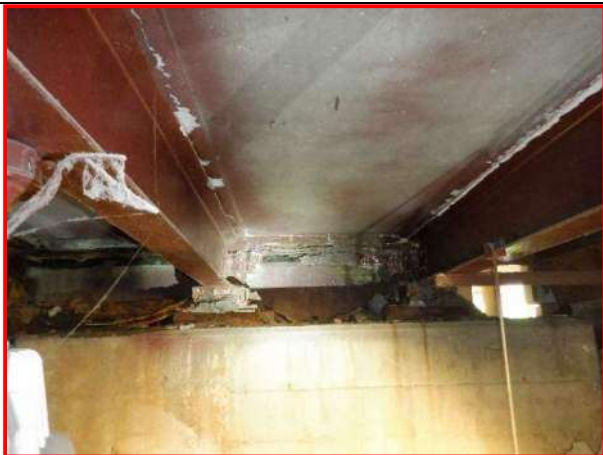
61. Span 5 sidewalk diaphragm, looking west

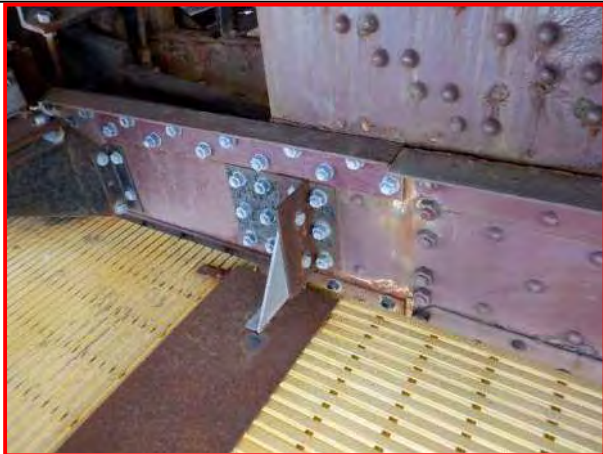
64. Southwest Truss Member 0-2, looking north

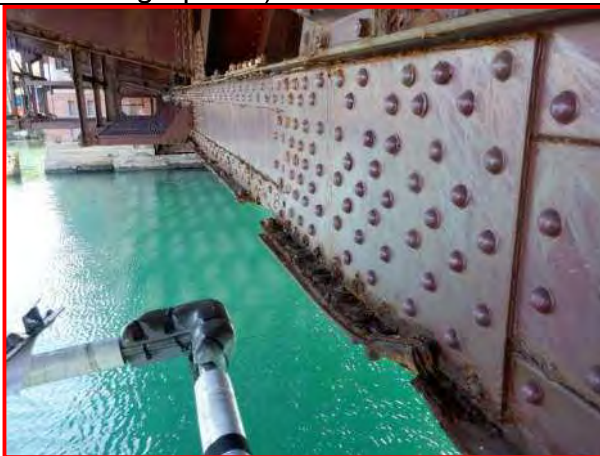
65. Northwest Truss Member 2-4, looking east

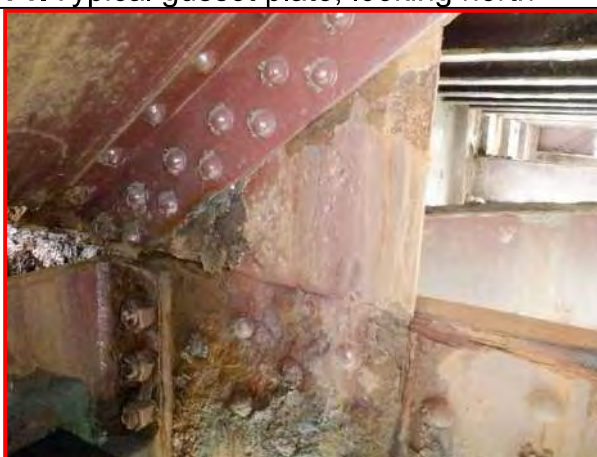
72. Northwest inside face gusset plate at Panel Point 0, looking southeast

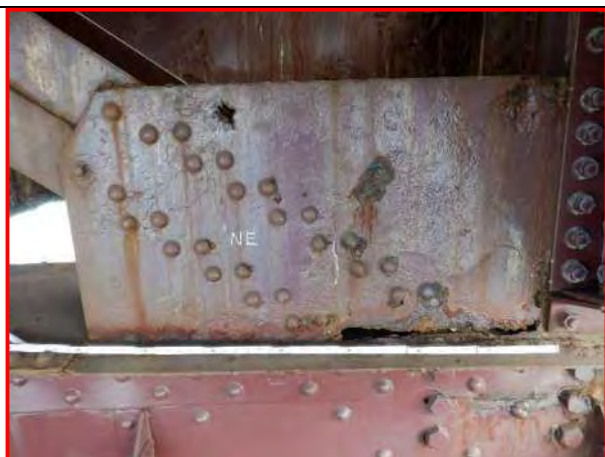
73. Northeast outside face gusset plate at Panel Point 0, looking south

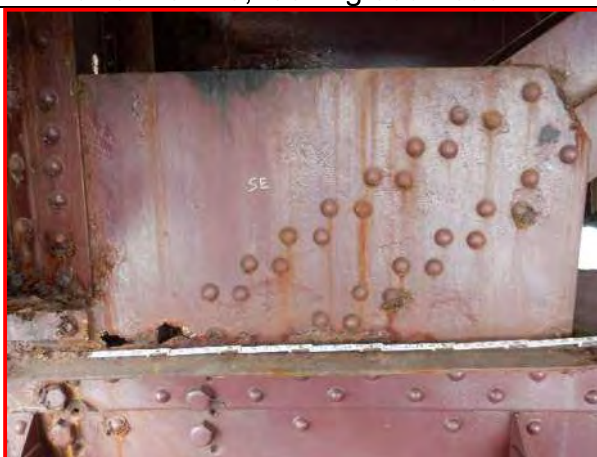
74. Southeast outside face gusset plate at Panel Point 0, looking north

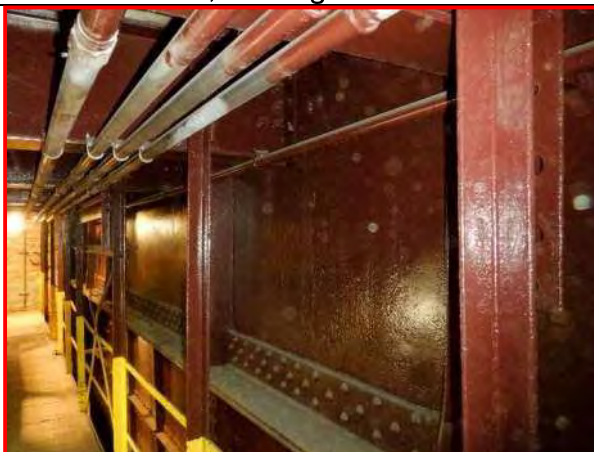
- There are conduits attached to the bottom flange of stringers within the fixed spans, truss members, and floorbeams (see Photograph 79).
- There are several conduits and lights attached to the enclosure walls within.

79. Span 1 conduits, looking south

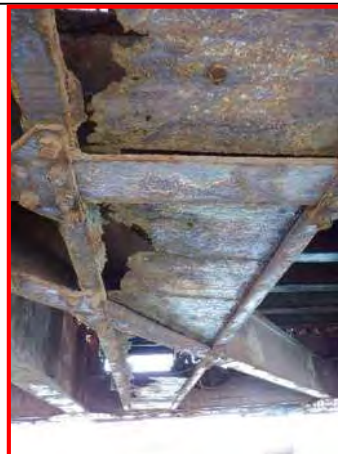
81. Catwalk steel plate near Floorbeam 2-2W, looking north and up

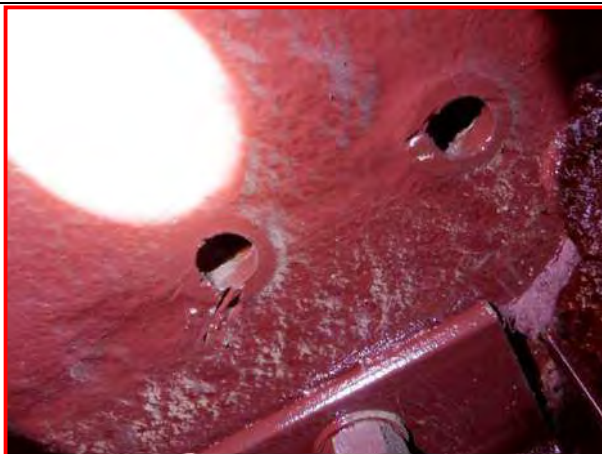
87. West Anchor Column Floorbeam, looking east

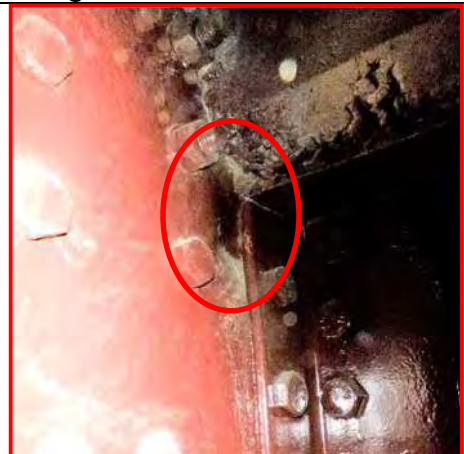
88. East Anchor Column Floorbeam, looking northwest

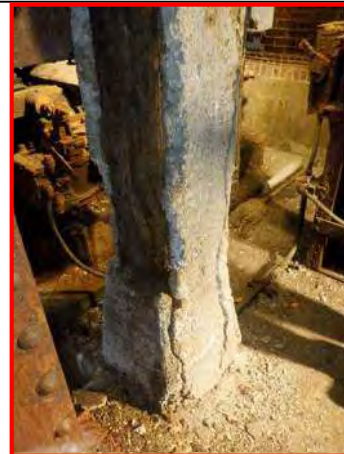
90. Sidewalk column near the Southwest Anchor Column, looking southeast
