**CITY OF CHICAGO - DEPARTMENT OF TRANSPORTATION
BRIDGE INVENTORY REPORT**

Structure No. 016-6043

**106th Street
over
the Calumet River**

Inspection Date: August 12, 2021

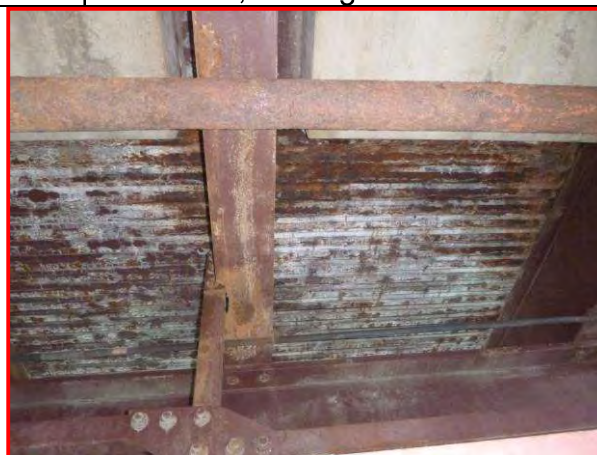
16. Span 3 soffit, looking east

- In the east fixed spans, the underside of the deck has hairline longitudinal and transverse cracks with efflorescence (see Photograph 15).
- In the west fixed spans, the underside of the deck has isolated hairline longitudinal and transverse cracks with efflorescence.
- The sidewalk soffits in Spans 2 and 4 have scattered hairline cracks, some with efflorescence, and areas of poor consolidation which have resulted in exposed rebar. The soffits have delaminations, and timber formwork left in place.
- Various fillets in the fixed spans are chipped or broken.
- In the movable span, the open steel grating exhibits minor corrosion and a few isolated missing deck-to-stringer connection bolts.
- In the movable span, the deck pans in the deck and sidewalk have heavy corrosion, section loss, and scattered corrosion holes (see Photograph 16).

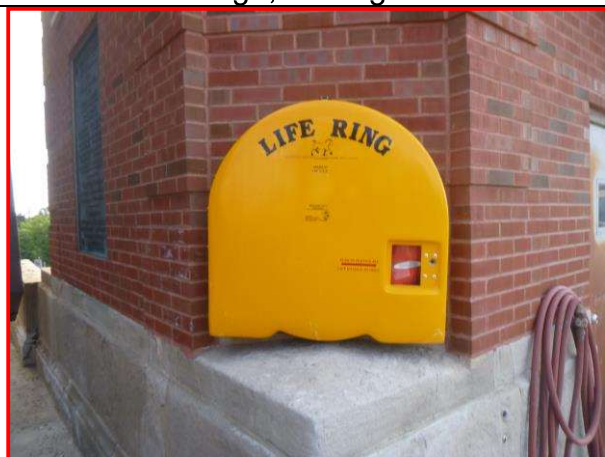
22. West bridge house life ring, looking southeast

- Life rings are in place at the bridge houses (see Photograph 22).

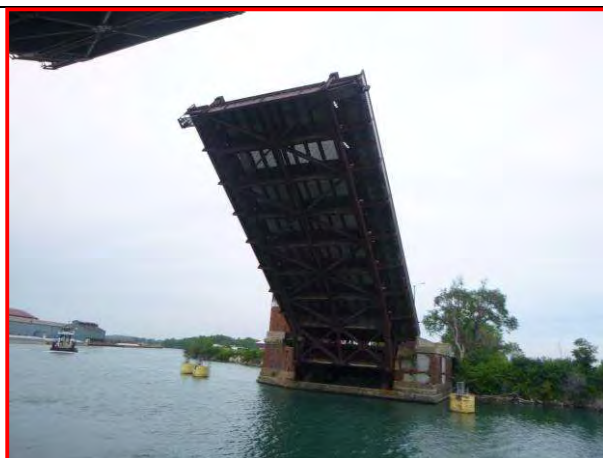
23. Overall underside of the movable superstructure framing, looking southwest

- The superstructure is in poor overall condition which corresponds to a NBIS and IDOT condition rating of 4. (Note – this condition rating is governed by the Fracture Critical rating.)

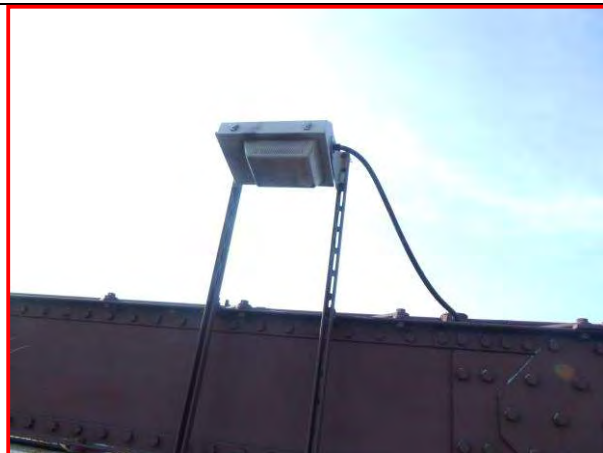
- The top chords of the south trusses have attached lights and conduit (see Photograph 54).

54. Lights and conduit attached to the top truss, looking south

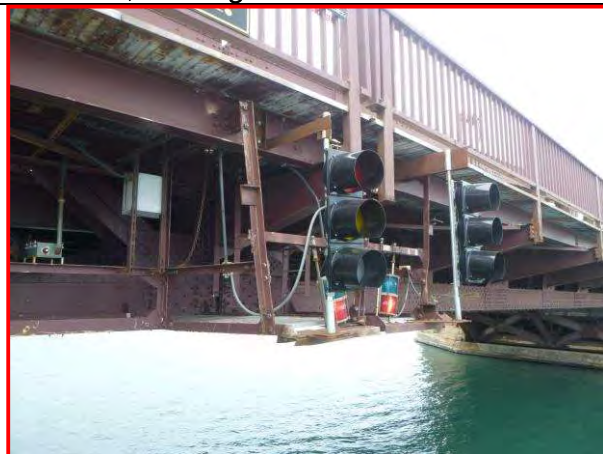
55. North navigation light, looking south

- The navigational lights below the center break are in place and functioning (see Photograph 55).
- Impact damage was observed on the north catwalks below the center break.

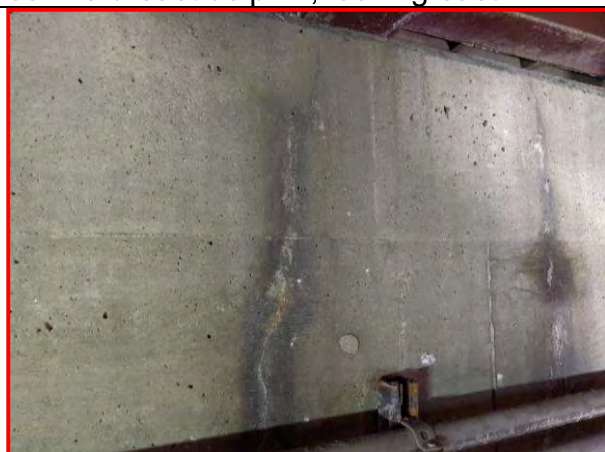
64. West Abutment wall, looking northwest

- On the West Abutment, there are conduits attached to the stem wall (see Photograph 64).

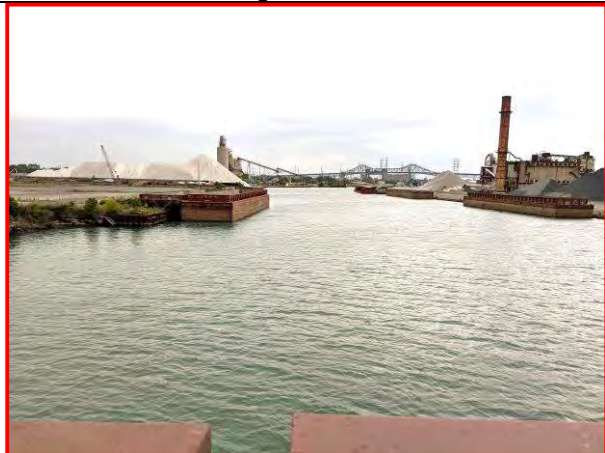
68. Upstream, looking north

- The channel is in satisfactory condition which corresponds to a NBIS and IDOT general condition rating of 6.
