**CITY OF CHICAGO - DEPARTMENT OF TRANSPORTATION
BRIDGE INVENTORY REPORT**

Structure No. 016-6037

**Ewing Avenue (US41 – 92nd Street)
over
the Calumet River**

Inspection Date: August 10, 2021

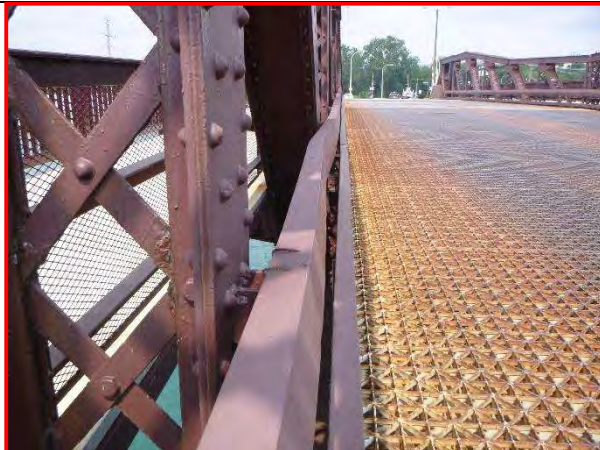
- The west brush rail in Span 3 exhibits 3' long section that is bent (see Photograph 7).

7. West brush rail, Span 3, looking north.

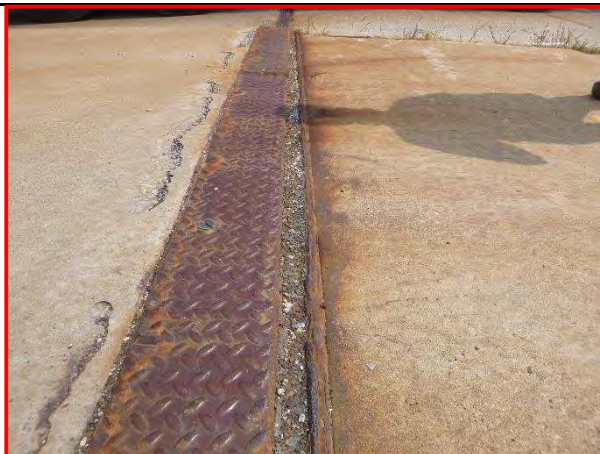
- The expansion joints exhibit sections of depressed and torn glands, moderate to heavy corrosion of the steel rails, and moderate debris accumulation (see Photograph 14).
- The sidewalk expansion joints exhibited heavy corrosion and debris buildup (see Photograph 15).
- The center and rear breaks along Span 3 exhibit moderate corrosion (see Photograph 16).
- At 85° Fahrenheit, the center break at the east sidewalk has a 1.75" gap, and the west sidewalk has a 2.125".
- The north center plate at the east sidewalk exhibits a 1" vertical distortion (see Photograph 17).

15. Southwest sidewalk expansion joint, looking east.

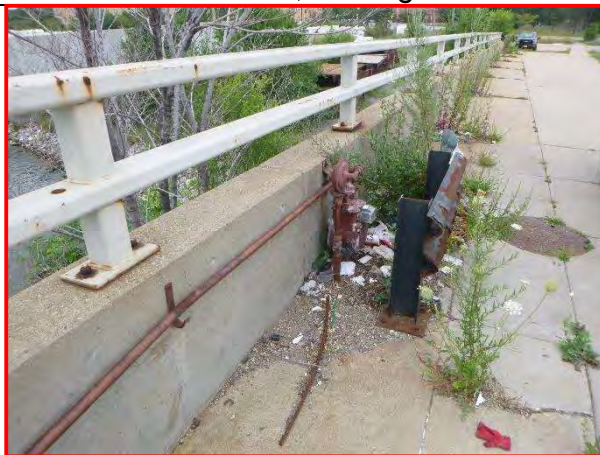
- The northwest approach sidewalk contains a gas line and terminal. The utility is protected by a guardrail (see Photograph 25).

25. Gas Utility, northwest approach sidewalk, looking northwest.

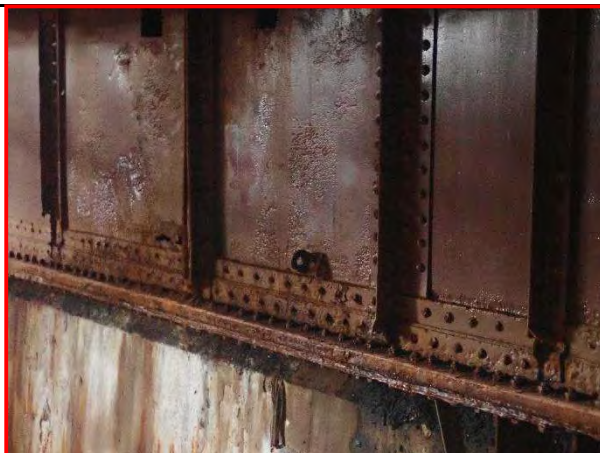
40. Hole in bottom of web in northwest longitudinal girder, looking southwest.

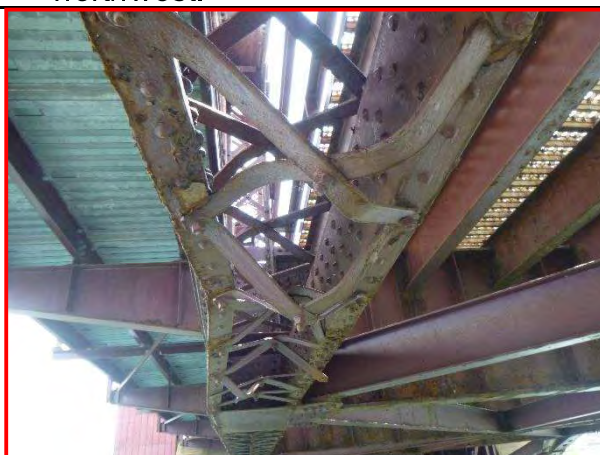
49. Bottom chord, member 2-4SE, looking south.

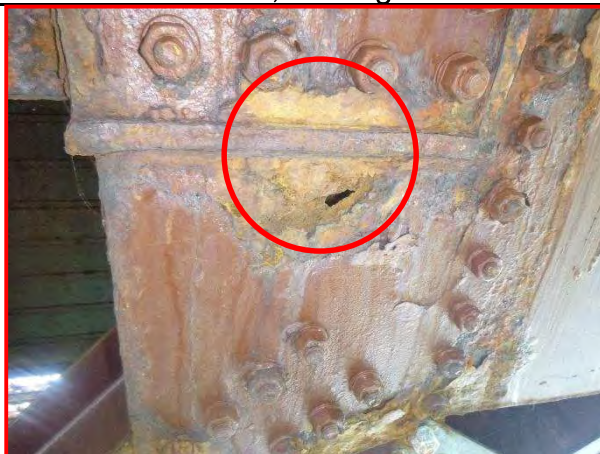
53. Bottom chord 0-2 and lateral bracing connection, southwest truss, looking west.

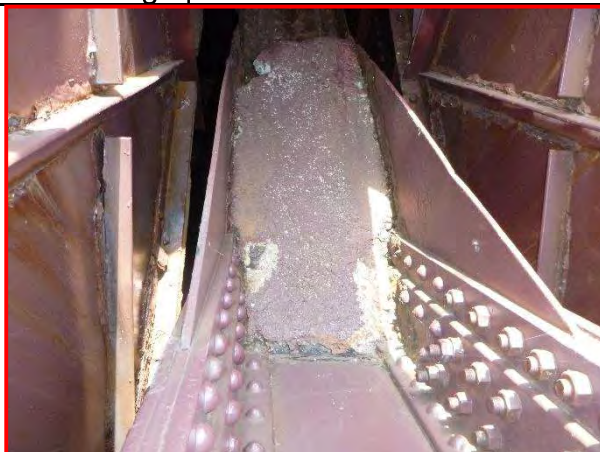
57. Truss member B-12, southeast truss, looking south.

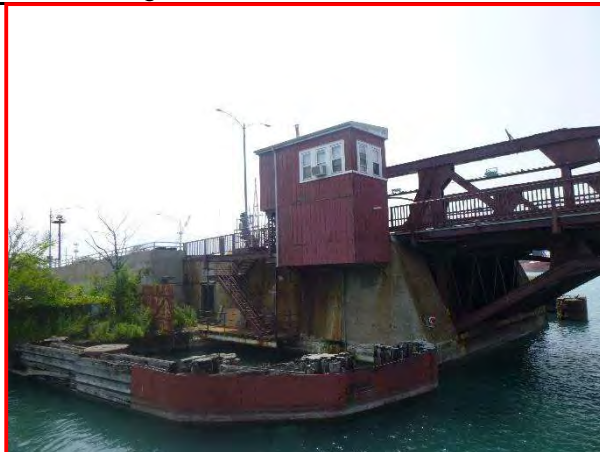
67. Overall Northwest bridge house, looking northeast.

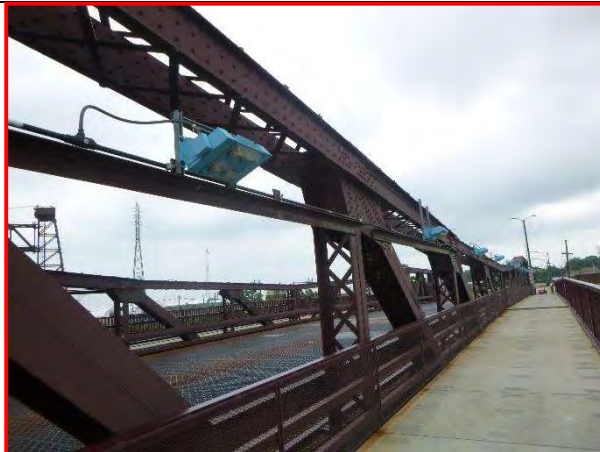
- There are lights attached to the top chord directly or to angles welded to the trusses above the deck (see Photograph 68).
- There are conduits attached to the lattice truss.

68. Lights attached to the truss, looking south.

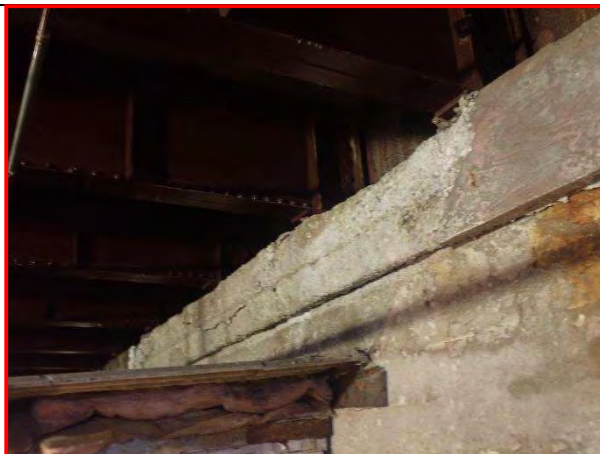
72. South Abutment bearing seats, looking southeast.

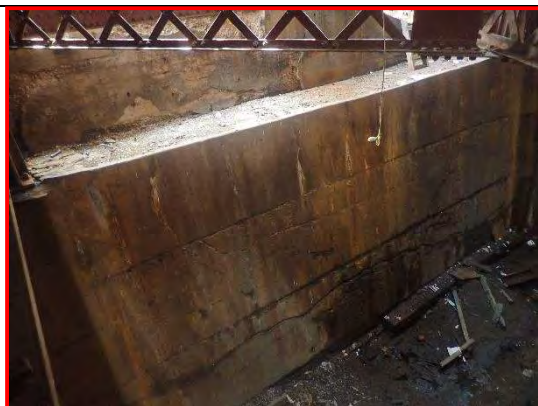
74. View of north face of north river pier, looking south.

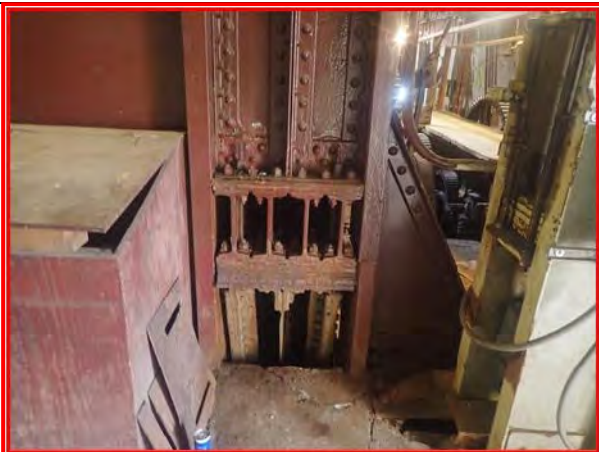
78. Northwest anchor column, looking south.

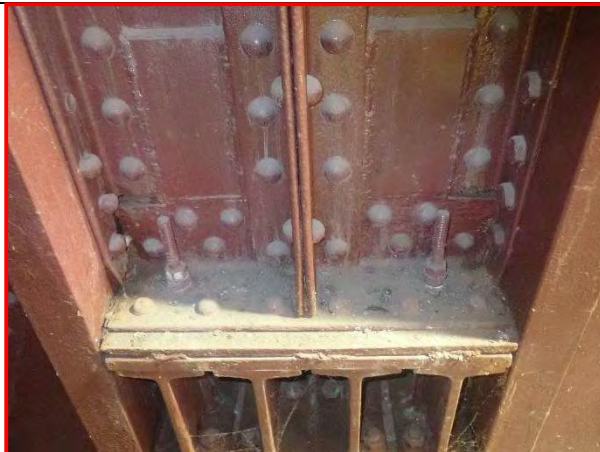
79. Southwest anchor column, looking north.
