**CITY OF CHICAGO - DEPARTMENT OF TRANSPORTATION  
BRIDGE INVENTORY REPORT**

**Structure No. 016-6038**

**95<sup>th</sup> Street  
over  
the Calumet River**

**Inspection Date: August 11, 2021**

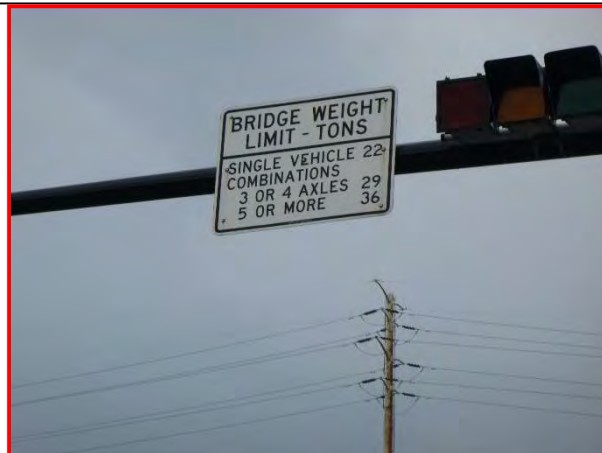
- The bridge is open to traffic and is load posted (see Photograph 1).
- The weight limit signs are located east of the structure at the intersection of 95<sup>th</sup> Street and S Ewing Avenue, and west of the structure at the intersection of South Chicago Avenue and 95<sup>th</sup> Street.

1. Weight limit posting sign, looking east.

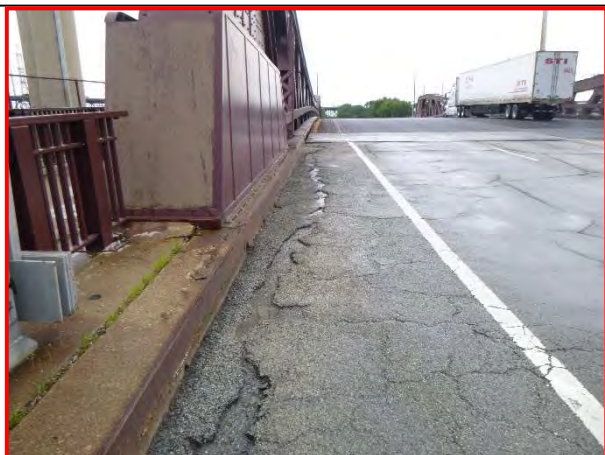
6. Span 2, south curb, looking west.

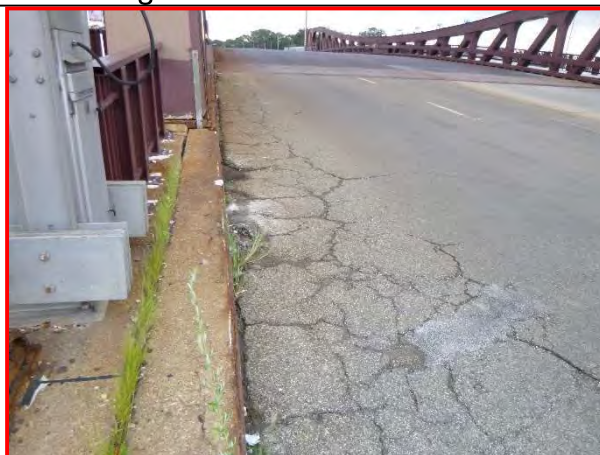
7. Span 4, north curb, looking east.

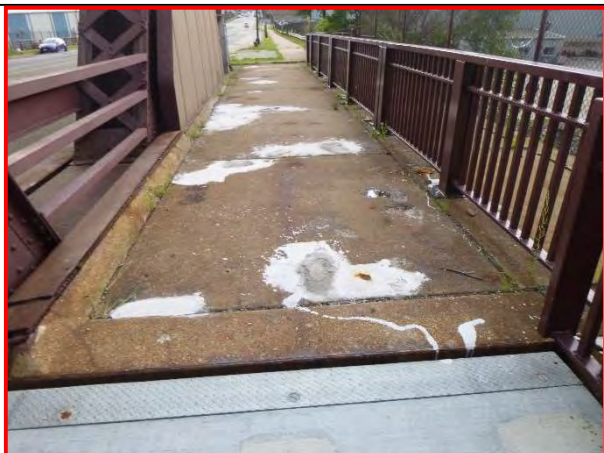
- The south sidewalk at the east expansion joint exhibits heavy spalling, with heaving up to 4” vertically (see Photograph 15).
- The south sidewalk in Spans 1 and 2 exhibits heaving (see Photograph 16).
- There is a concrete patch at the southwest corner of the truss. (see Photograph 17).
- The southwest approach sidewalk has been patched (see Photograph 18).
- The northeast approach sidewalk has a grate approximately 20’ from the east expansion joint that is bent in up to 2” (see Photograph 19).

16. Spans 1 and 2 sidewalk, looking east.

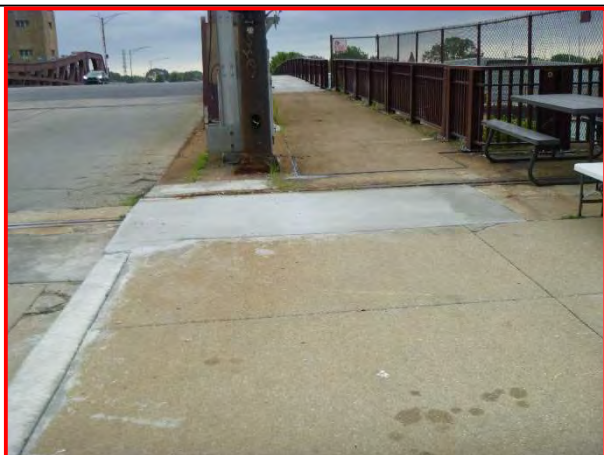
18. Southwest approach sidewalk, looking east.

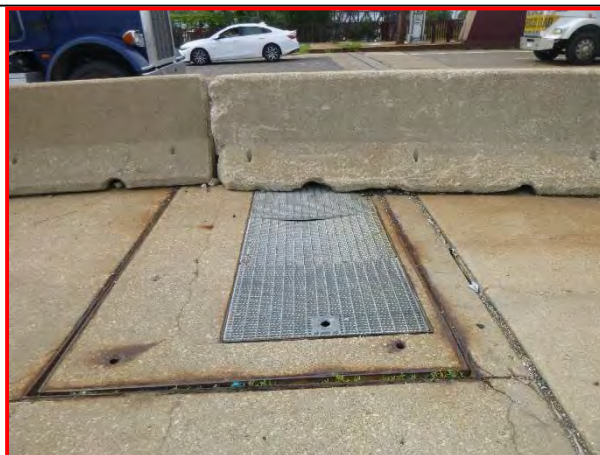
19. Typical fixed span sidewalk, looking east.

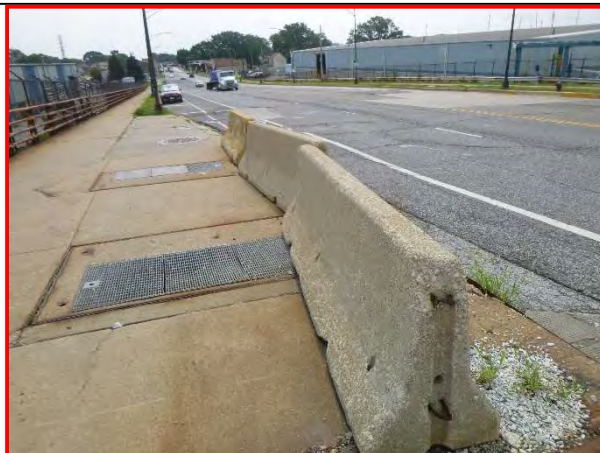
- There are no guardrails on the structure; however, temporary concrete barriers are in place along the Northeast Approach Sidewalk (see Photograph 27).

27. Temporary concrete barriers along northeast sidewalk, looking east.

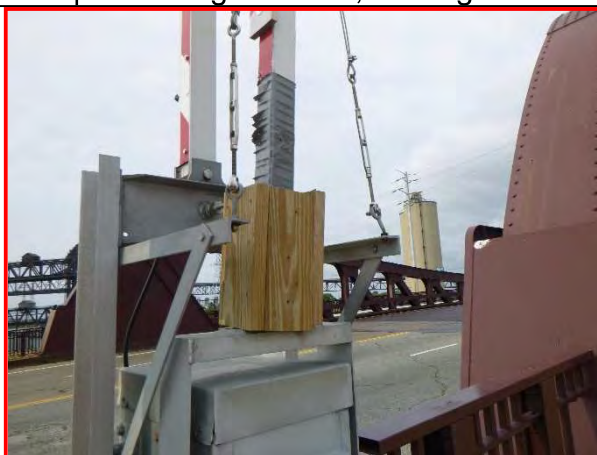
- The center truss has counterweight boxes attached to the truss (see Photograph 30).
- The life preservers are in place at the northeast and northwest corners (See Photograph 31).
- The traffic and pedestrian barriers are in place in Spans 1 and 5. The northeast traffic Span 1 barrier exhibits repairs made with wood and tape (see Photograph 32).

32. Span 1 northeast traffic barrier, looking southwest.

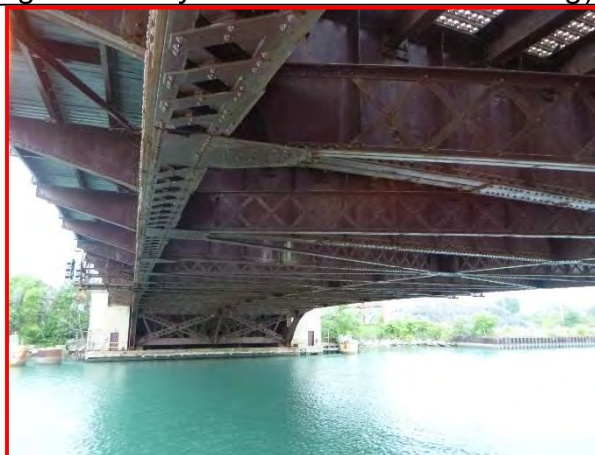
33. Overall underside of the movable superstructure, looking northwest.

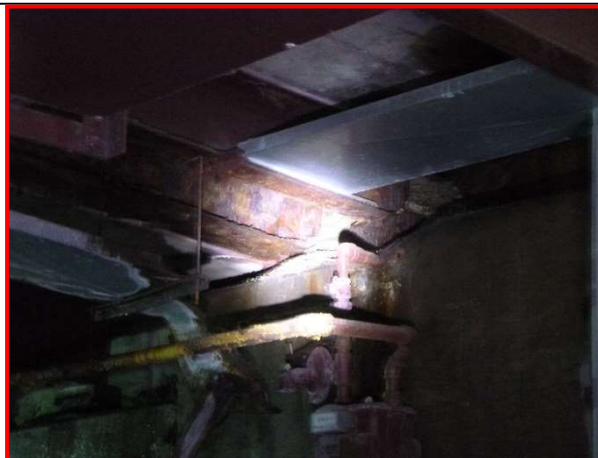
- The abutment bearings exhibit several cracked castings, several missing anchor bolts, and moderate to heavy section loss on the anchor bolt, with up to 3 inches of misalignment to the West Abutment bearings (see Photograph 34).
- The grout pads at the East Abutment bearings are heavily cracked and spalled (see Photograph 35).
- The trunnion bearings in the fixed spans exhibit minor to moderate corrosion with minor section loss (see Photograph 36).
- The live load bearings exhibit moderate corrosion and moderate to heavy section loss and minor debris accumulation. The anchor bolts have moderate section loss (see Photograph 37).

**35.** East Abutment bearings, looking east.

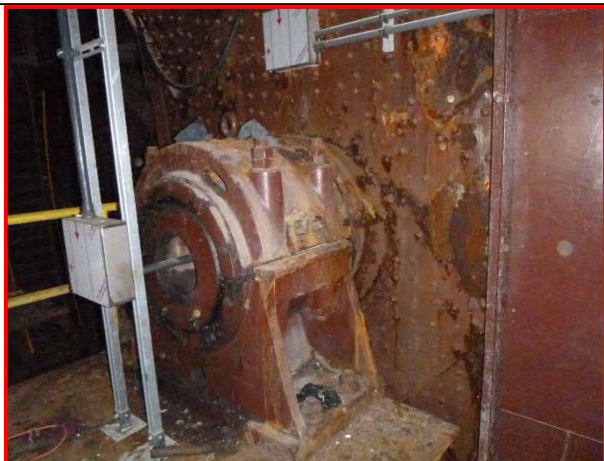
**36.** Southeast trunnion bearing, looking northwest.

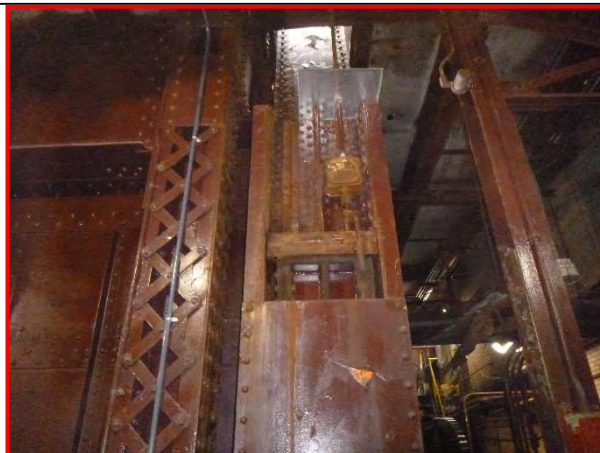
- West Live Load Bearings, the top shoes are out of alignment with the bottom castings up to 1/2 inch to the south.
- The secondary live load bearings on the anchor columns exhibit pack rust between the bumper stiffener plates, and there are no gaps between the steel bumpers and the anchor shoes (see Photograph 38).
- The longitudinal girder bearings on the river piers exhibit moderate corrosion (see Photograph 39).

38. Northeast secondary live load bearing, looking west.

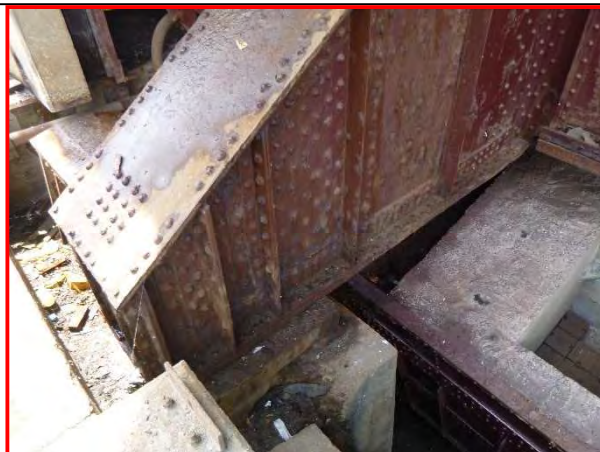
39. Southwest longitudinal girder bearing, looking south.

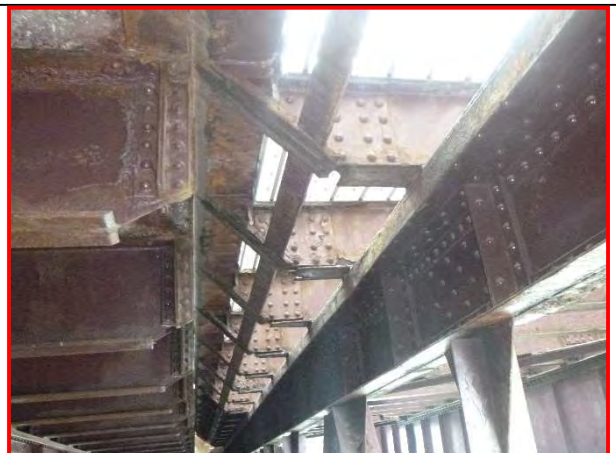
42. Section loss along a stringer in Span 3, looking southeast.

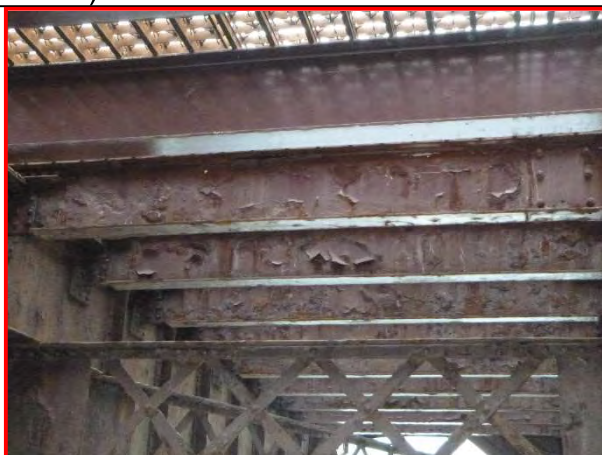
- In the movable span, the roadway stringers typically exhibit minor to moderate corrosion, widespread corrosion holes (up to 4" long by 5" high) along the web, and paint peeling and flaking (see Photograph 43).

43. Panel 8 stringers, looking north.

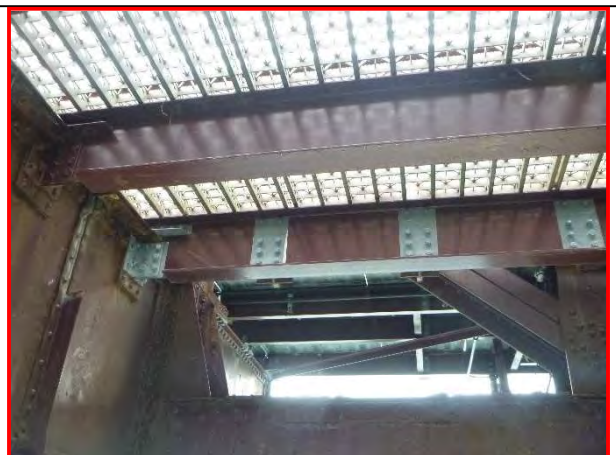
- In the movable span, there are varying degrees of corrosion, section loss and corrosion holes along the web and stringer end connections, as well as various stringer and connection repairs. The cantilever stringers supporting the center break exhibit moderate corrosion and minor section loss. The sidewalk stringers in the movable span exhibit minor to moderate corrosion with section loss and scattered corrosion holes. A few of the sidewalk stringers are out of plumb. See Exhibit 1 located at the end of the report for deficiencies and repairs in Movable Span Stringers (see Photographs 44 to 50).

44. Panel 7, Stringer 1, looking south.

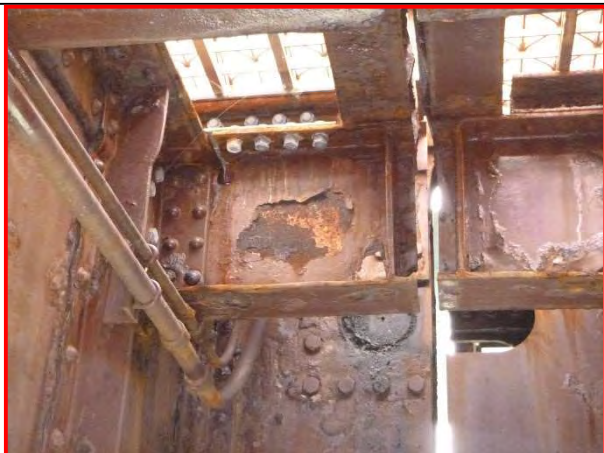
45. Panel 8, Stringer 1, looking south.

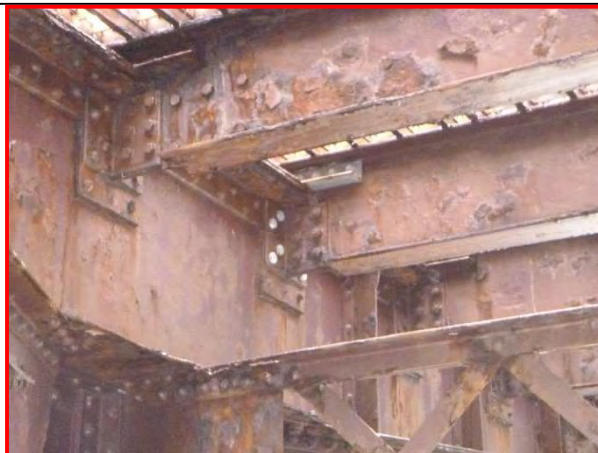
46. Panel 9, Stringer 9, looking southeast.

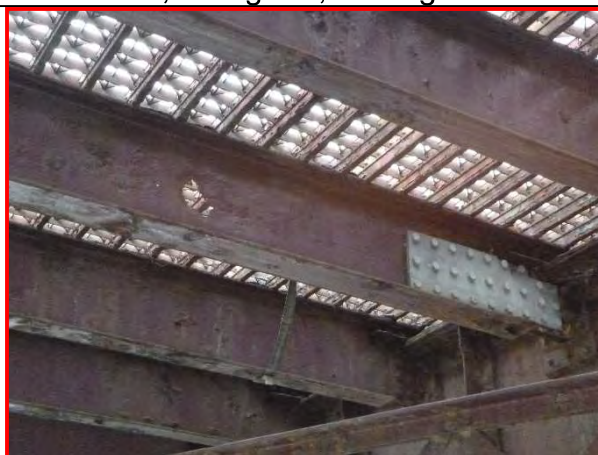
48. Panel 12, Stringer 6, looking southwest.

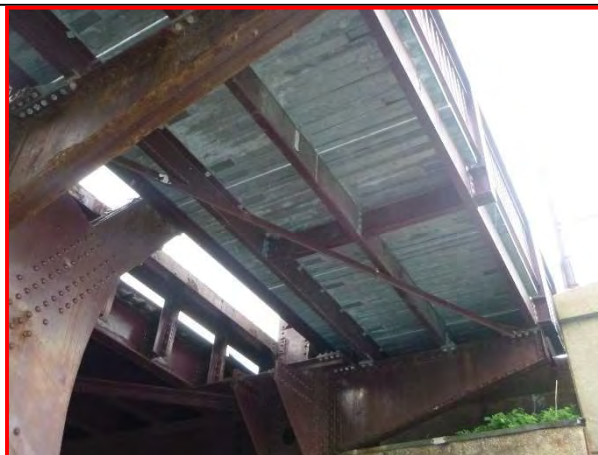
50. Span 2 south sidewalk stringer, looking northeast.

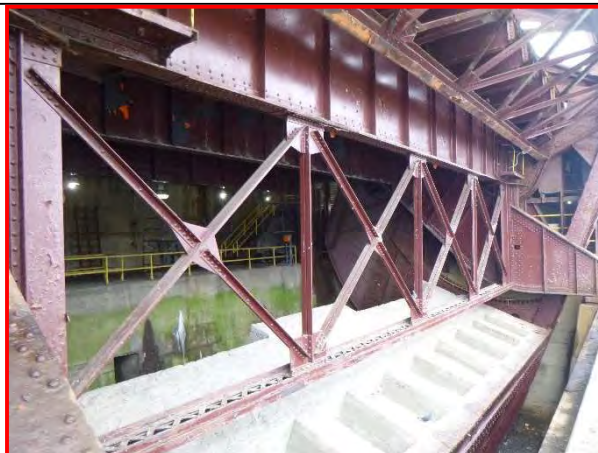
- The trunnion girders and trunnion cross girders exhibit localized areas of moderate to heavy corrosion with minor to moderate section loss and paint peeling (see Photographs 51 and 52).
- The west trunnion cross girder is rotated up to 3 degrees out of plumb at both ends.
- Localized areas of vertical stiffener corrosion and minor section loss are present at the trunnion girder ends near the river piers (see Photograph 53).

**51.** Southeast trunnion girder, looking south.

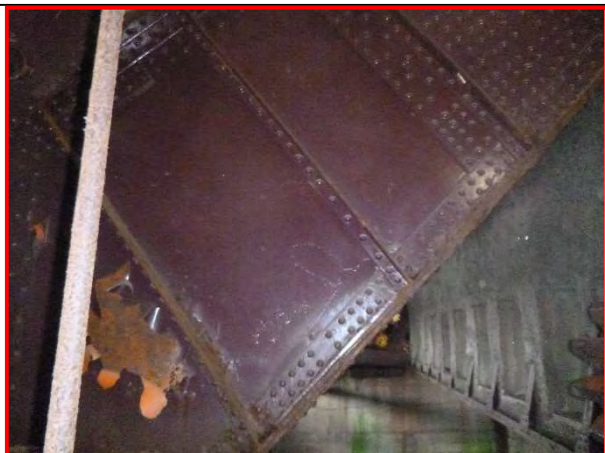
**52.** Southeast trunnion girder, looking north.

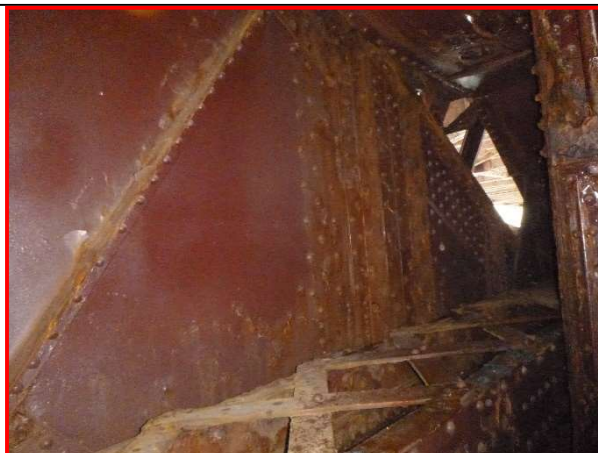
**53.** Vertical stiffeners of the southeast trunnion girder, looking east.

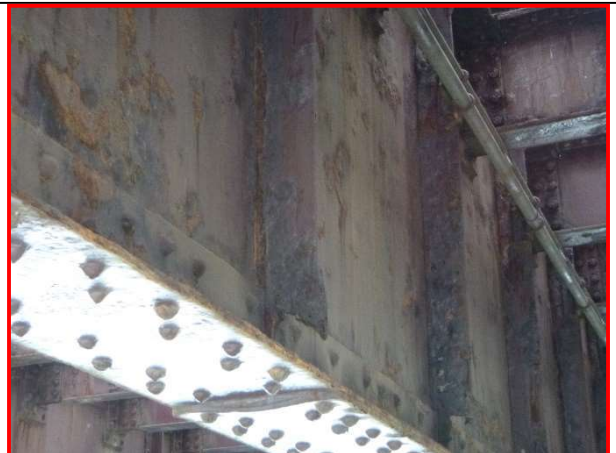
56. Typical moveable span floorbeam, looking southeast.

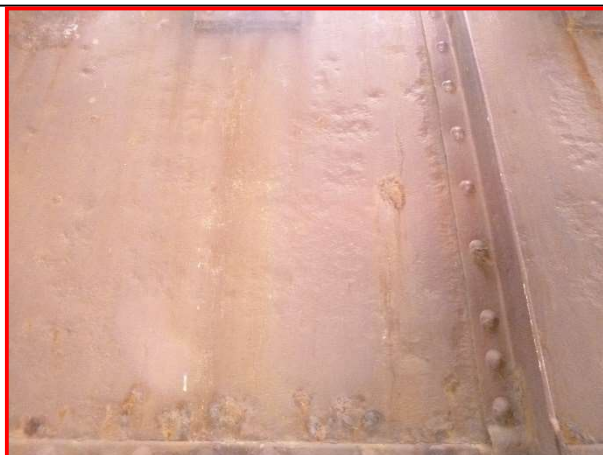
57. Typical floorbeam pitting, looking east.

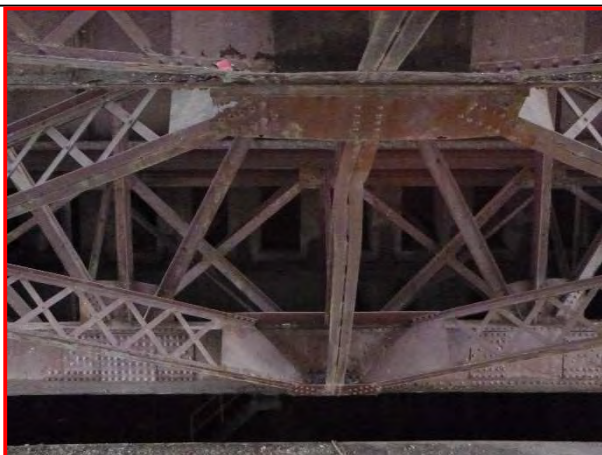
- In the movable span, the lateral bracing exhibits heavy corrosion, corrosion holes, several broken lacing bars, and a few locations of bent flanges (see Photographs 60-62).
- Several sidewalk lateral bracing connection plates have corrosion holes, and some lateral bracing members are also sagging.
- Span 2 and 4, the lattice trusses and connections exhibit moderate to heavy corrosion and scattered corrosion holes.

61. Panel 1 lateral bracing, looking east.

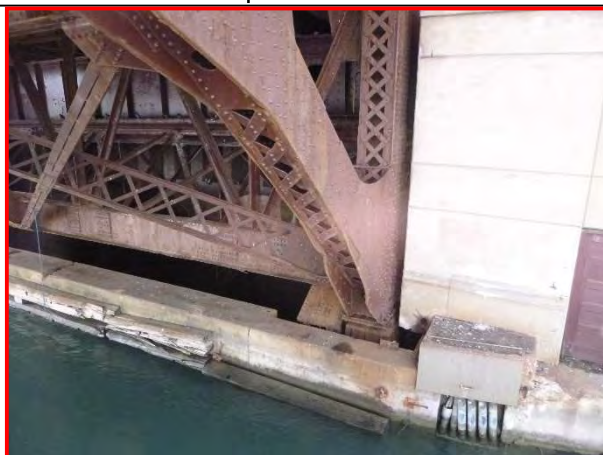
- The bascule trusses exhibit corrosion with scattered areas of minor to moderate section loss, pack rust, and scattered locations of bent members (see Photograph 64).
- In the moveable span, bottom chord members at the northeast and northwest supports exhibit bent flanges (see Photographs 65-66).
- Near the rear end of the trusses over the counterweight pits, the truss bottom chords exhibit minor to moderate corrosion along the bottom flanges with moderate rivet head loss.
- Pack rust is typically present along the bottom chord and fill plate interface.

**65.** Bottom chord member at northwest support, looking west.

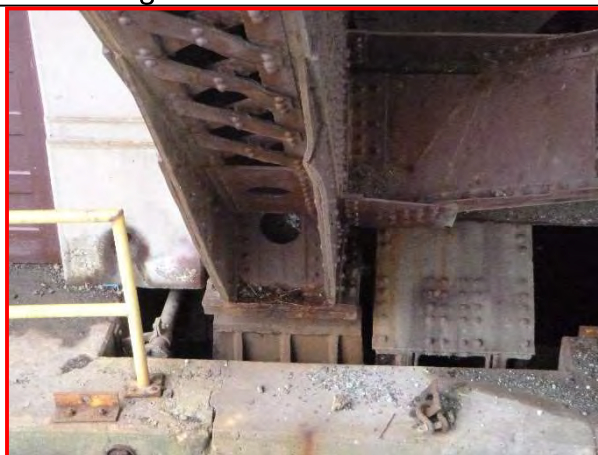
**66.** Bottom chord member at northeast support, looking east.

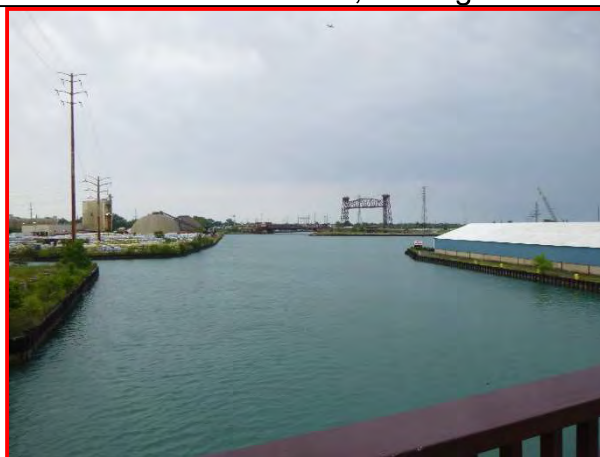
88. Upstream channel, looking north.
