**CITY OF CHICAGO - DEPARTMENT OF TRANSPORTATION
BRIDGE INVENTORY REPORT**

Structure No. 016-6042

**100th Street
over
the Calumet River**

Inspection Date: August 16, 2021

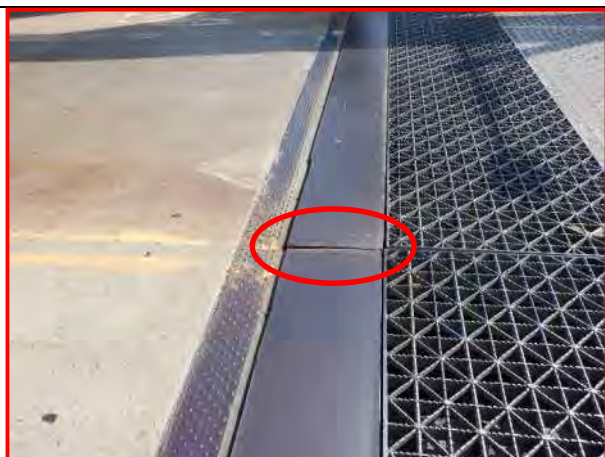
- In the south sidewalk at the center break, the west leaf is resting on top of the east leaf (see Photograph 21).
- At the rear breaks, the fixed spans are between $\frac{1}{8}$ " to $\frac{1}{4}$ " lower than the movable span. The east break weldment is cracked along the centerline of roadway (see Photograph 22).
- The northwest longitudinal sidewalk joint is failing (see Photograph 23).

22. East rear break, looking south

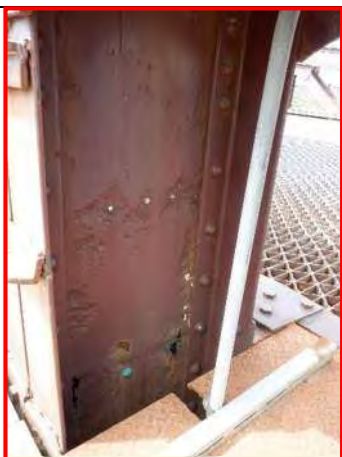
69. Typical Vertical Truss Member, looking northwest
