**CITY OF CHICAGO - DEPARTMENT OF TRANSPORTATION
BRIDGE INVENTORY REPORT**

Structure No. 016-6037

**Ewing Avenue (US41 – 92nd Street)
over
the Calumet River**

Inspection Date: August 10, 2021

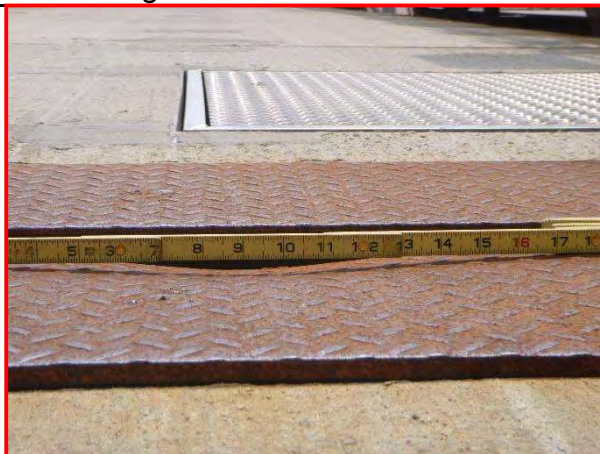
- The expansion joints exhibit sections of depressed and torn glands, moderate to heavy corrosion of the steel rails, and moderate debris accumulation (see Photograph 14).
- The sidewalk expansion joints exhibited heavy corrosion and debris buildup (see Photograph 15).
- The center and rear breaks along Span 3 exhibit moderate corrosion (see Photograph 16).
- At 85° Fahrenheit, the center break at the east sidewalk has a 1.75" gap, and the west sidewalk has a 2.125".
- The north center plate at the east sidewalk exhibits a 1" vertical distortion (see Photograph 17).

17. East sidewalk center plate, looking south.

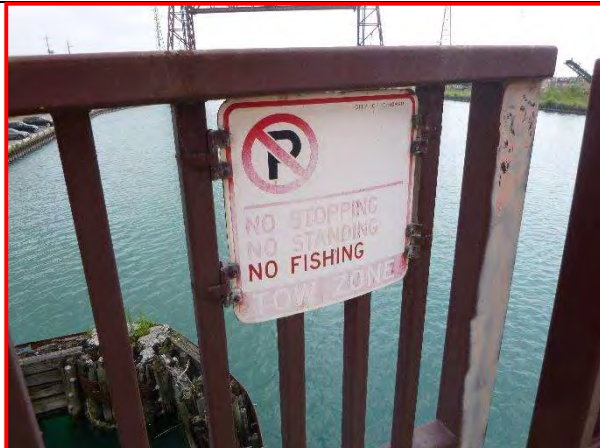
- Signage throughout the structure are typically faded (see Photograph 26).

26. No parking signage, looking east.

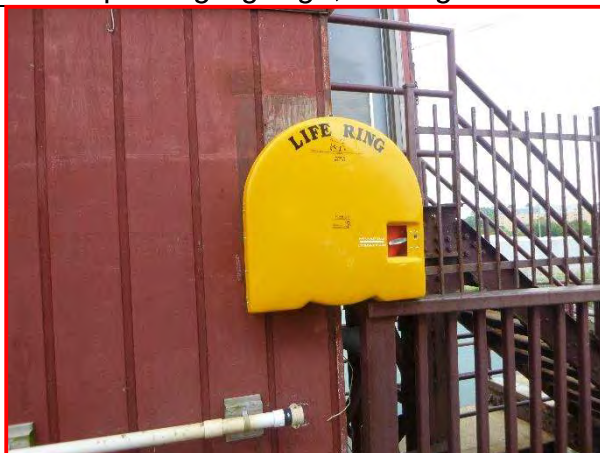
- The life preservers were in place (see Photograph 27).

27. No parking signage, looking east.
