**CITY OF CHICAGO - DEPARTMENT OF TRANSPORTATION  
BRIDGE INVENTORY REPORT**

**Structure No. 016-6038**

**95<sup>th</sup> Street  
over  
the Calumet River**

**Inspection Date: August 11, 2021**

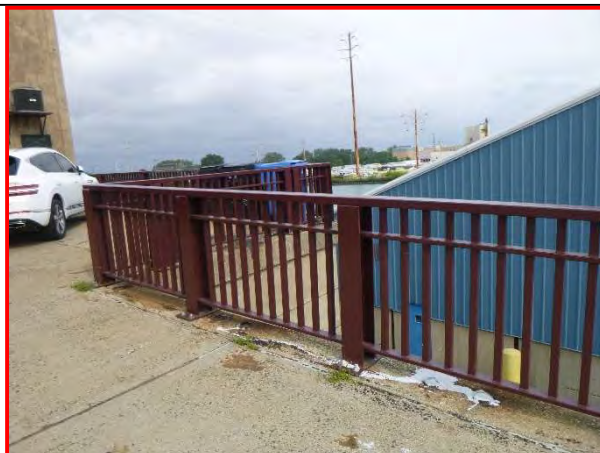
- The railings in Span 3 exhibit isolated areas of moderate corrosion and scattered paint peeling/scrapes throughout (see Photograph 8).
- Span 3, there are steel railings field welded to the outside face of the vertical and diagonal truss members above the sidewalk.
- Sections of the fixed span pedestrian railings have been replaced (see Photograph 9).

9. Fixed span pedestrian rail, looking northwest.

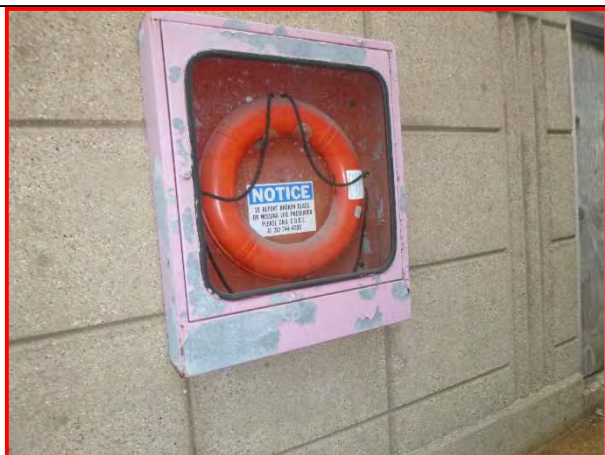
31. Life preserver at northwest corner, looking north.

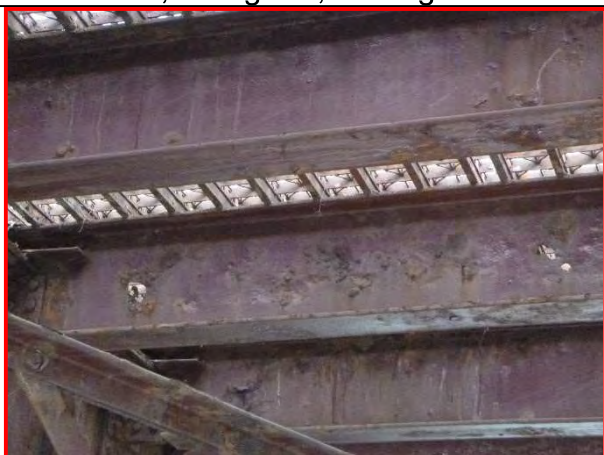
- In the movable span, there are varying degrees of corrosion, section loss and corrosion holes along the web and stringer end connections, as well as various stringer and connection repairs. The cantilever stringers supporting the center break exhibit moderate corrosion and minor section loss. The sidewalk stringers in the movable span exhibit minor to moderate corrosion with section loss and scattered corrosion holes. A few of the sidewalk stringers are out of plumb. See Exhibit 1 located at the end of the report for deficiencies and repairs in Movable Span Stringers (see Photographs 44 to 50).

47. Panel 9, Stringer 4, looking north.

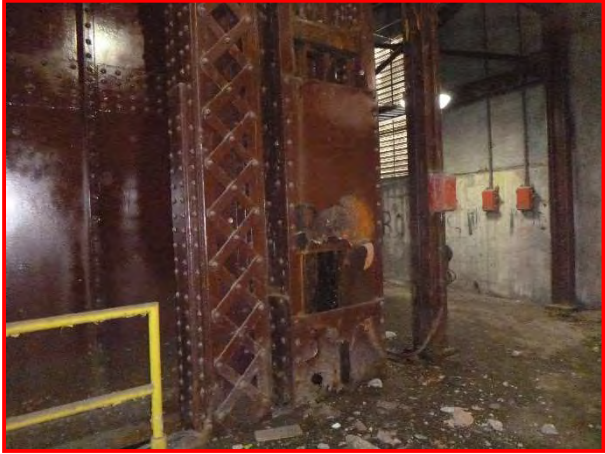
<p>79. East face of river pier wall, looking west.</p>
<p><i>Columns</i></p> <ul style="list-style-type: none"><li>• The batten plates near the base of the anchor columns are heavily corroded with corrosion holes (see Photograph 80).</li><li>• The trunnion girder columns exhibit areas of minor section loss with corrosion holes in the lacing bars, as well as heavy rivet head loss.</li><li>• The sidewalk columns exhibit minor section loss near the bases. The grout pads of the sidewalk columns are cracked and spalled.</li></ul>

<p>80. West anchor column and trunnion column, looking southeast.</p>

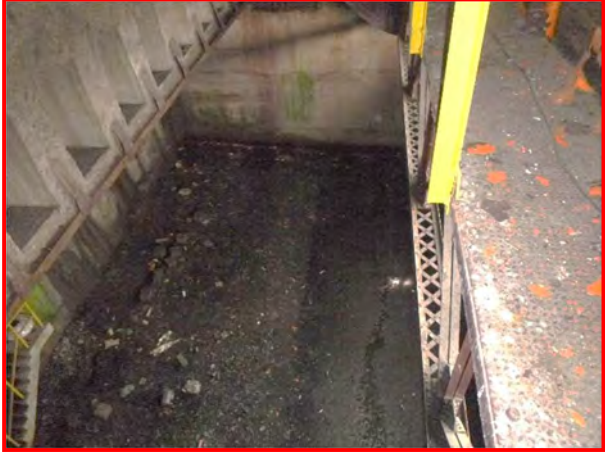
<p><i>Counterweight Pits</i></p> <ul style="list-style-type: none"><li>• The counterweight pit side walls exhibit narrow to medium vertical and horizontal cracks with leaching, as well as several large spalls with exposed and corroded reinforcement (see Photograph 81).</li><li>• There is cracked and spalled concrete below the machinery bearing plates at midspan of the side walls.</li><li>• There is debris and steel counterweight blocks within the pits.</li><li>• During the time of inspection there was no standing water in the counterweight pits.</li></ul>

<p>81. Overall view of east pit, looking down/northeast.</p>
